NCKRI REPORT OF INVESTIGATION 1

GEOLOGIC AND HYDROLOGIC RECONNAISSANCE OF LAS CRUCES, PETÉN DEPARTMENT, GUATEMALA

Lewis Land
George Veni

January 2011

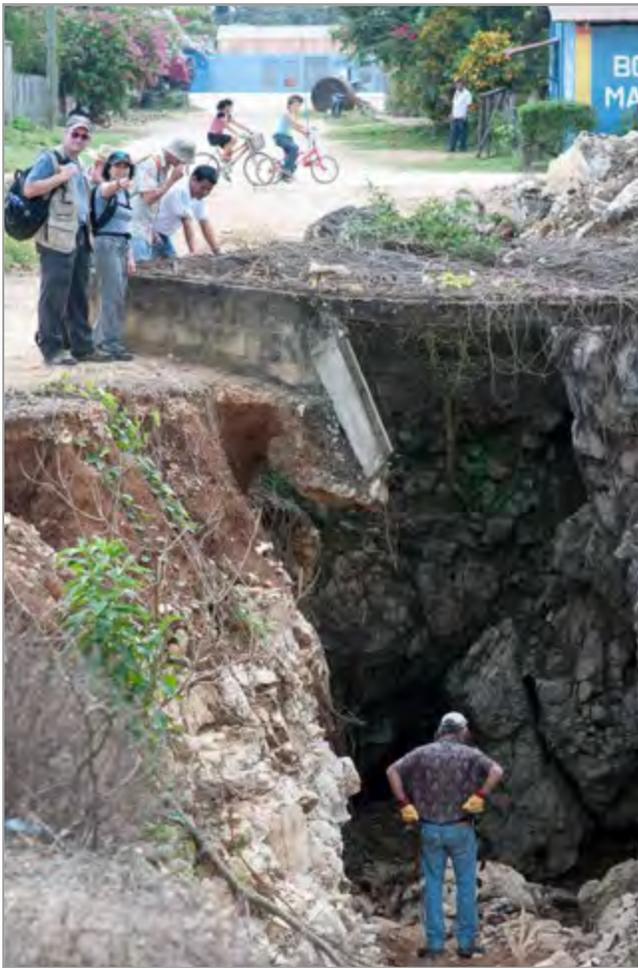
entrance is about 4 m in diameter, but the cave itself extends only about 8 m and narrows to a passage about 50 cm in diameter that is choked with trash (Figure 2). A smaller second entrance that does not receive significant natural drainage is present about 15 m west of the main entrance to the cave. Because of limited access, its connection to the main entrance is assumed but not known. In addition to El Tragante, a sinkhole approximately 25 m in diameter occurs on the north side of town (cover photo). Las Cruces residents also report the existence of a second cave within the village limits that was filled recently to prevent access by children and animals.

Figure 2. Dr. Lewis Land inspects the main entrance of El Tragante; a debris-catching grate had spanned the channel but was damaged by flooding and removed.

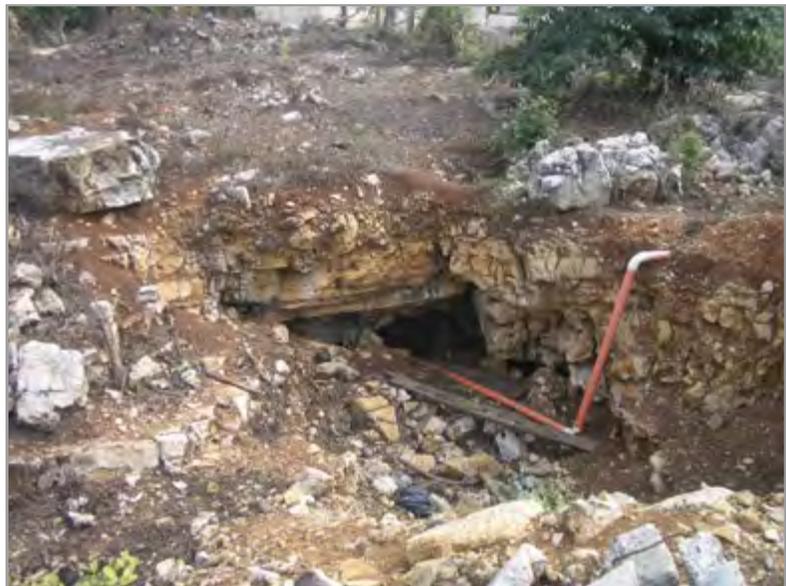
Figure 4. Sewage pipe into the probable second entrance of El Tragante; this entrance is 3 m deep.

While remediation of groundwater quality was not a part of this study, contamination of the karstic groundwater supply would be at least partially mitigated by removal of the sewage line into the probable second entrance of El Tragante. In addition, Las Cruces residents should stop discharging graywater and sewage into the existing canal, since that waste is transported directly into the limestone aquifer via El Tragante. Lastly, the installation of a debris rack, designed to keep trash from entering the cave and not restricting recharge, would reduce both flooding and groundwater contamination.

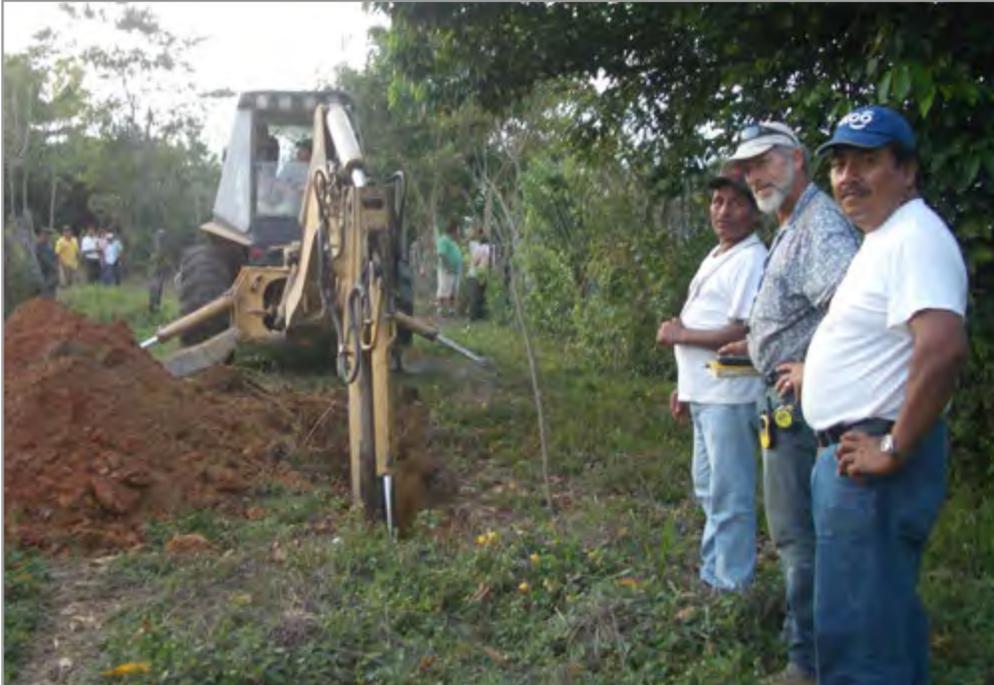
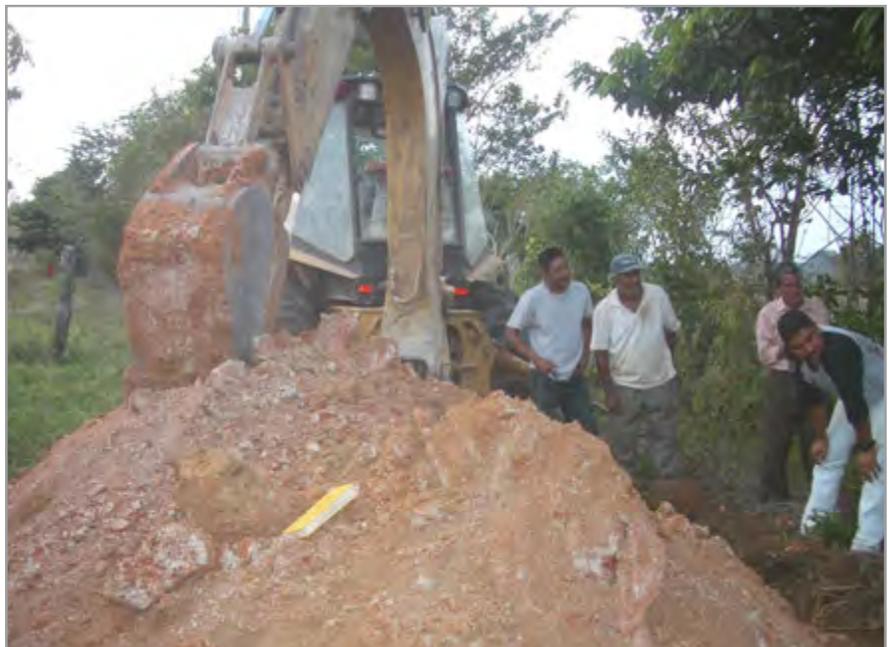
Test Pit 250

Description: Maximum depth 3.5 m. Reddish-brown soil (silt, clay, organics). Clay content increases slightly with depth. Slight water flow (<1 L/min) encountered near the base of the pit. This is the only test pit excavated on the east-west leg of the proposed channel on the north side of town. Therefore, investigators should use caution in extrapolating these results to the rest of the east-west transect.

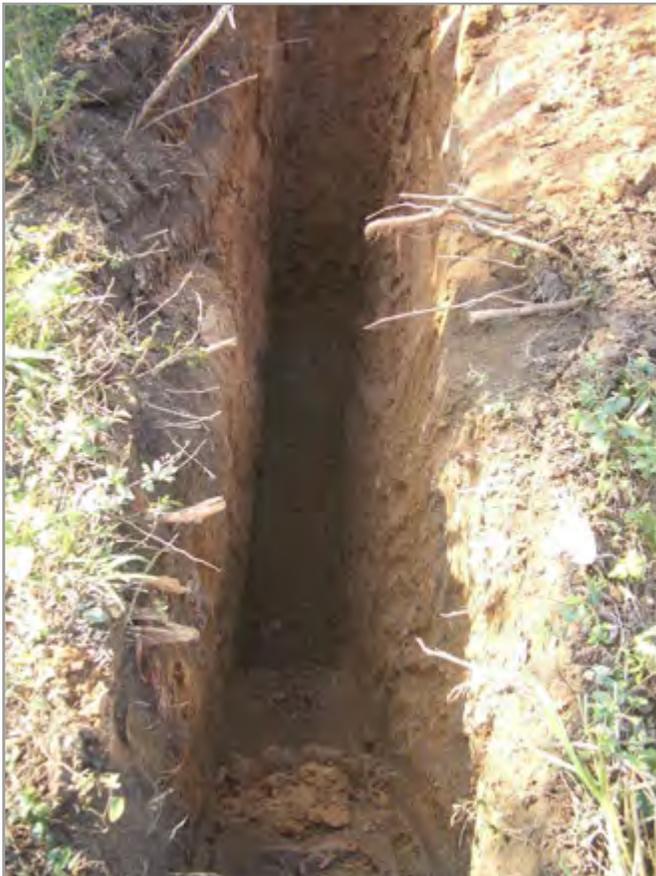
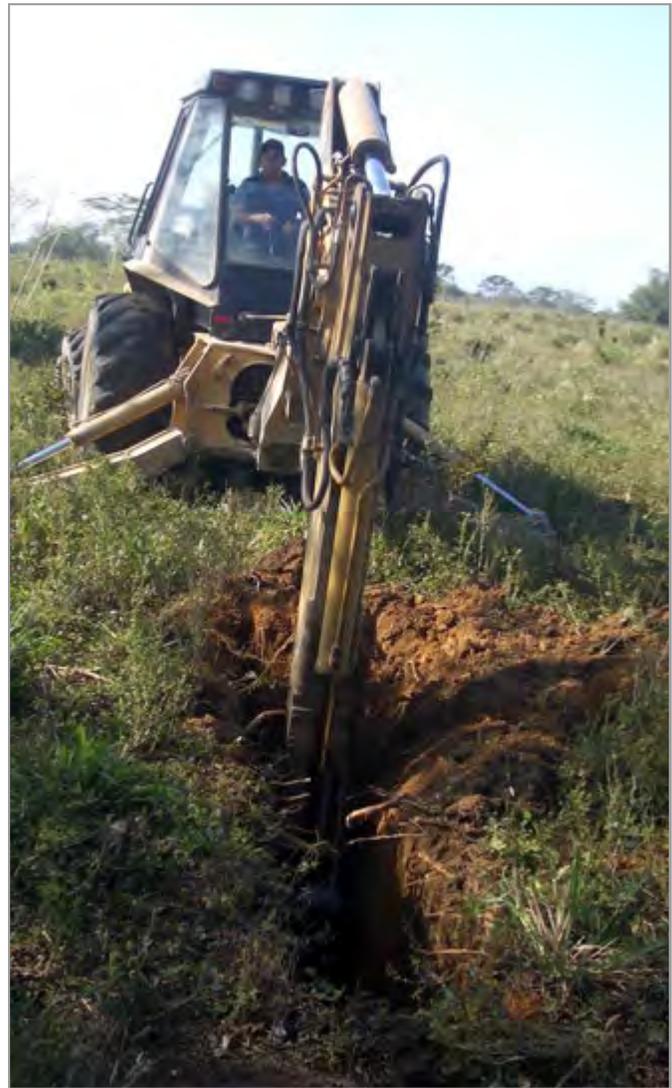
Test Pit 10

Description: Maximum depth 3.7 m. Orange-red clay, becoming lighter with depth. Dense red clay with gray streaks below 3 m. Stiff, highly-compacted red clay is present at the base of the pit. No water flow was encountered. This is the northernmost pit on the north-south leg of the proposed channel.

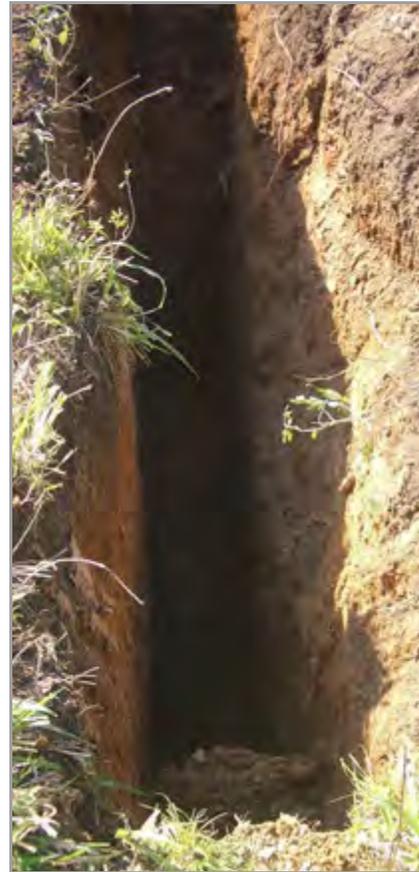
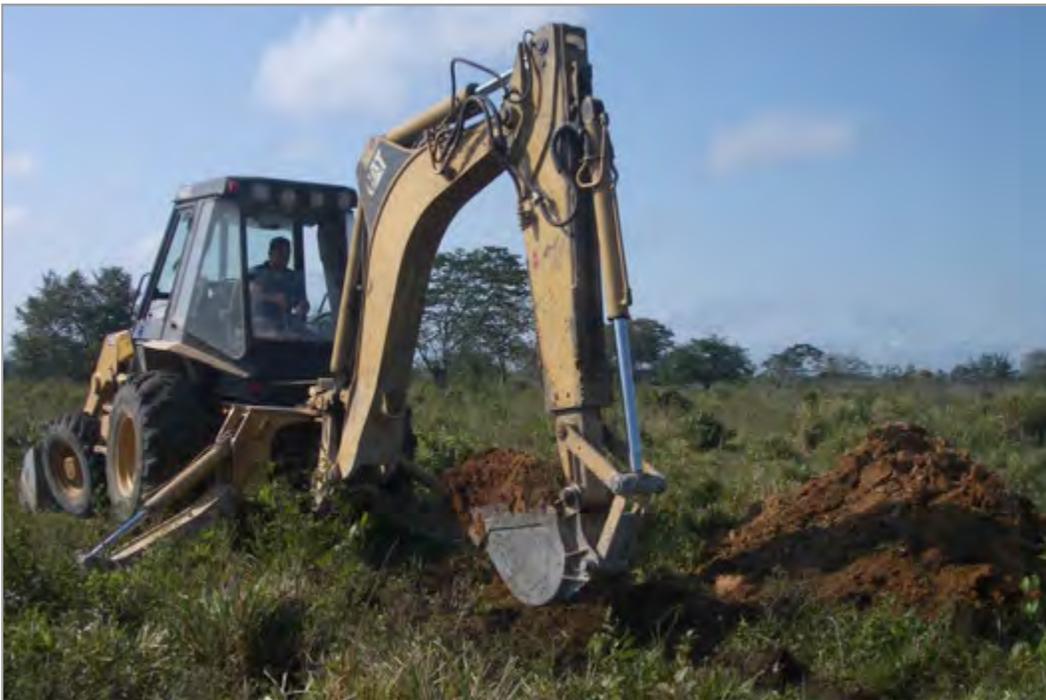
Test Pit 20

Description: Maximum depth 4 m. Dense, orange-red clay. No water flow was encountered.

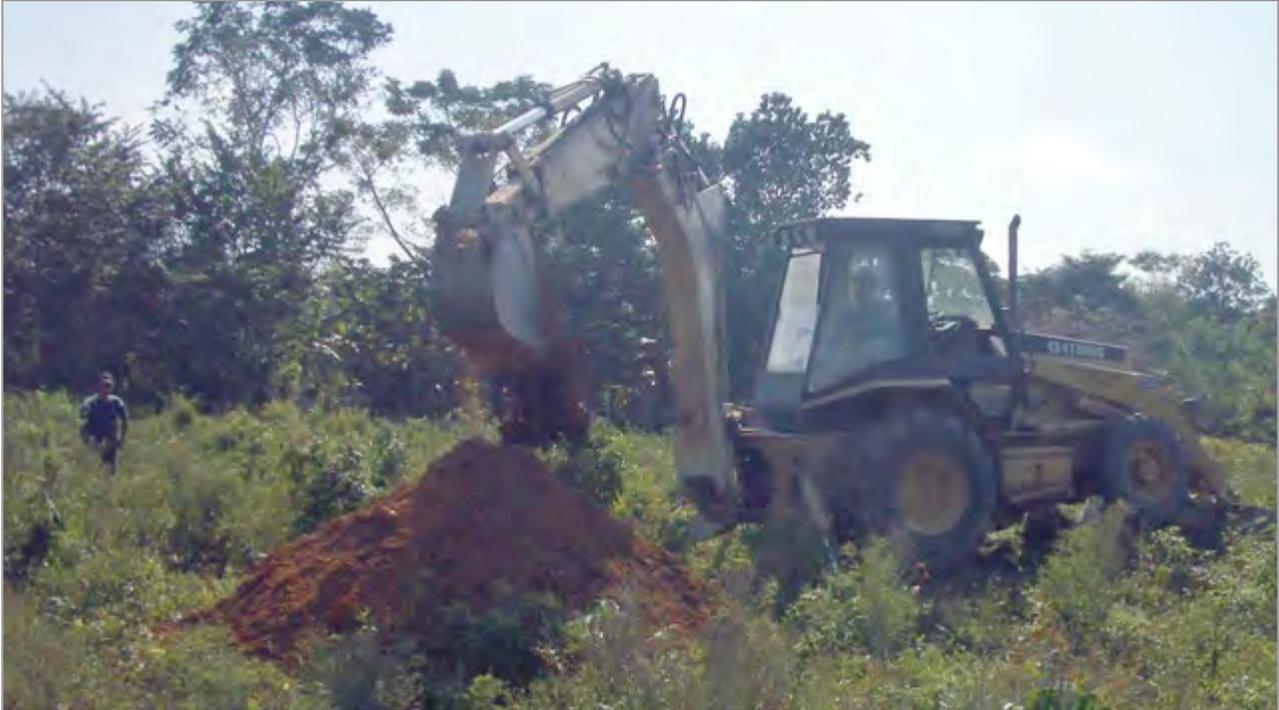
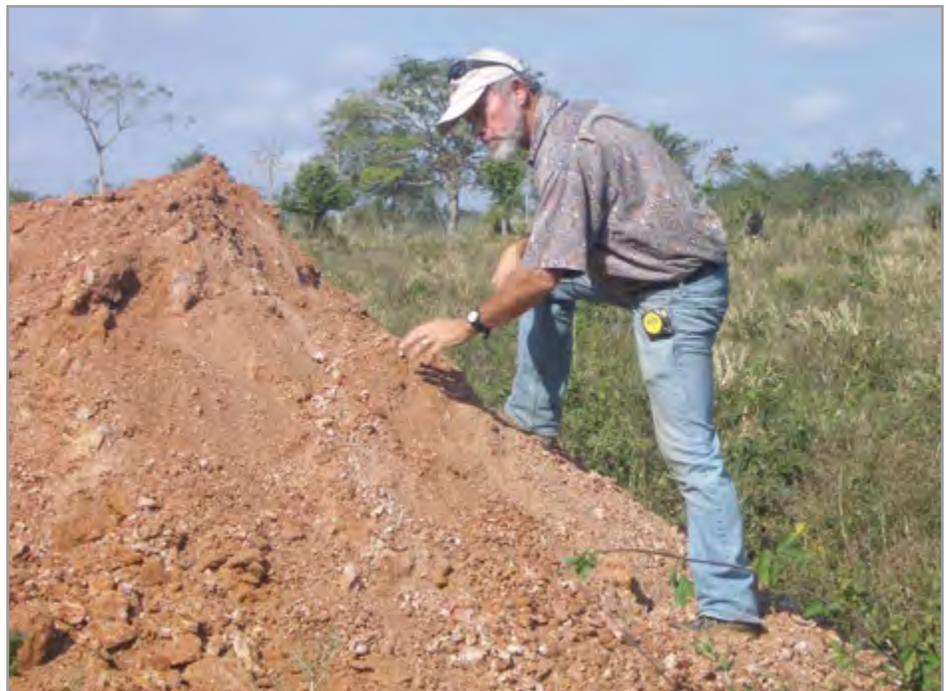
Test Pit 30

Description: Maximum depth 3.8 m. Light red clay, not as clumped and compacted as at the more northerly sites. No water flow was encountered.

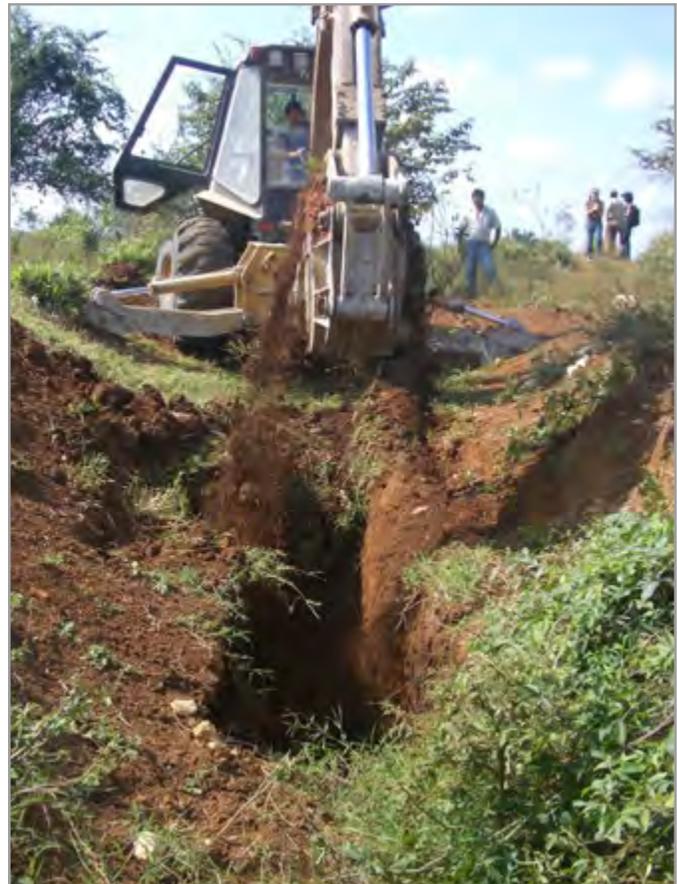
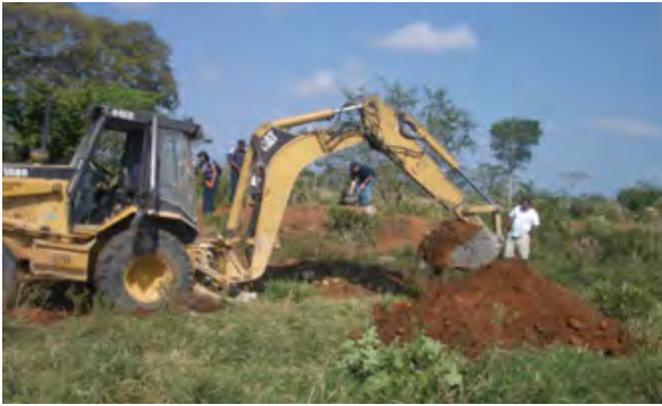
Test Pit 40

Description: At this pit the transect turns southwest to follow a shallow, pre-existing ditch that is approximately 1.5 m deep. The backhoe was located in the ditch, thus the maximum depth below average ground level was about 5.5 m while the depth of excavation was 4 m. Unconsolidated, reddish-brown soil was present to the bottom of the pit; the soil was comprised of silt, organics, and a small amount of clay. Abundant limestone cobbles and boulders in the berm adjacent to the pre-existing ditch suggested the presence of near-surface bedrock excavated during construction of the channel. However, field assistants from the local community reported the rock is part of an ancient Maya wall, probably for a terrace. The absence of any subsurface limestone confirms this hypothesis, which is further supported by the presence of small, poorly preserved limestone structures of obvious human origin within 100 m of Test Pit 40. One of these structures is a rubble-walled pit constructed without mortar, which a local guide suggested was used as storage for valuables by the Maya (Figure A11).

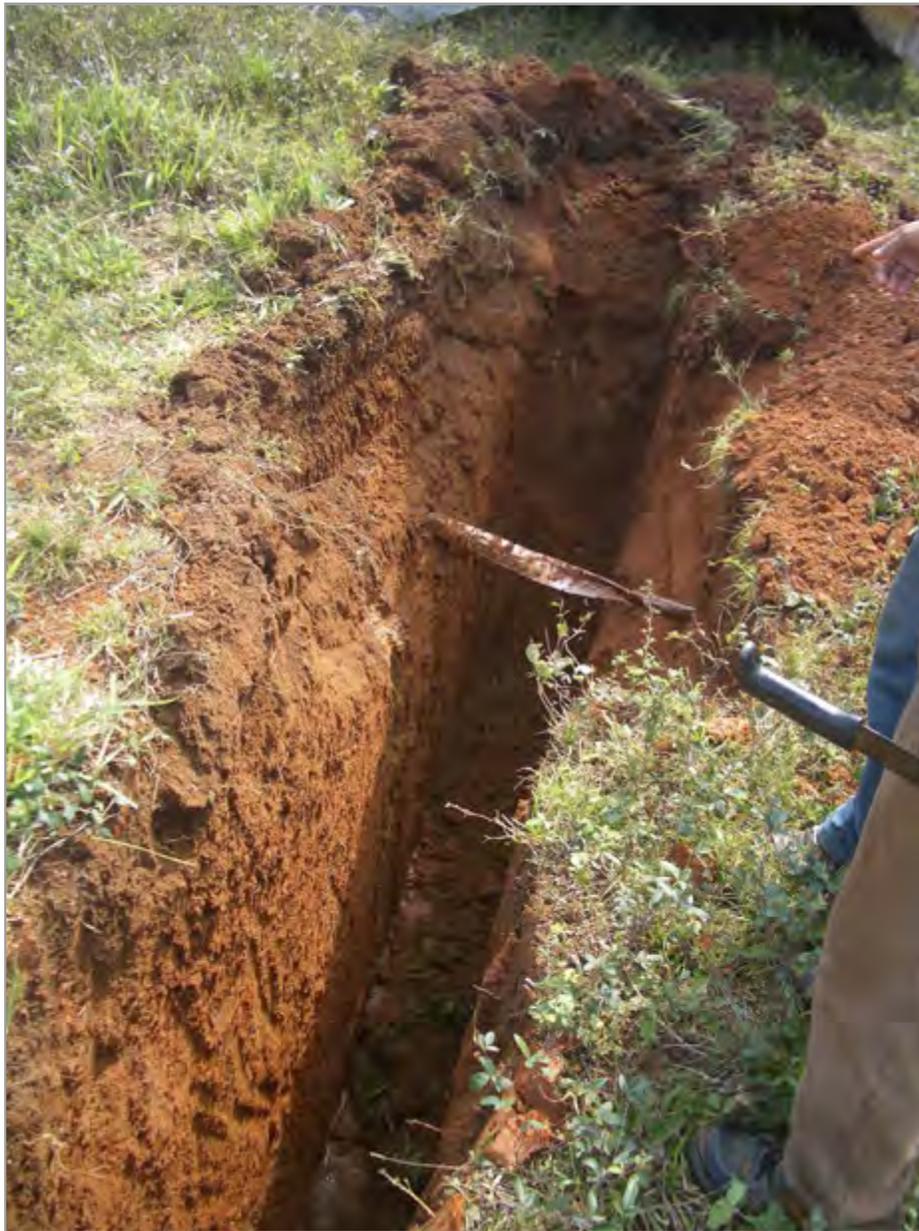
Test Pit 80

Description: Maximum depth 2.9 m. Red-brown clay-rich soil. Excavation was terminated before reaching the maximum depth possible for the backhoe because it broke an 8-cm diameter PVC pipe about 75 cm below ground level at the east end (nearer the village) of the pit. An estimated 1-2 L/min of water flowed from the broken pipe. Subsequent discussion with Rod Beadle of EWB suggested the pipe is a tile drain, placed to drain lower areas of fields where water could accumulate during rainy conditions.

Figure A15. Broken PVC pipe in Test Pit 80.

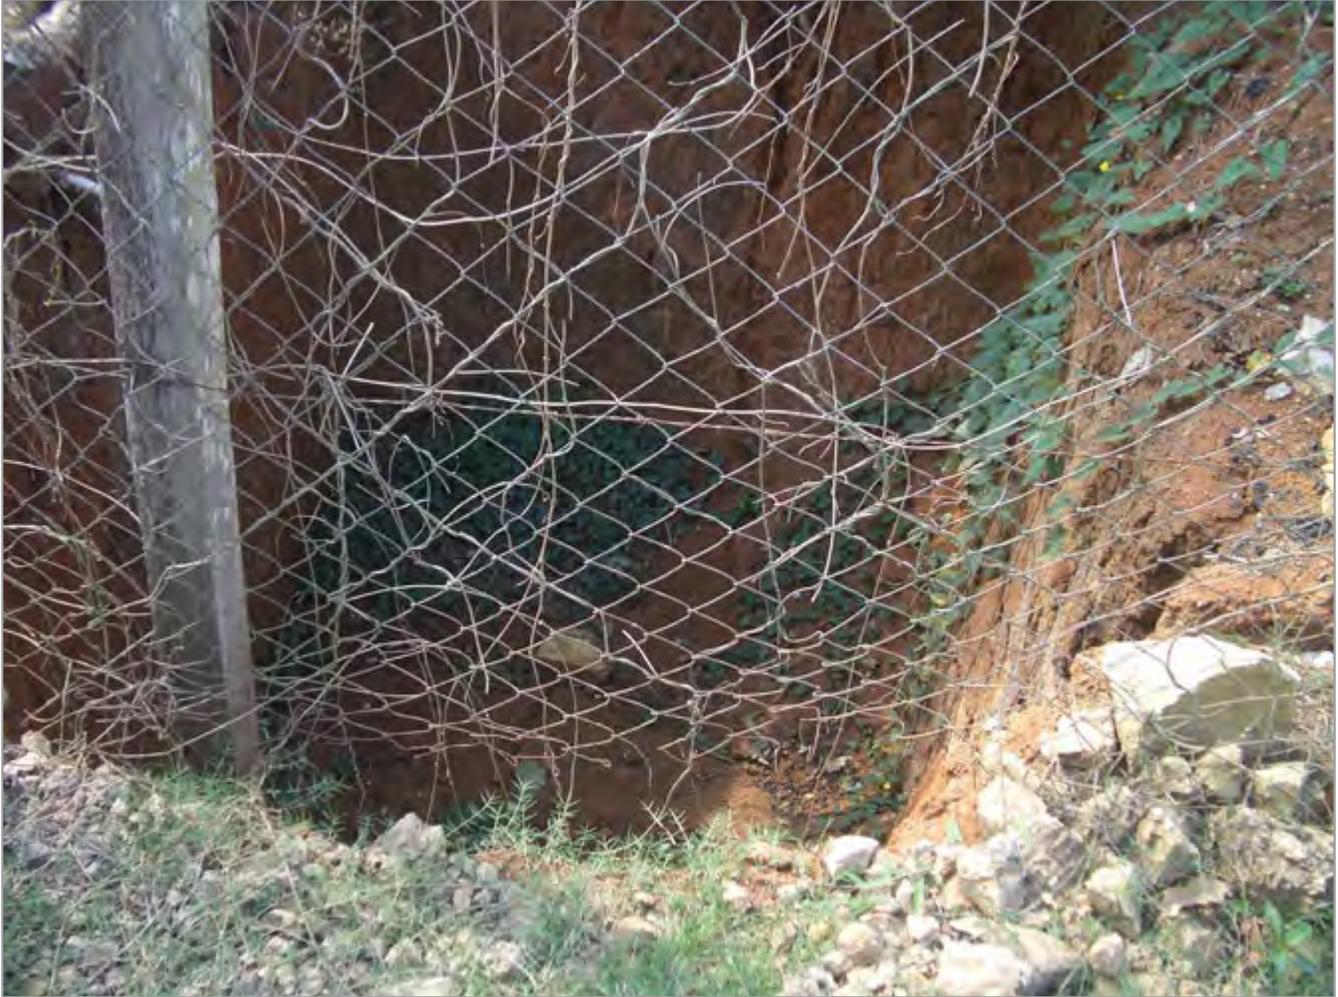
Description: Maximum depth approximately 3 m. Red soil and clay. This station is a cesspit recently excavated by a homeowner 50 m north of the main east-west highway through Las Cruces. There was no evidence that the owner had begun using the cesspit, so it was incorporated into the test pit survey.

Figure A16. Unused cesspit near Las Cruces, used as Test Pit 90 in survey.

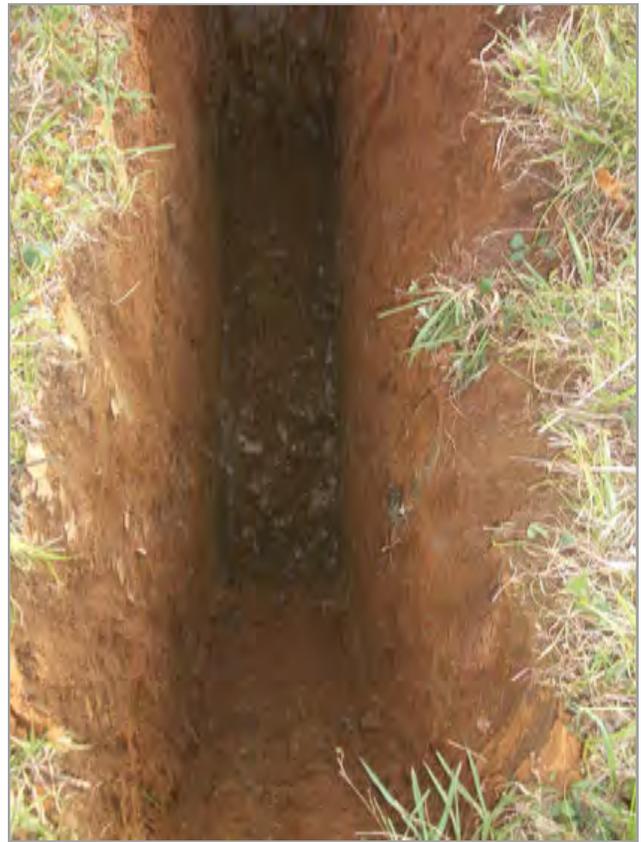
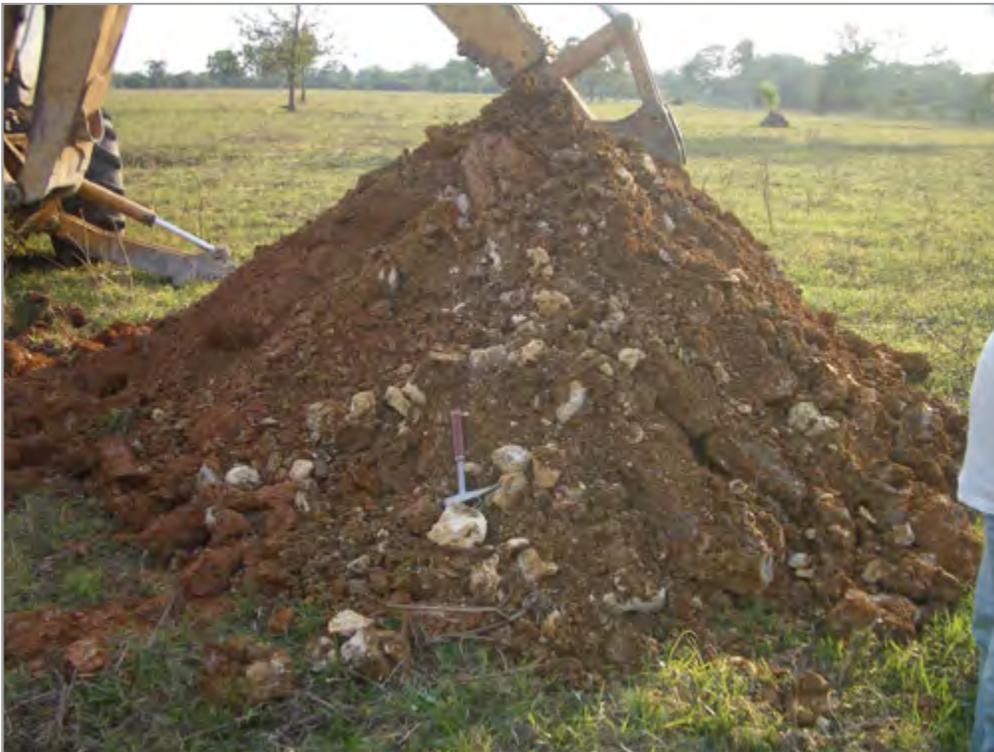
Test Pit 240

Description: Maximum depth 3.6 m. Reddish-brown soil down to about 3 m. Dense orange clay was found at 3.5 m depth, at which point the backhoe encountered weathered limestone bedrock. Bedrock was encountered near the depth limit of the backhoe. The limestone was insufficiently exposed for a detailed examination, but it was clearly bedrock, not isolated limestone boulders. This pit is the northernmost site at which we found any material other than soil and clay. Test pit site spacing was increased to Test Pit 230 because of time constraints.

Figure A18. Weathered limestone cobbles in sediment excavated from Test Pit 240.

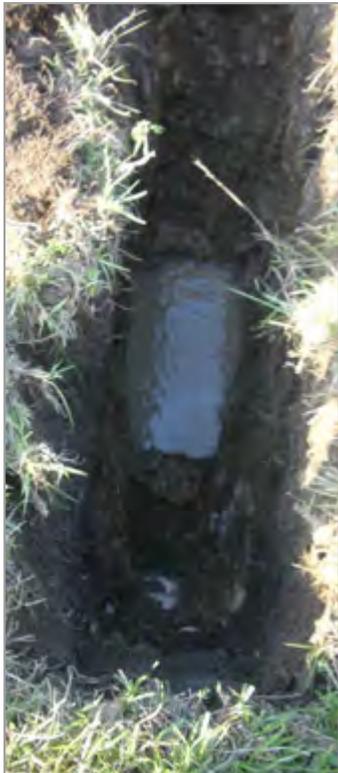
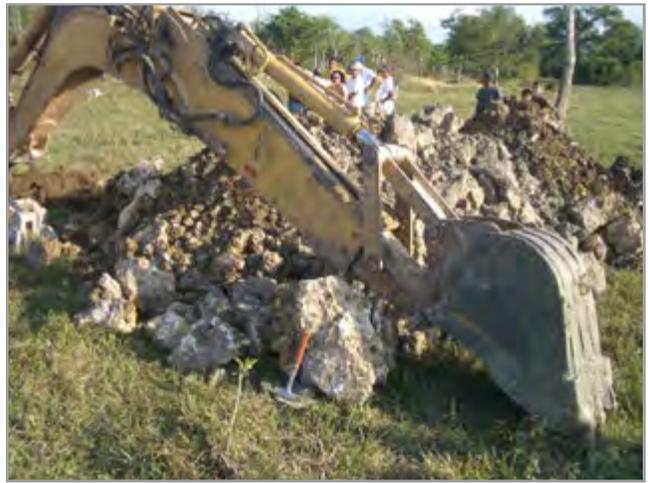
Test Pit 220

Description: Maximum depth 3.3 m. Rich, dark-brown to black soil down to about 1.5 m, in contrast to surficial material in test pits to the north and south. Below that depth the backhoe encountered large limestone boulders and weathered bedrock. At this point the backhoe was relocated and the trench extended roughly 2 m north. Limestone cobbles and boulders 50-75 cm in diameter were encountered ~0.5 m below ground level. At a depth of 3.1 m water flowed into the pit at an estimated rate of 3 L/minute for about 10 minutes.

Figure A20. Test Pit 220, showing water flowing into the bottom of the test pit.

Figure A21. Limestone boulders excavated from Test Pit 220.

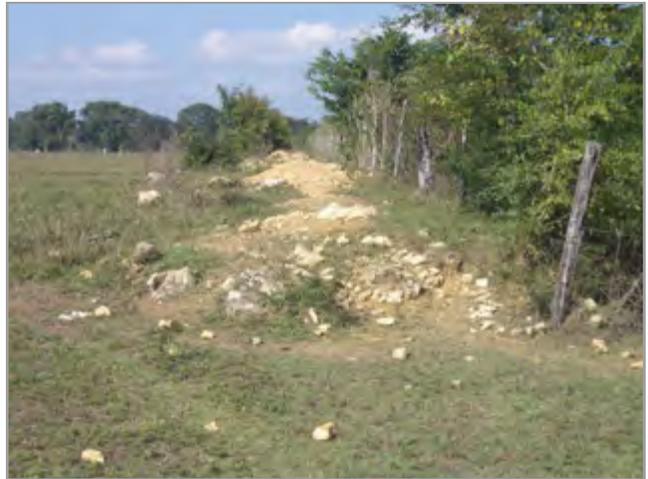
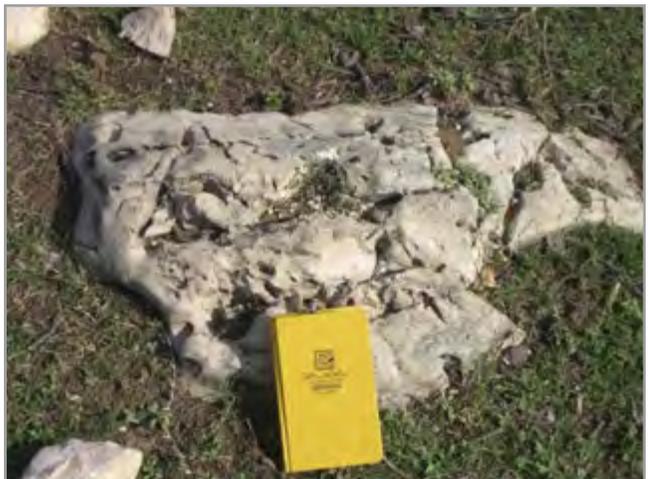
During a surface reconnaissance two days prior to excavating the pit, limestone cobbles and boulders were observed in a berm along a drainage ditch 10 m east of the pit (Figure A22). A shallow 10-m diameter by 1-m deep sinkhole was also found 30 m south of this pit, further suggesting the presence of near-surface bedrock in this area. Figure A23 shows a good example of the local limestone and its solution features. Local assistants from the community claimed the limestone boulders were Maya relicts, as at Test Pit 40. While some of the smaller rock unearthed by the backhoe may in fact be Maya building material, it seems clear that most of the limestone excavated at this site is bedrock

Figure A22. Limestone cobbles and boulders in earthen berm near Test Pit 220.

Figure A23. Close-up of limestone boulder near Test Pit 220.

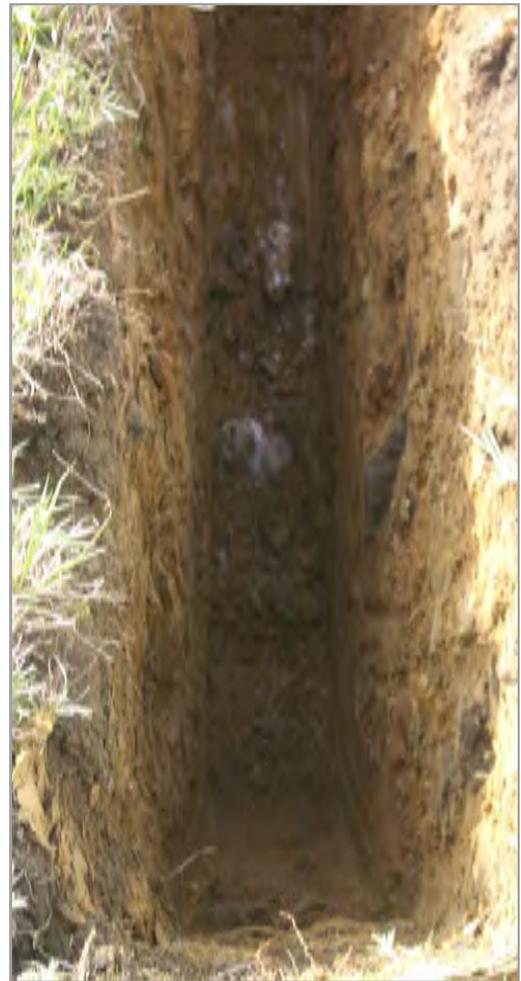
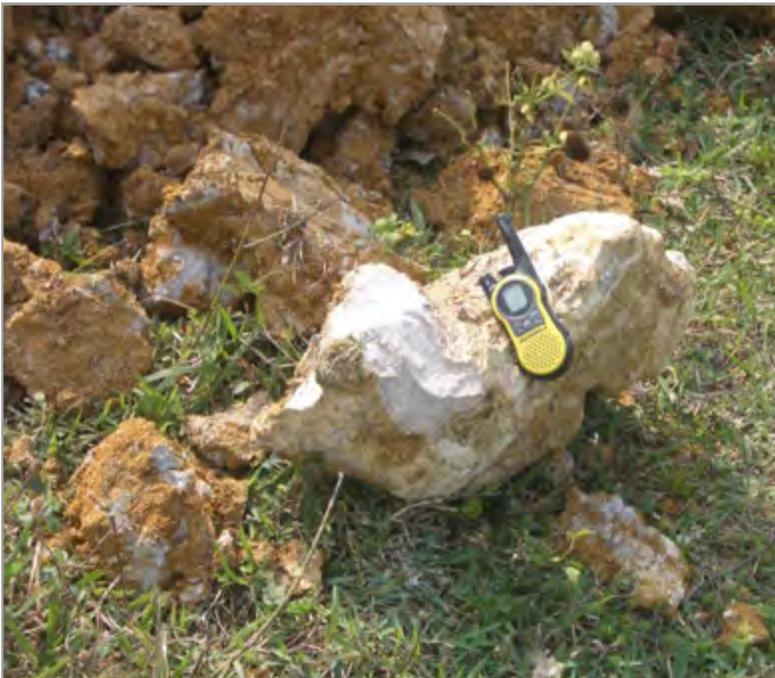
Test Pit 100

Description: Maximum depth 3.7 m. Dark brown soil down to ~1 m followed by dense orange and gray clay with high plasticity to the near the bottom. The last few backhoe buckets brought up several limestone boulders, 30-50 cm in diameter, mixed with dense orange clay. Limestone boulders unearthed at this pit do not appear to be bedrock, although they may indicate proximity to bedrock. This is the southernmost station at which any material other than soil and clay were observed in the test pits.

Figure A25. Weathered limestone boulder excavated from Test Pit 100.

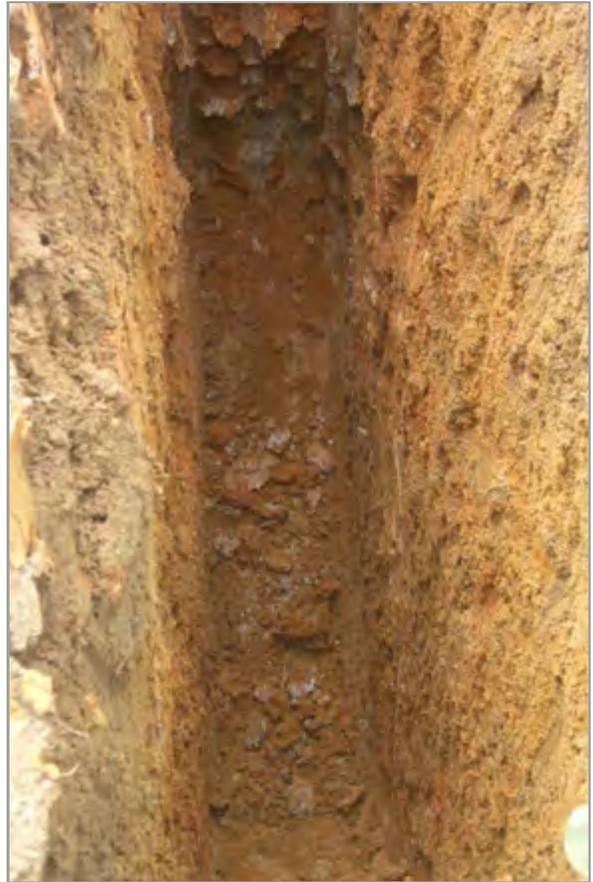
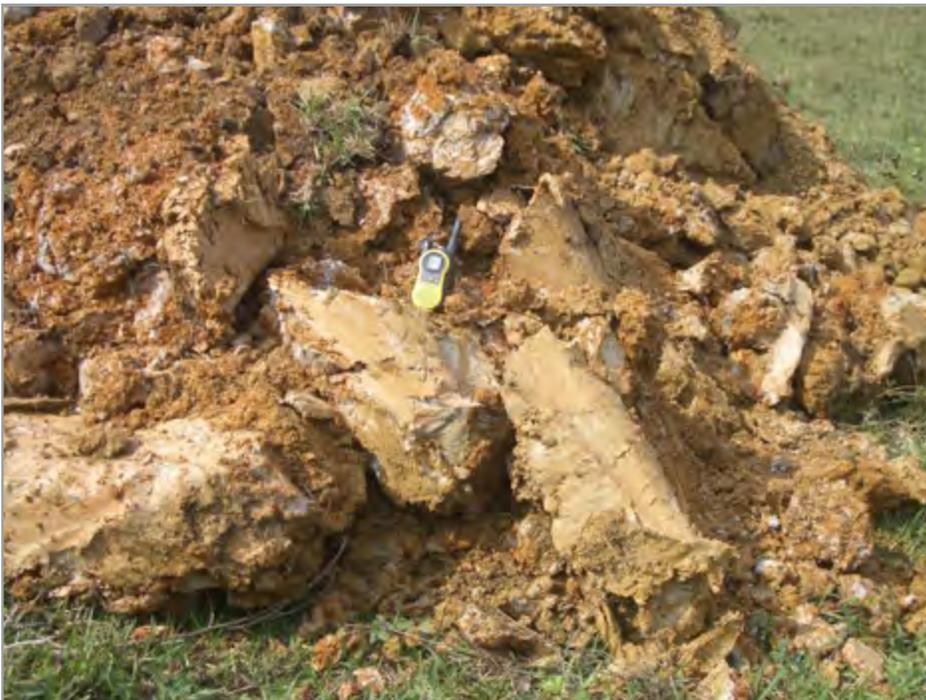
Test Pit 110

Description: Maximum depth 4 m. Brown soil down to about 1 m, underlain by dense orange clay that continues to the bottom. A trickle of water (<1 L/min) flowed into the base of pit.

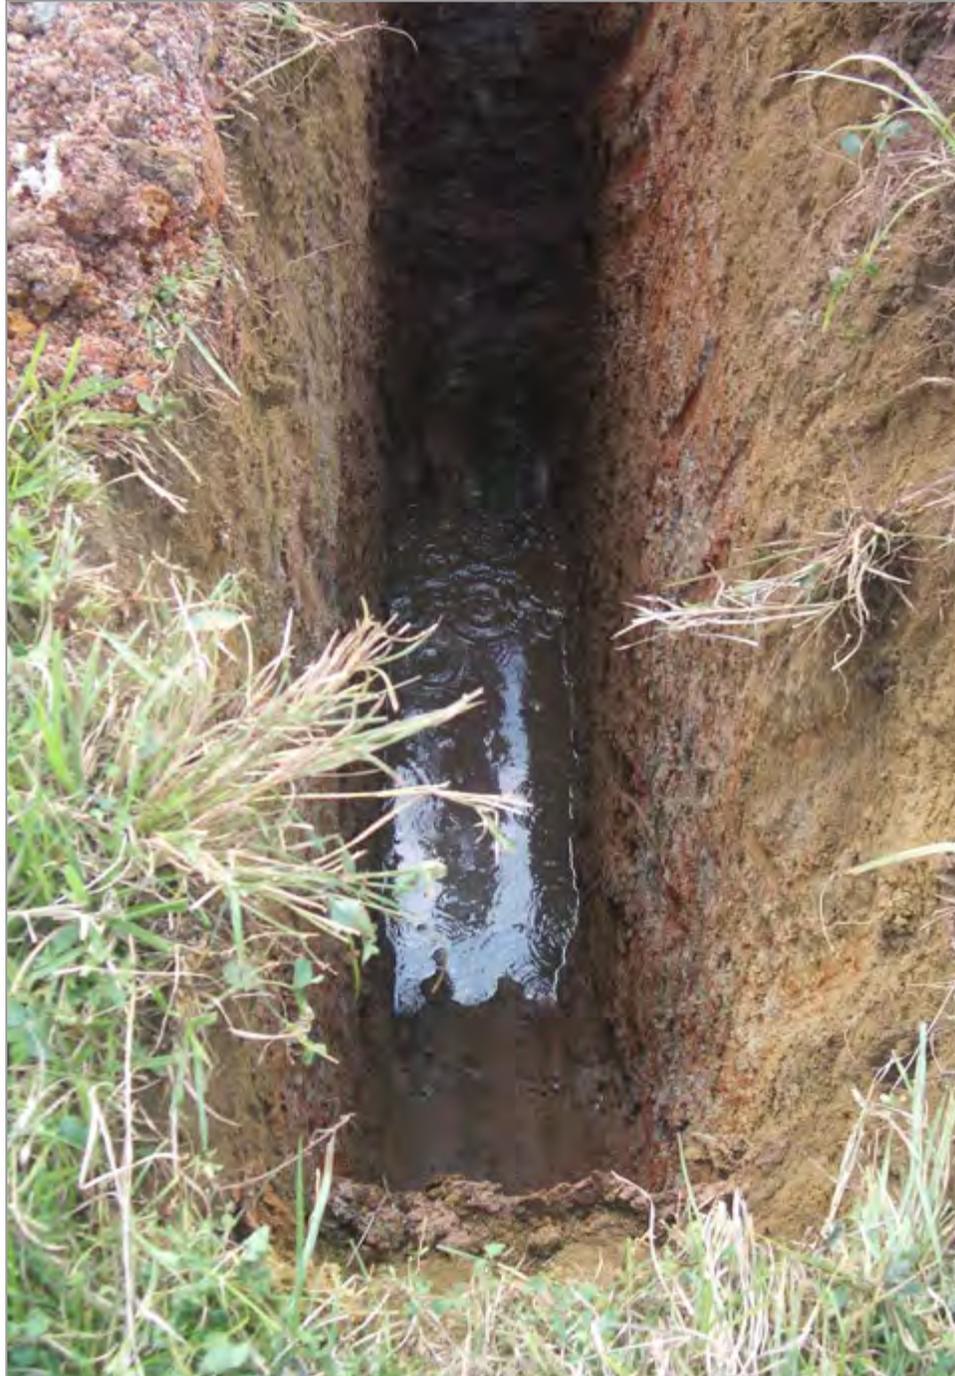
Test Pit 170

Description: Maximum depth 3.6 m. Reddish-brown soil down to 2.5 m, underlain by dense orange clay. Water flowed into the pit at a depth of 3.1 m at an estimated rate of 4 L/min.

Figure A35. Water flow into Test Pit 170.

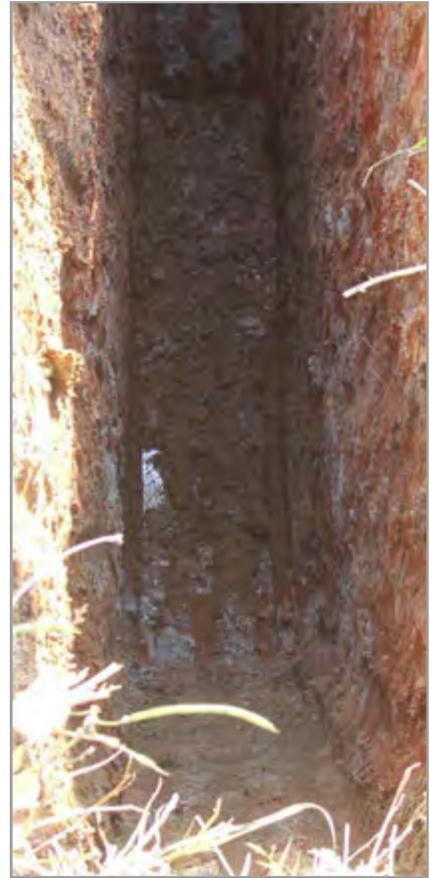
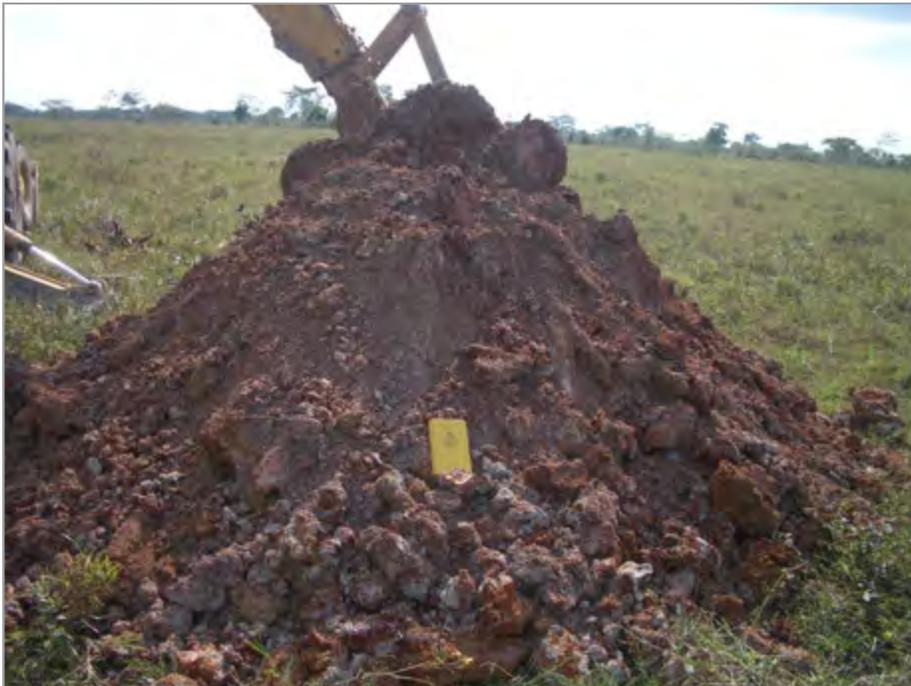
Test Pit 200

Description: Maximum depth 3.85 m. Brownish soil down to ~1 m, underlain by dense red and gray clay. Water flowed near the base of the pit at an estimated rate of 4 L/min.
