NCKRI REPORT OF INVESTIGATION 6

**GEOPHYSICAL INVESTIGATION OF FLOOD-INDUCED
SINKHOLE COLLAPSES, LAKEWOOD REGION,
EDDY COUNTY, NEW MEXICO**

Lewis Land
Lasha Asanidze

June 2014

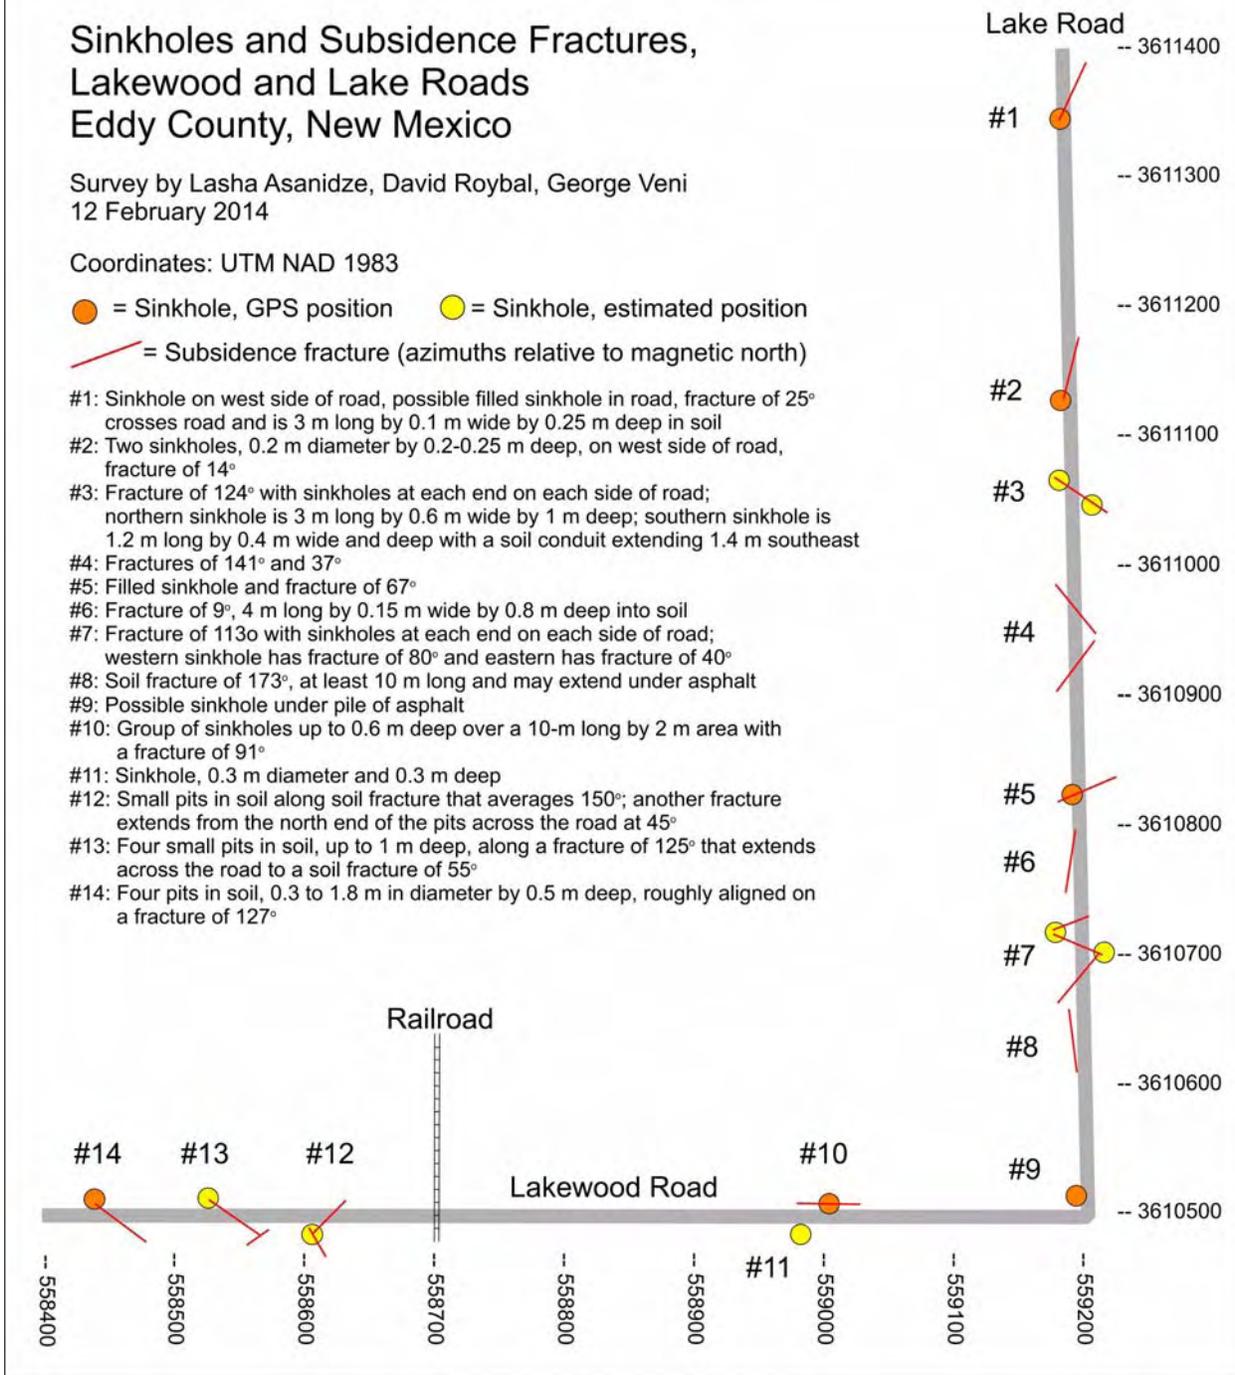
- #1: Sinkhole on west side of road, possible filled sinkhole in road, fracture of 25° crosses road and is 3 m long by 0.1 m wide by 0.25 m deep in soil

- #2: Two sinkholes, 0.2 m diameter by 0.2-0.25 m deep, on west side of road, fracture of 14°
- #3: Fracture of 124° with sinkholes at each end on each side of road; northern sinkhole is 3 m long by 0.6 m wide by 1 m deep; southern sinkhole is 1.2 m long by 0.4 m wide and deep with a soil conduit extending 1.4 m southeast

- #4: Fractures of 141° and 37°
- #5: Filled sinkhole and fracture of 67°
- #6: Fracture of 9°, 4 m long by 0.15 m wide by 0.8 m deep into soil
- #7: Fracture of 113° with sinkholes at each end on each side of road; western sinkhole has fracture of 80° and eastern has fracture of 40°

- #8: Soil fracture of 173°, at least 10 m long and may extend under asphalt
- #9: Possible sinkhole under pile of asphalt
- #10: Group of sinkholes up to 0.6 m deep over a 10-m long by 2 m area with a fracture of 91°

- #11: Sinkhole, 0.3 m diameter and 0.3 m deep
- #12: Small pits in soil along soil fracture that averages 150°; another fracture extends from the north end of the pits across the road at 45°

- #13: Four small pits in soil, up to 1 m deep, along a fracture of 125° that extends across the road to a soil fracture of 55°
- #14: Four pits in soil, 0.3 to 1.8 m in diameter by 0.5 m deep, roughly aligned on a fracture of 127°

Figure 1. Reconnaissance survey of sinkholes and subsidence fissures in Lakewood area.

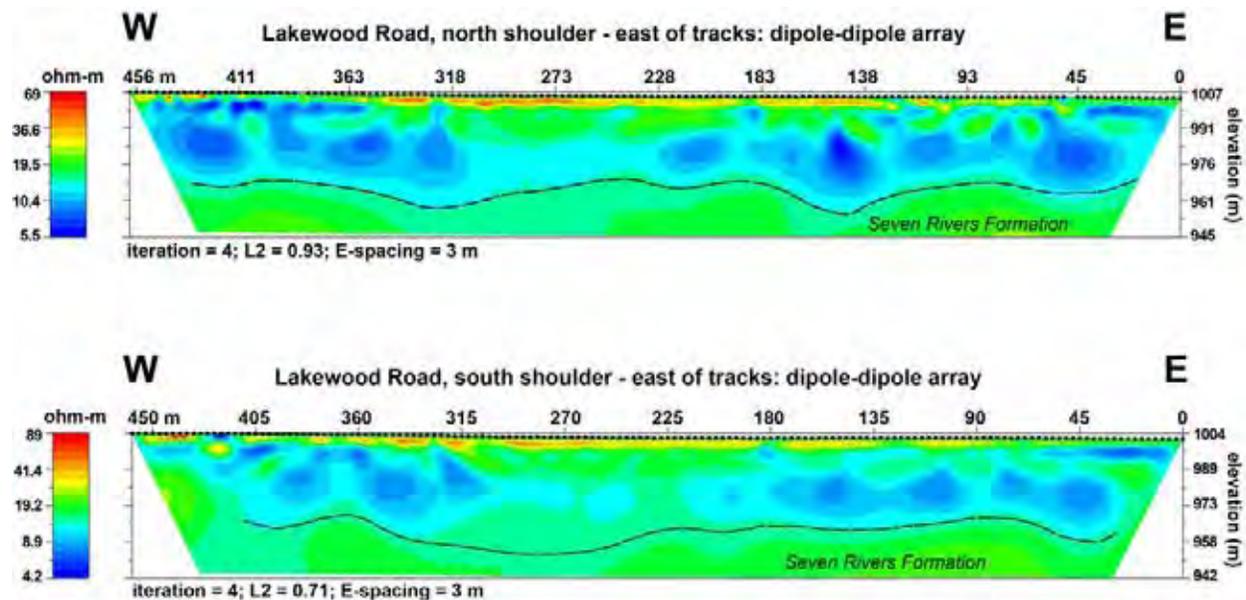
Figure 3. Electrical resistivity profiles conducted along the north and south shoulders of Lakewood Road, east of the BN&SF railroad tracks.

A small, distinctive pod of relatively high resistivity occurs approximately 8 m below ground level at the west end of the south shoulder profile at 420 m, overlain by a near-surface interval of low-resistivity. A subdued reflection of this feature is also present on the north shoulder profile. Resistivity values are too low for this feature to be caused by an air-filled cave, but it may

represent a shallow cavity filled with unconsolidated sediment.

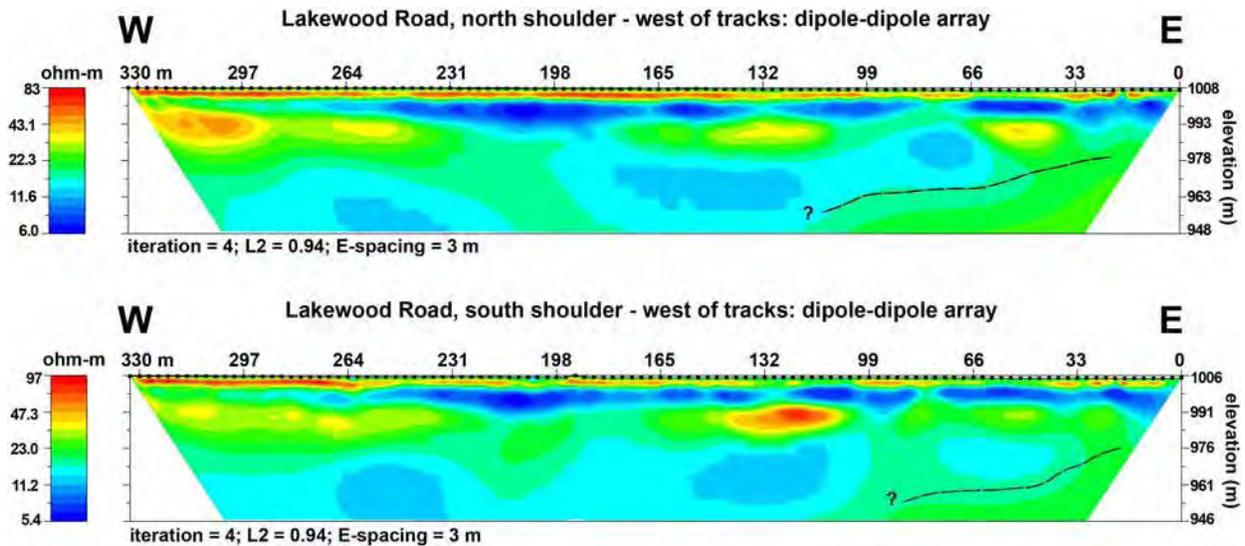
A thin layer of high resistivity is also present on the profiles west of the railway, reflecting air-filled pore space in sand and gravel of the soil horizon. This layer is underlain by 40 to 50 m of generally lower resistivity material of the Pecos River floodplain. However, several lenticular bodies of higher resistivity are also present within this section. One distinctive high-resistivity lens is present on the south shoulder profile between 110 and 140 m, approximately 15 m below ground level. A more laterally extensive high resistivity layer occurs beneath the west end of the north shoulder profile. Subdued reflections of both of these features are also present on the opposite shoulder profiles. Because of their geometry and their presence within the alluvial section, we interpret these features as lenticular bodies of coarse sand and gravel in the unsaturated zone; it is unlikely that they represent caves. In spite of the presence of several small sinkholes along the shoulders of Lakewood Road west of the railway, no obvious subsurface cavities are visible on the ER profiles.

Figure 4. Electrical resistivity profiles conducted along the north and south shoulders of Lakewood Road, west of the BN&SF railroad tracks.

The top of the Seven Rivers Formation is poorly defined in the resistivity survey data collected west of the railway. It is possible that the top of the Seven Rivers exceeds our depth of investigation in this area, dipping locally to the west. Although regional dip is to the east, the topography of the Pecos Valley has been strongly influenced by local and regional subsidence due to subsurface gypsum dissolution (Bachman, 1984; Land, 2003), resulting in the presence of a number of sediment filled basins along the western margin of the river valley (Lyford, 1973).

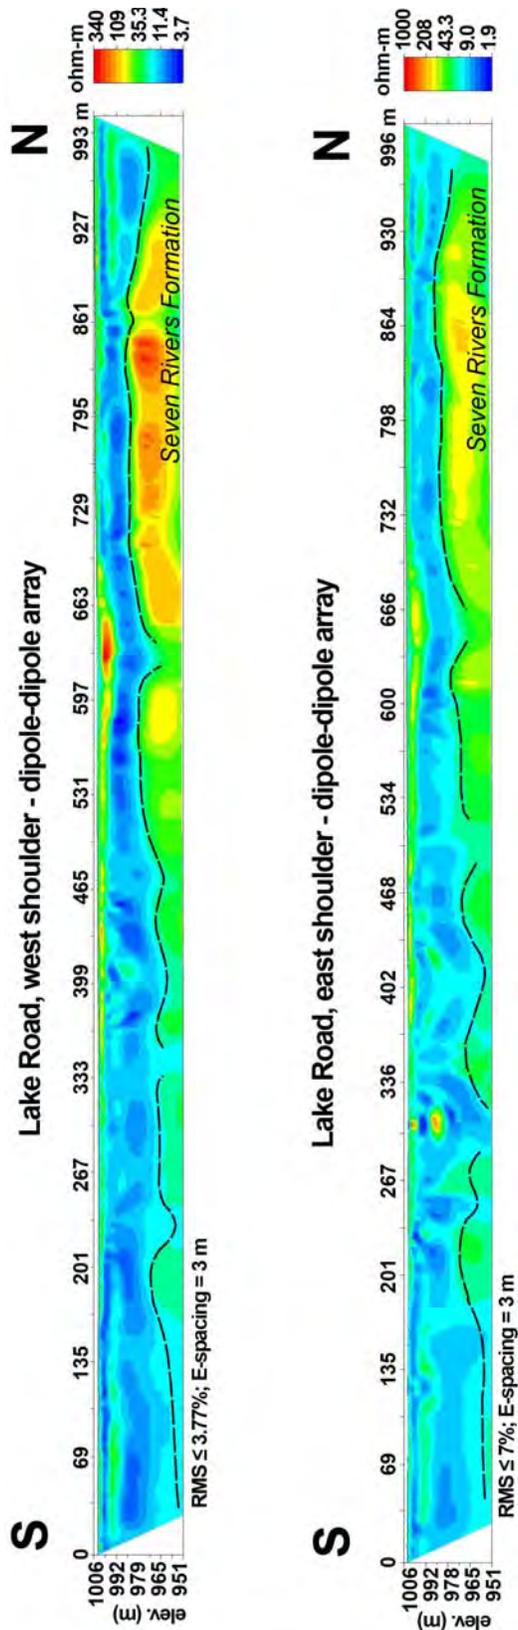
The higher resistivity section that represents the Seven Rivers Formation is interrupted in several places, reflecting the paleotopography developed on the top of the formation. One of these breaks occurs on the west shoulder profile between 600 and 650 m, where a sag in the top of the unit most likely represents a filled sinkhole. Subsidence over this feature appears to have caused a local near-surface accumulation of coarser sediment, as indicated by an overlying lenticular high resistivity zone. This feature is also visible on the east shoulder profile between approximately 630 and 670 m. Several less defined breaks in the Seven Rivers profile may also represent filled sinkholes.

A small but well defined pod of higher resistivity occurs at 305 m on the east shoulder profile, approximately 5 m below ground level. A second high resistivity pod occurs directly beneath the first at approximately 20 m below ground level. These features are likely to represent subsurface cavities partially filled with sediment, or two segments of a fissure adjacent to or extending beneath the roadway. A 4-m long soil fracture was identified near this section of the ER profile during the February, 2014, reconnaissance survey (Figure 1, number 6).

Figure 5. Electrical resistivity surveys conducted along the west and east shoulders of Lake Road.

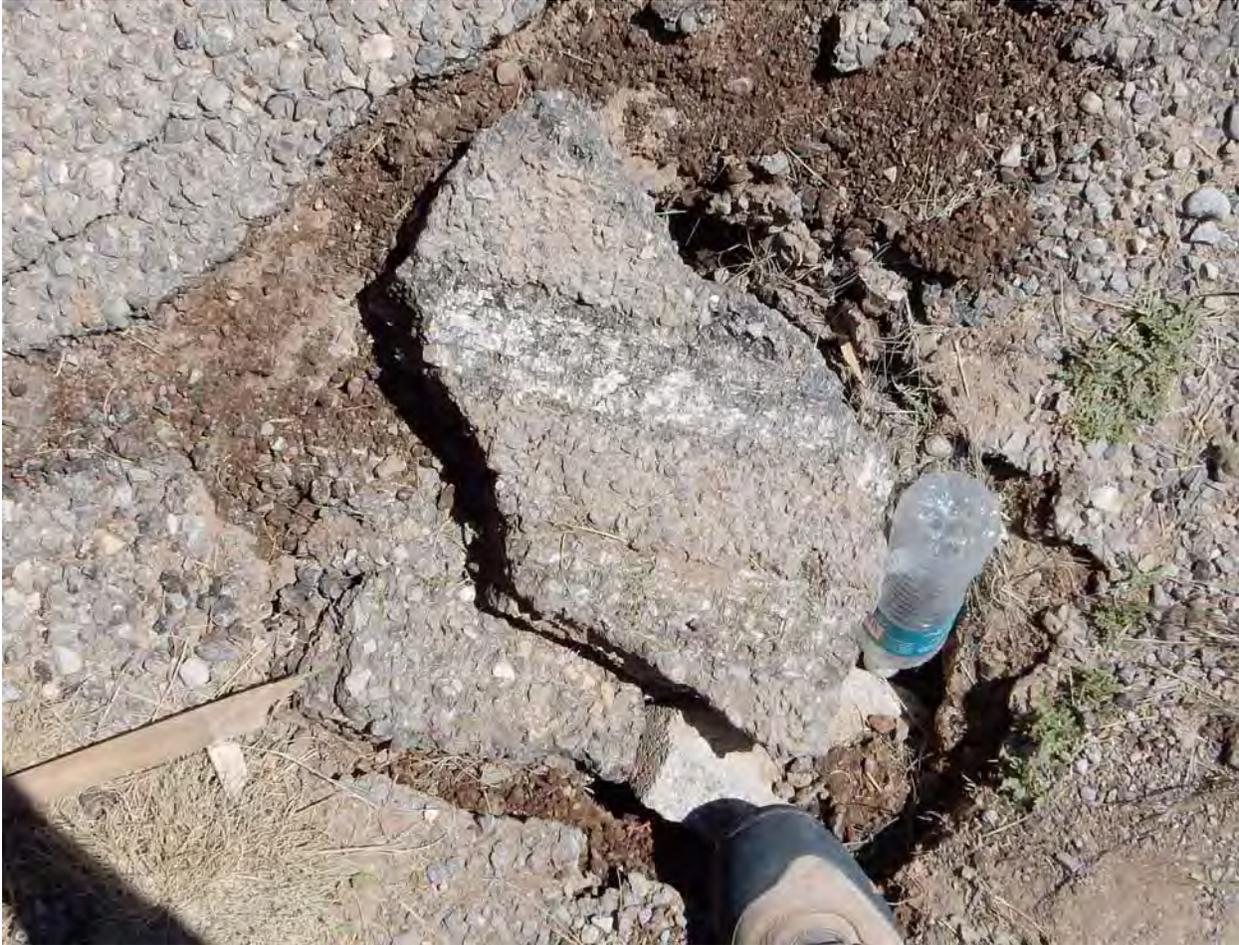
Figure A-1. Small collapse sinkhole, south side of Lakewood Road, filled with asphalt rubble; 0.46 m diameter. 559048, 3610704, 5 m.

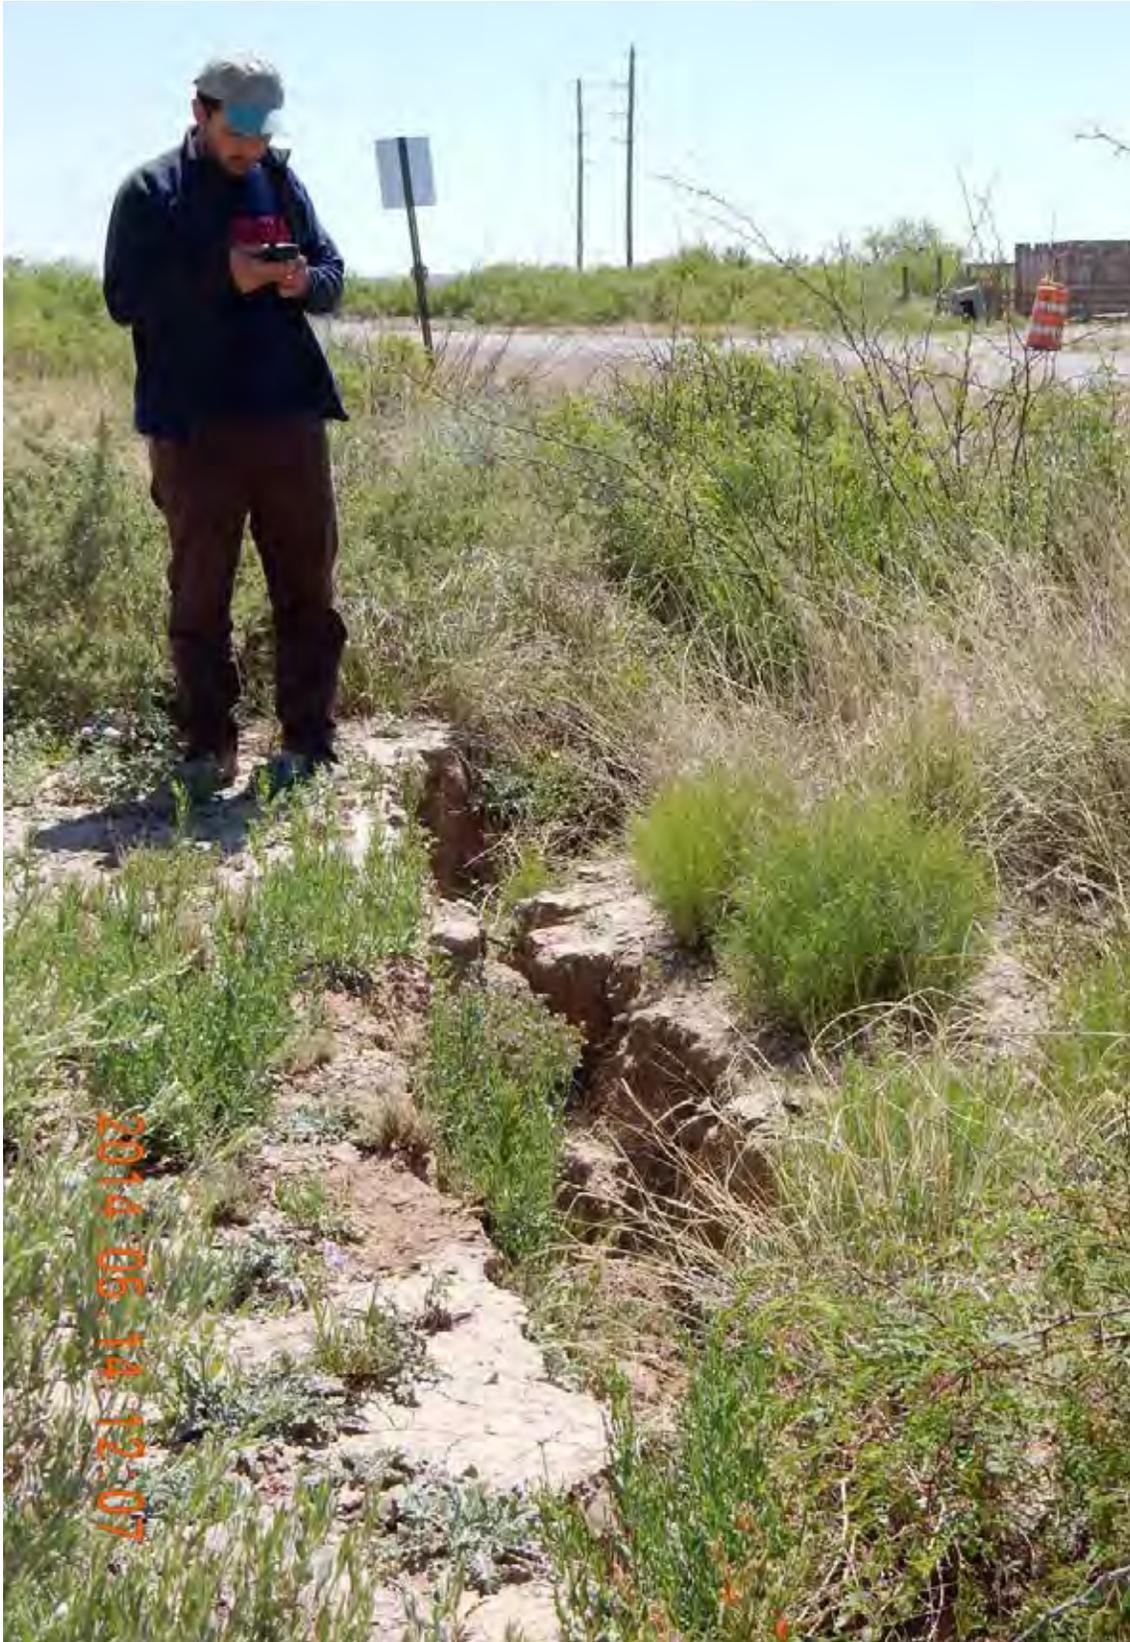
Figure A-2. Soil fracture, north side of Lakewood Road. Length ~18 m, width 0.5 – 1.5 m, depth 0.5 – 1.0 m, azimuth 102°. 559027, 3610715, 4 m.

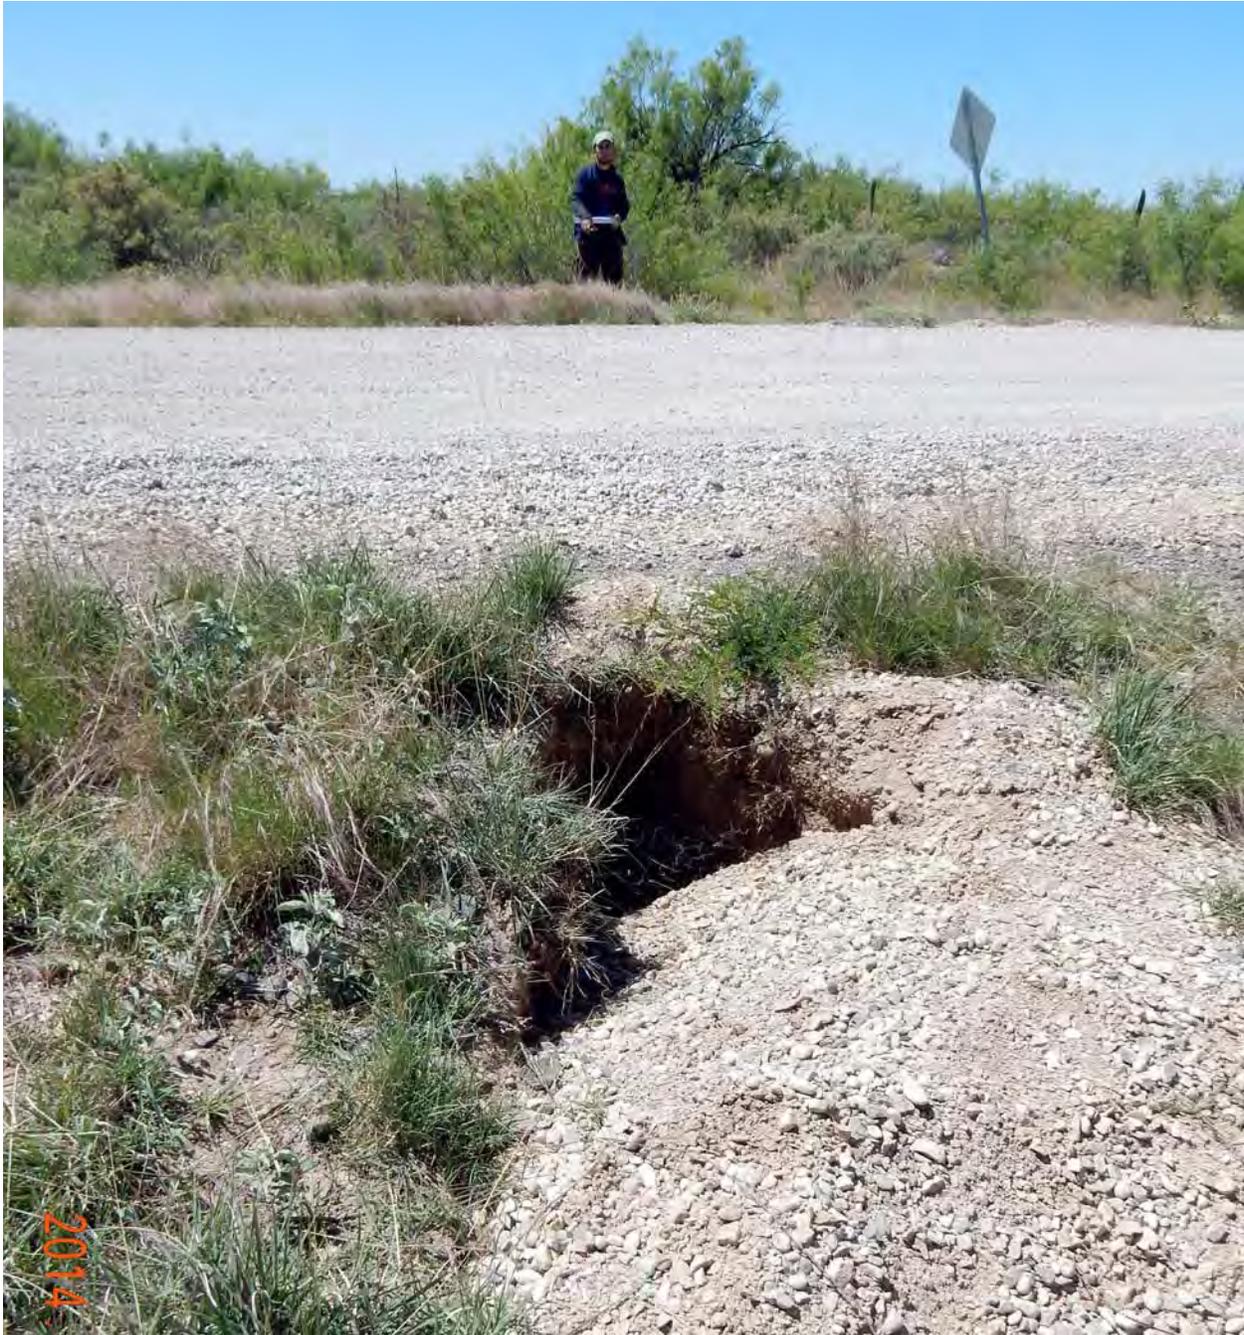
Figure A-3. Soil fracture mostly filled with gravel, north side of Lakewood Road. Pavement damage suggests fracture most likely extends beneath road to opposite shoulder, where asphalt slabs may cover fracture extension. Length, ~18 m (assuming fracture extends beneath road), width 1.4 m, depth where not filled 0.6 m, azimuth 20°. 559008, 3610714, 3 m.

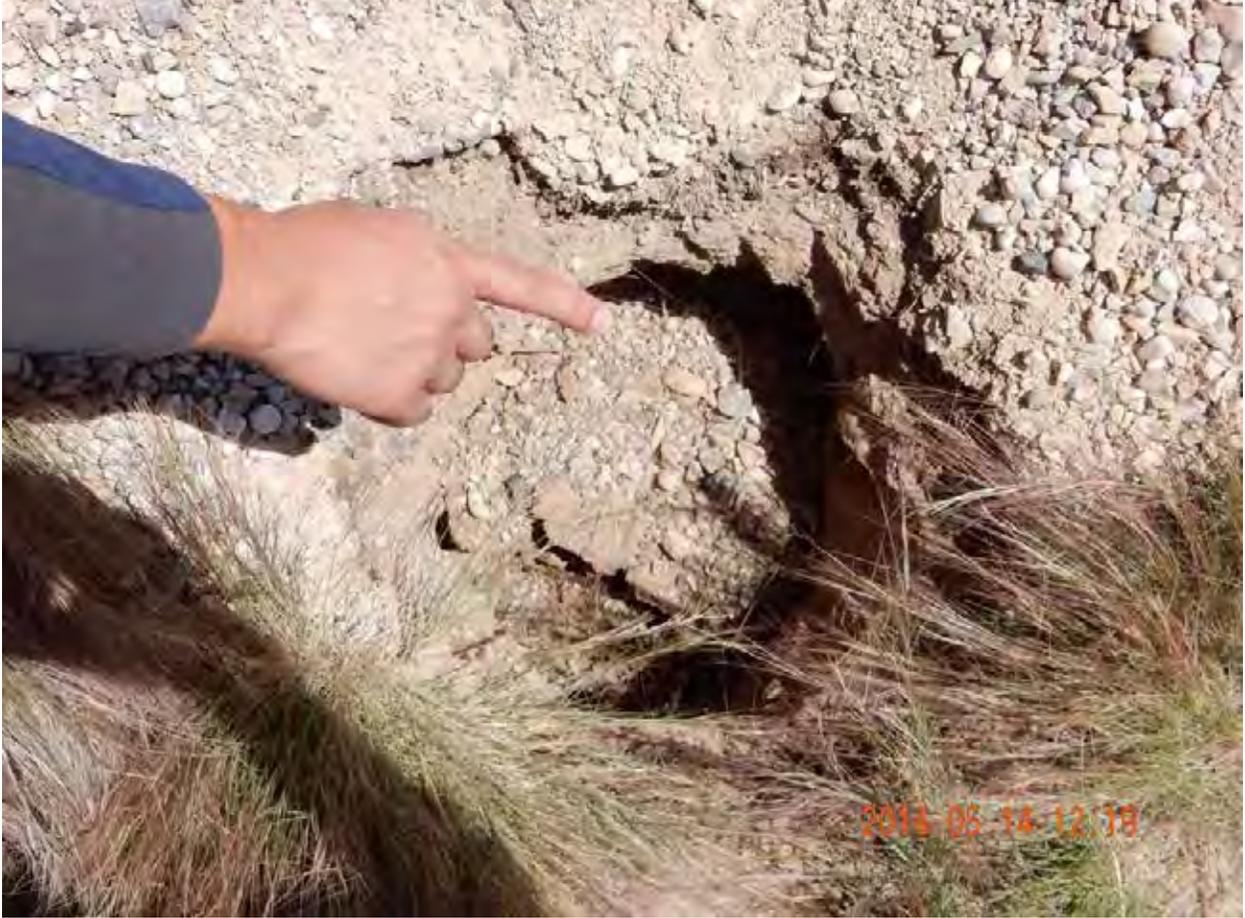
Figure A-4. Small sinkhole, south side of Lakewood Road. Diameter, 0.4 m, depth, 0.44 m. 558997, 3610704, 3 m.

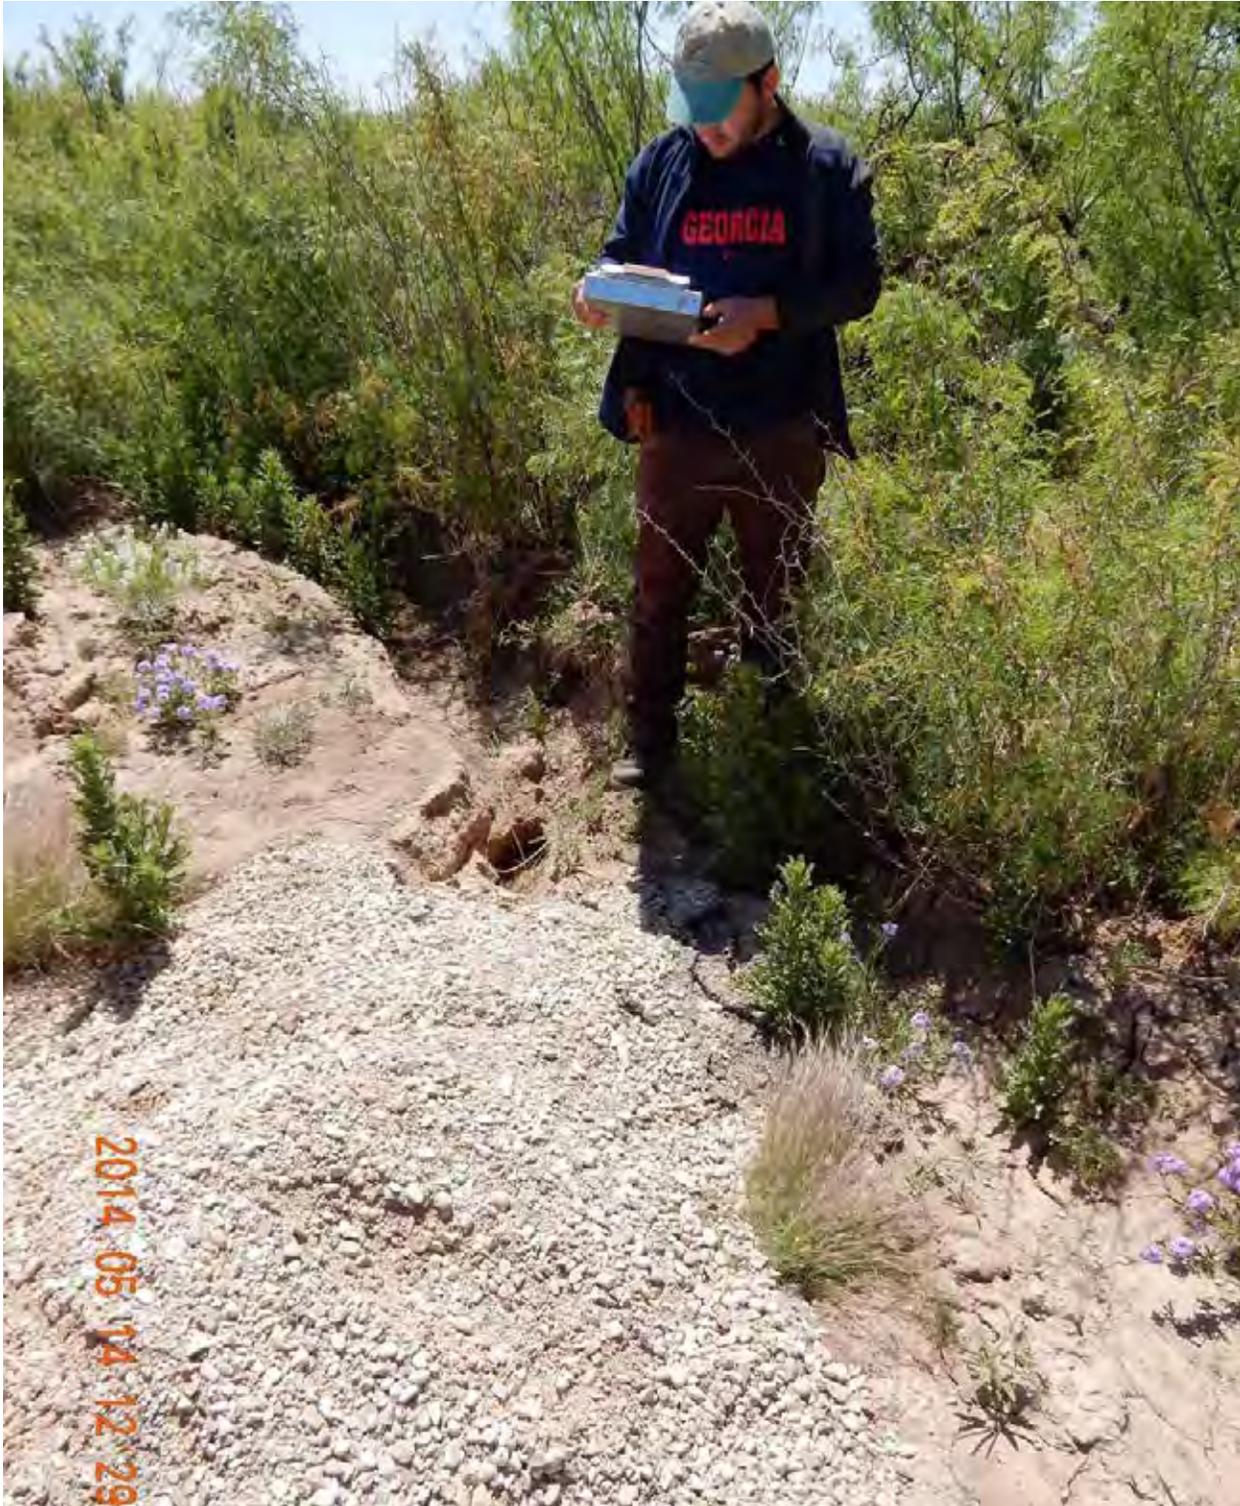
Figure A-5. Soil fracture, south side of Lakewood Road, mostly filled with gravel. Pavement damage indicates fracture extends beneath road to opposite shoulder, where a recent pile of gravel probably buries north end of feature. Length >10 m (assuming fracture extends beneath road), width 0.4 m, depth where not filled, 0.4 m, azimuth 137°. 558944, 3610701, 4 m.

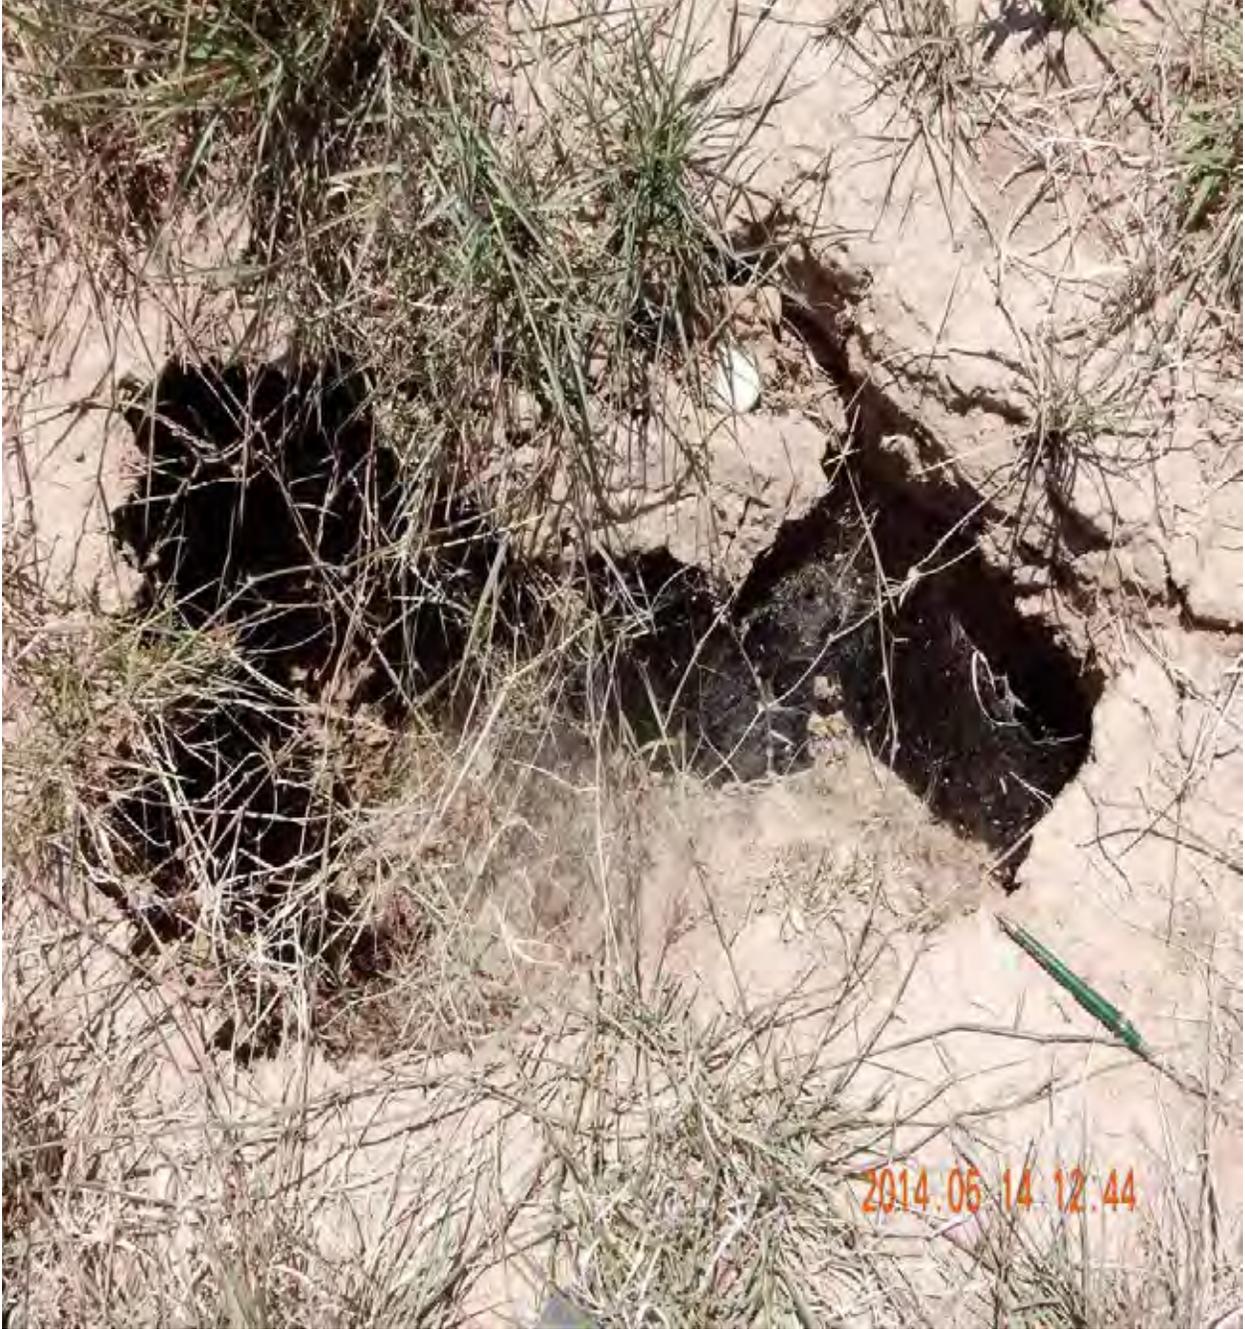
Figure A-6a. First of a pair of sinkholes following a soil fracture, south side Lakewood Road. Length 0.6 m, width 0.2 m, depth 0.9 m, fracture azimuth 62°. 558449, 3610702, 2 m.

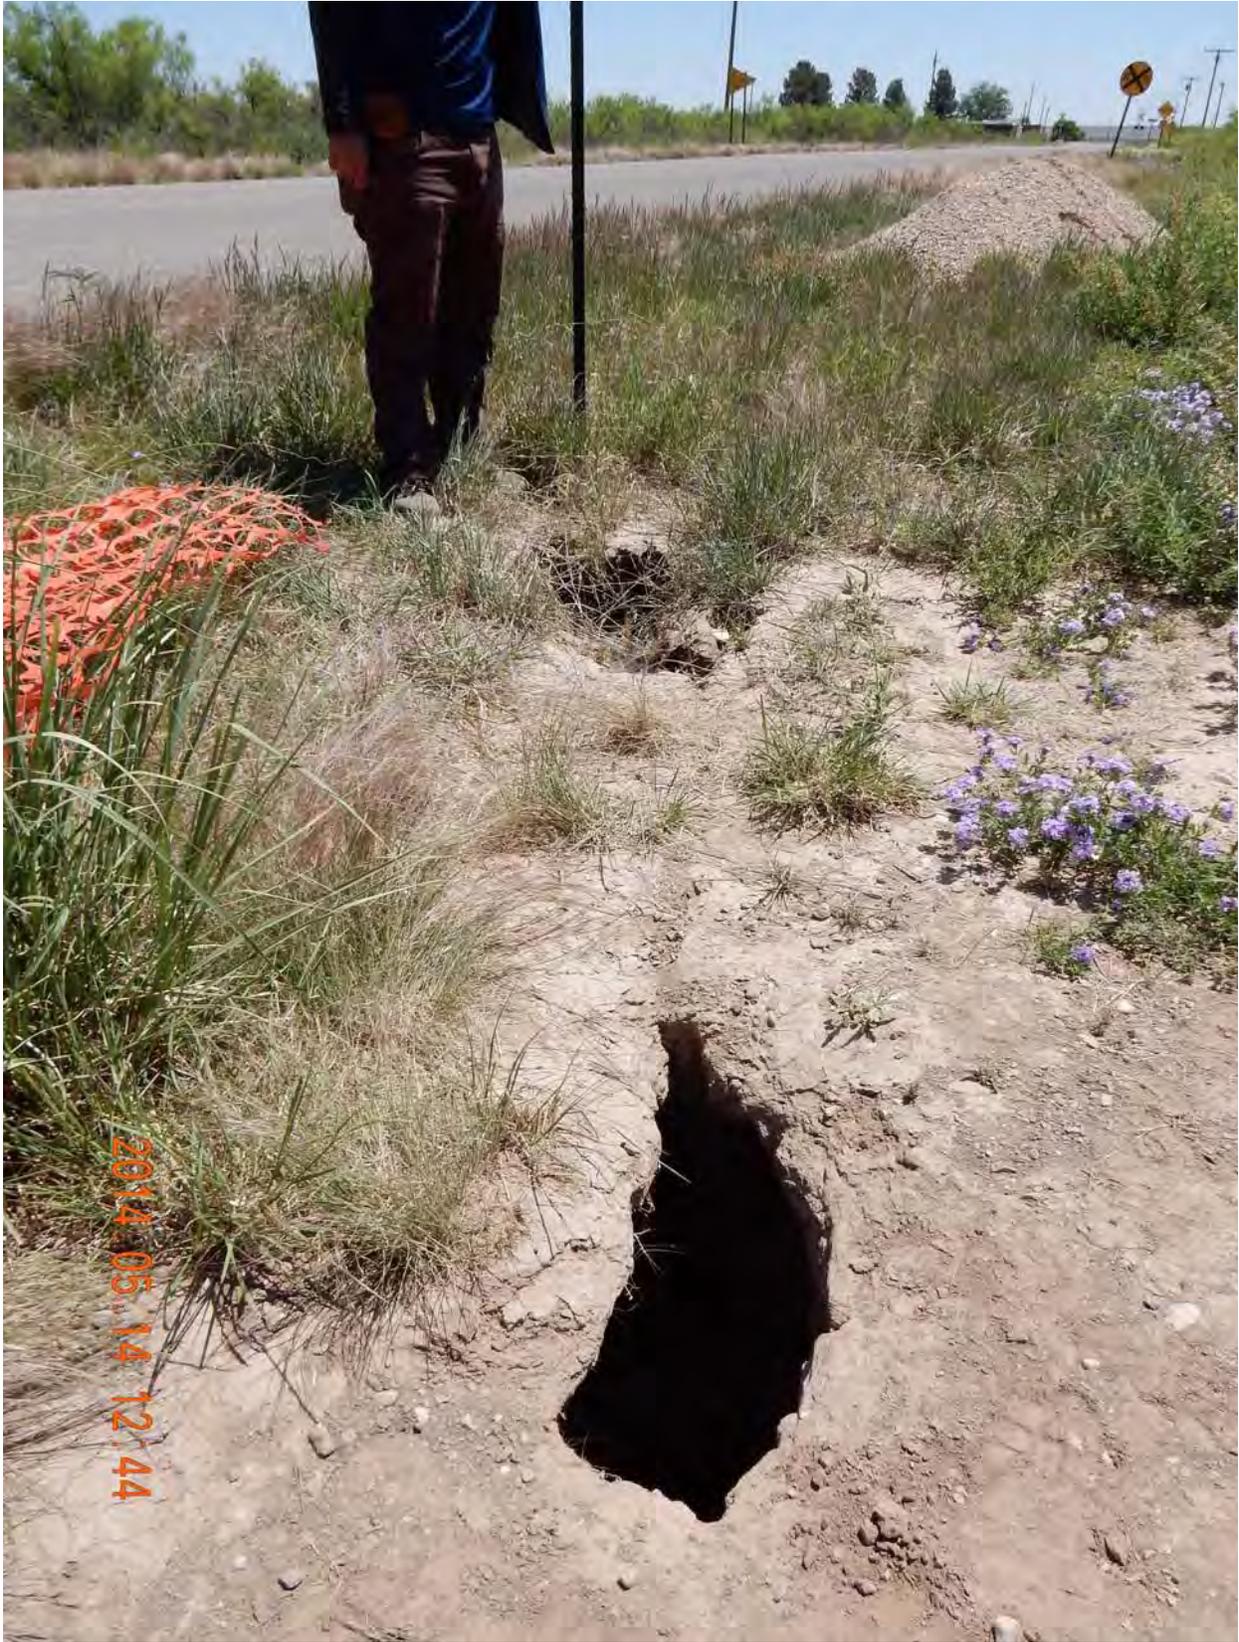
Figure A-6b. Second of a pair of sinkholes following a soil fracture, south side Lakewood Road. Length 0.83 m, width 0.41 m, depth 0.63 m, fracture azimuth 62°. 558449, 3610702, 2 m.

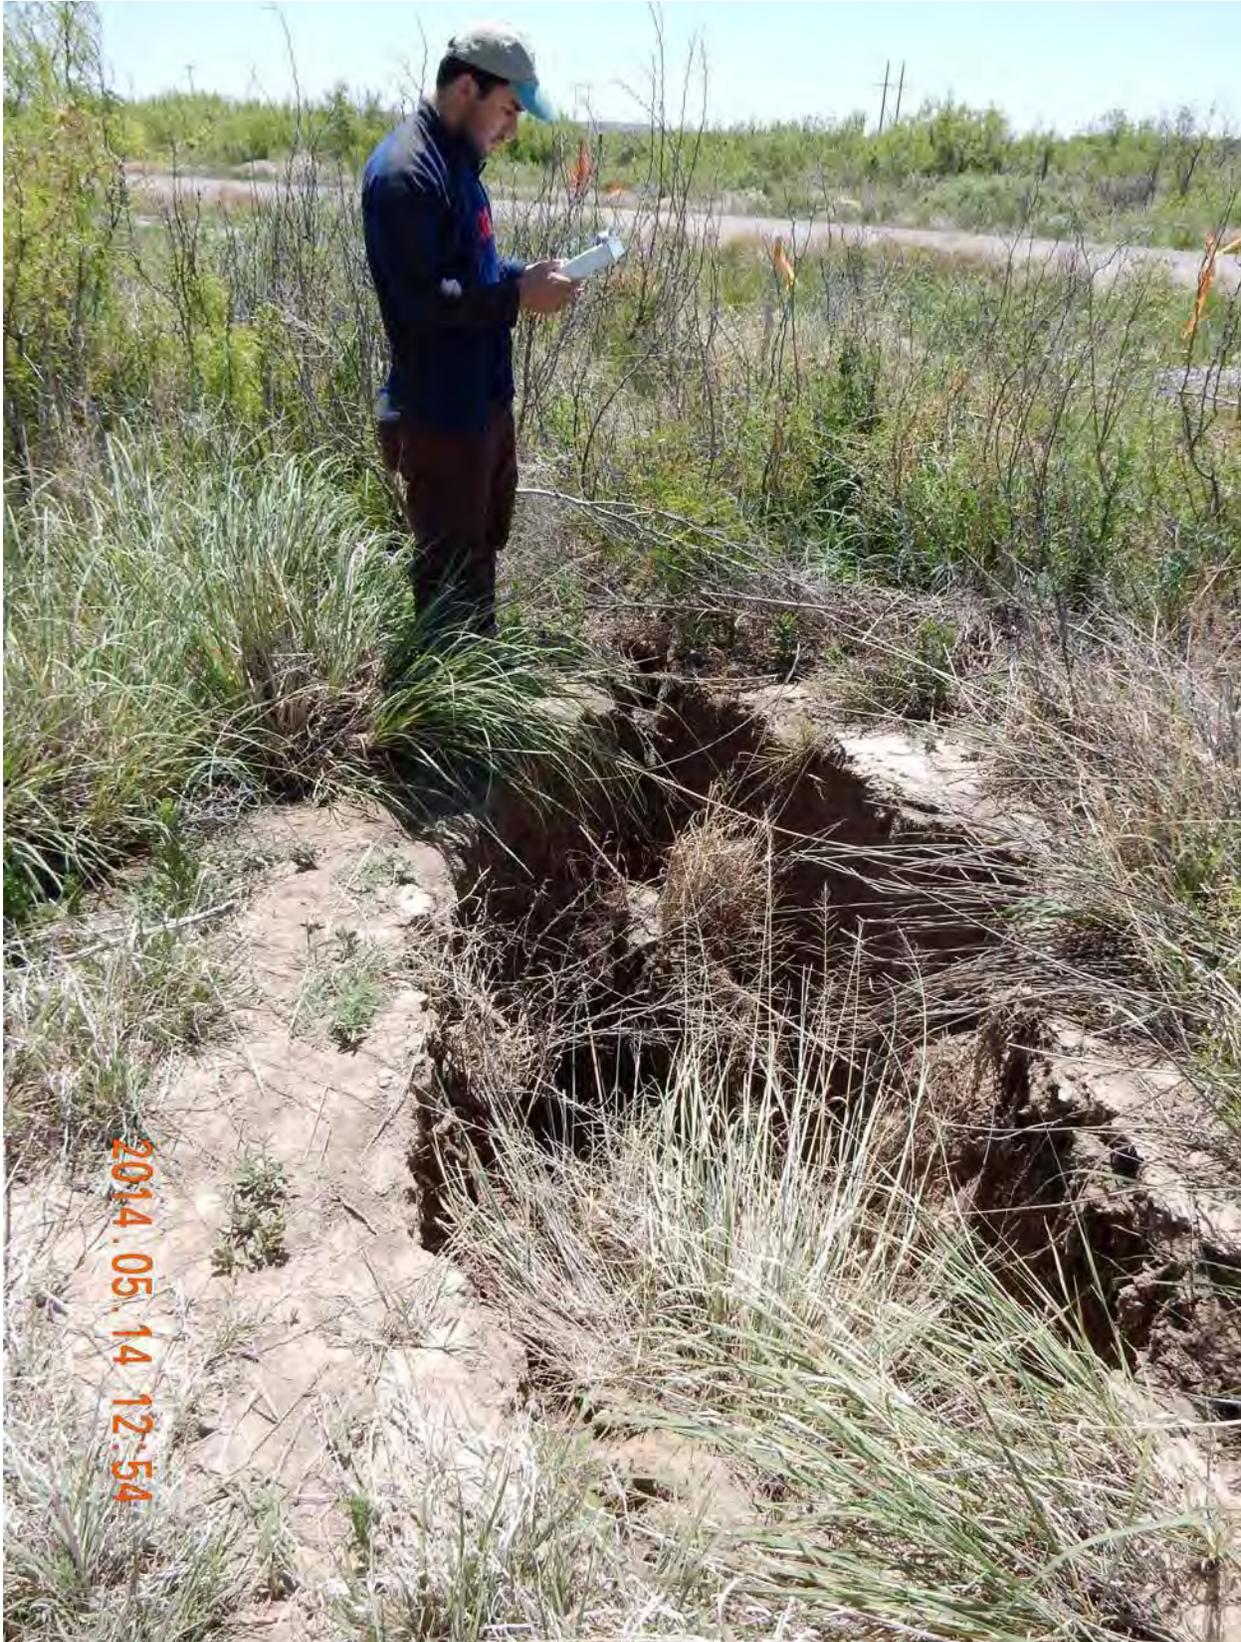
Figure A-7. First sinkhole in a cluster of five, north side Lakewood Road. First three sinkholes occur in a line oriented 122° . Length 3.2 m, width 1.35 m, depth 2.3 m. 558430, 3610719, 3 m.

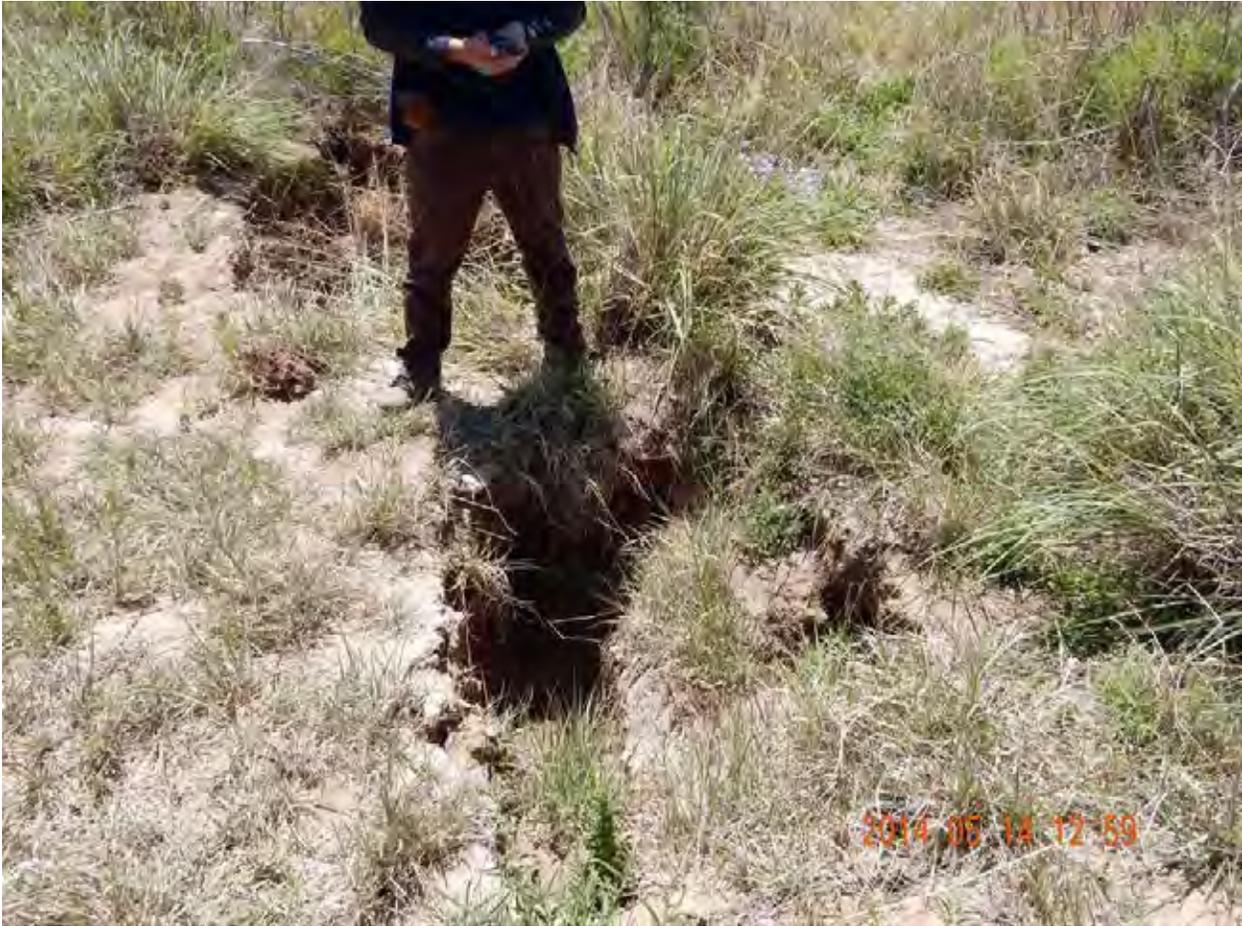
Figure A-8. Second sinkhole in a cluster of five, north side Lakewood Road. Length 1.58 m, width 1.0 m, depth 0.85 m. 558429, 3610721, 3 m.

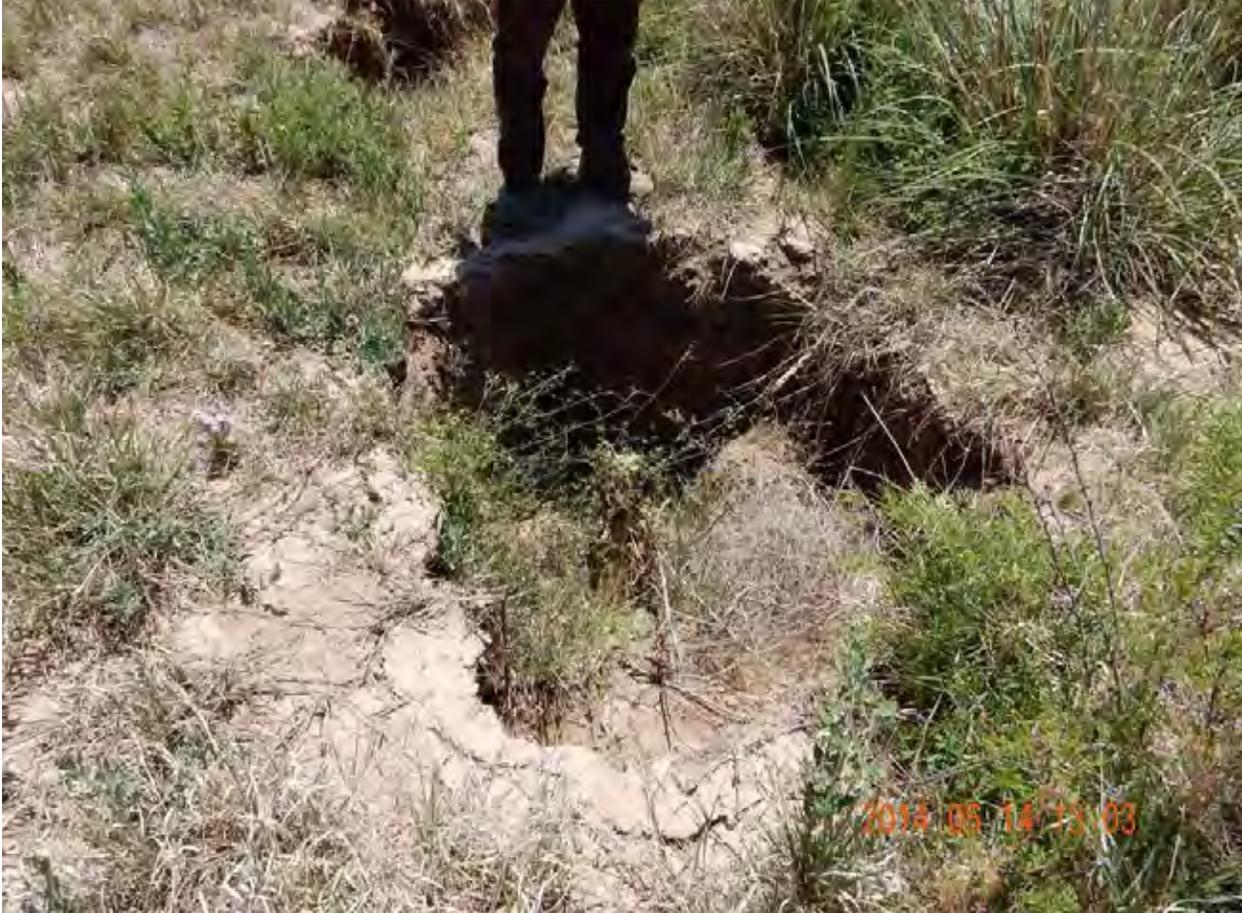
Figure A-9. Third sinkhole in a cluster of five, north side Lakewood Road. Length 1.7 m, width 1.52 m, depth 0.9 m. 558427, 3610724, 3 m.

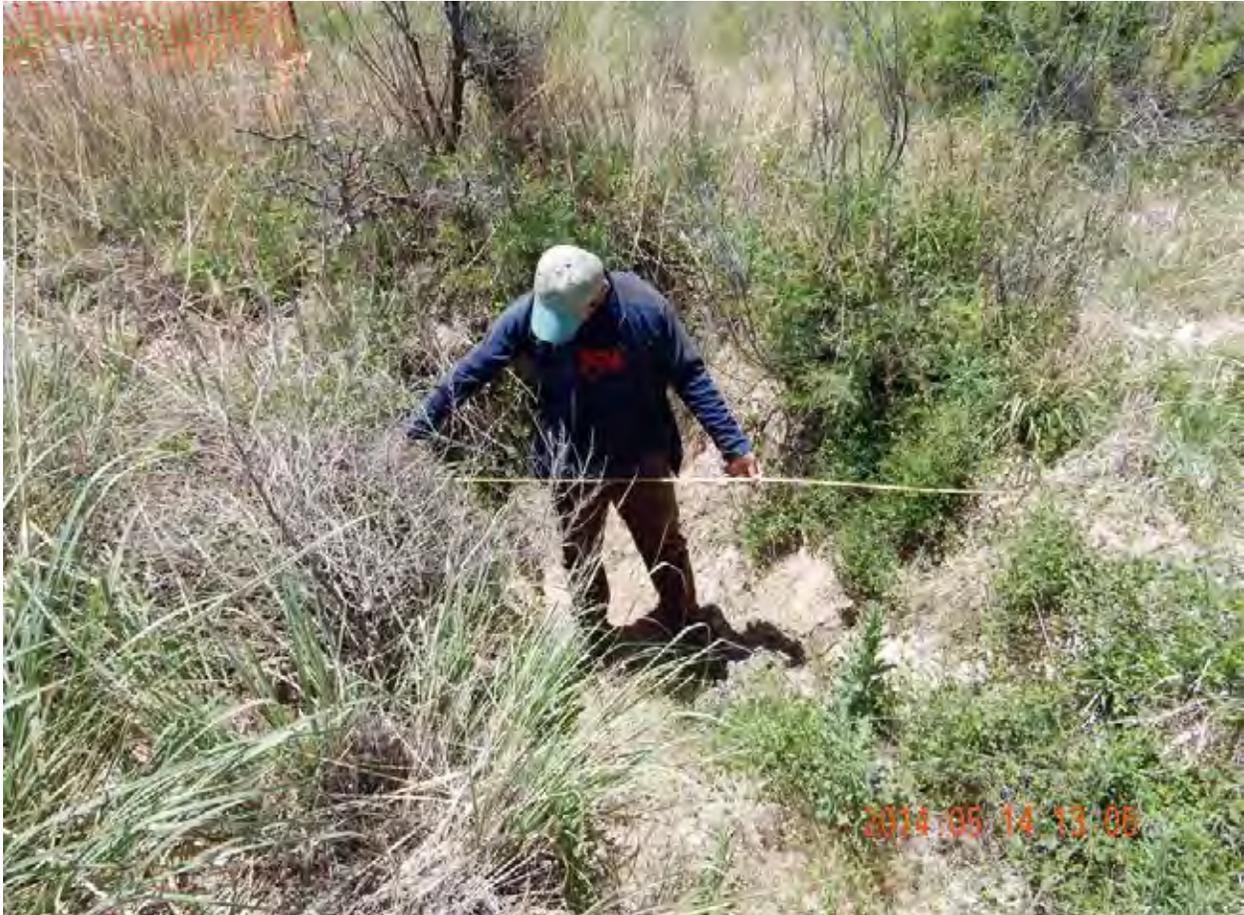
Figure A-10. Fourth sinkhole in a cluster of five, north side Lakewood Road. Length 3.6 m, width 1.92 m, depth 1.0 m. 558423, 3610719, 3 m.
