NCKRI REPORT OF INVESTIGATION 6

**GEOPHYSICAL INVESTIGATION OF FLOOD-INDUCED
SINKHOLE COLLAPSES, LAKEWOOD REGION,
EDDY COUNTY, NEW MEXICO**

Lewis Land
Lasha Asanidze

June 2014

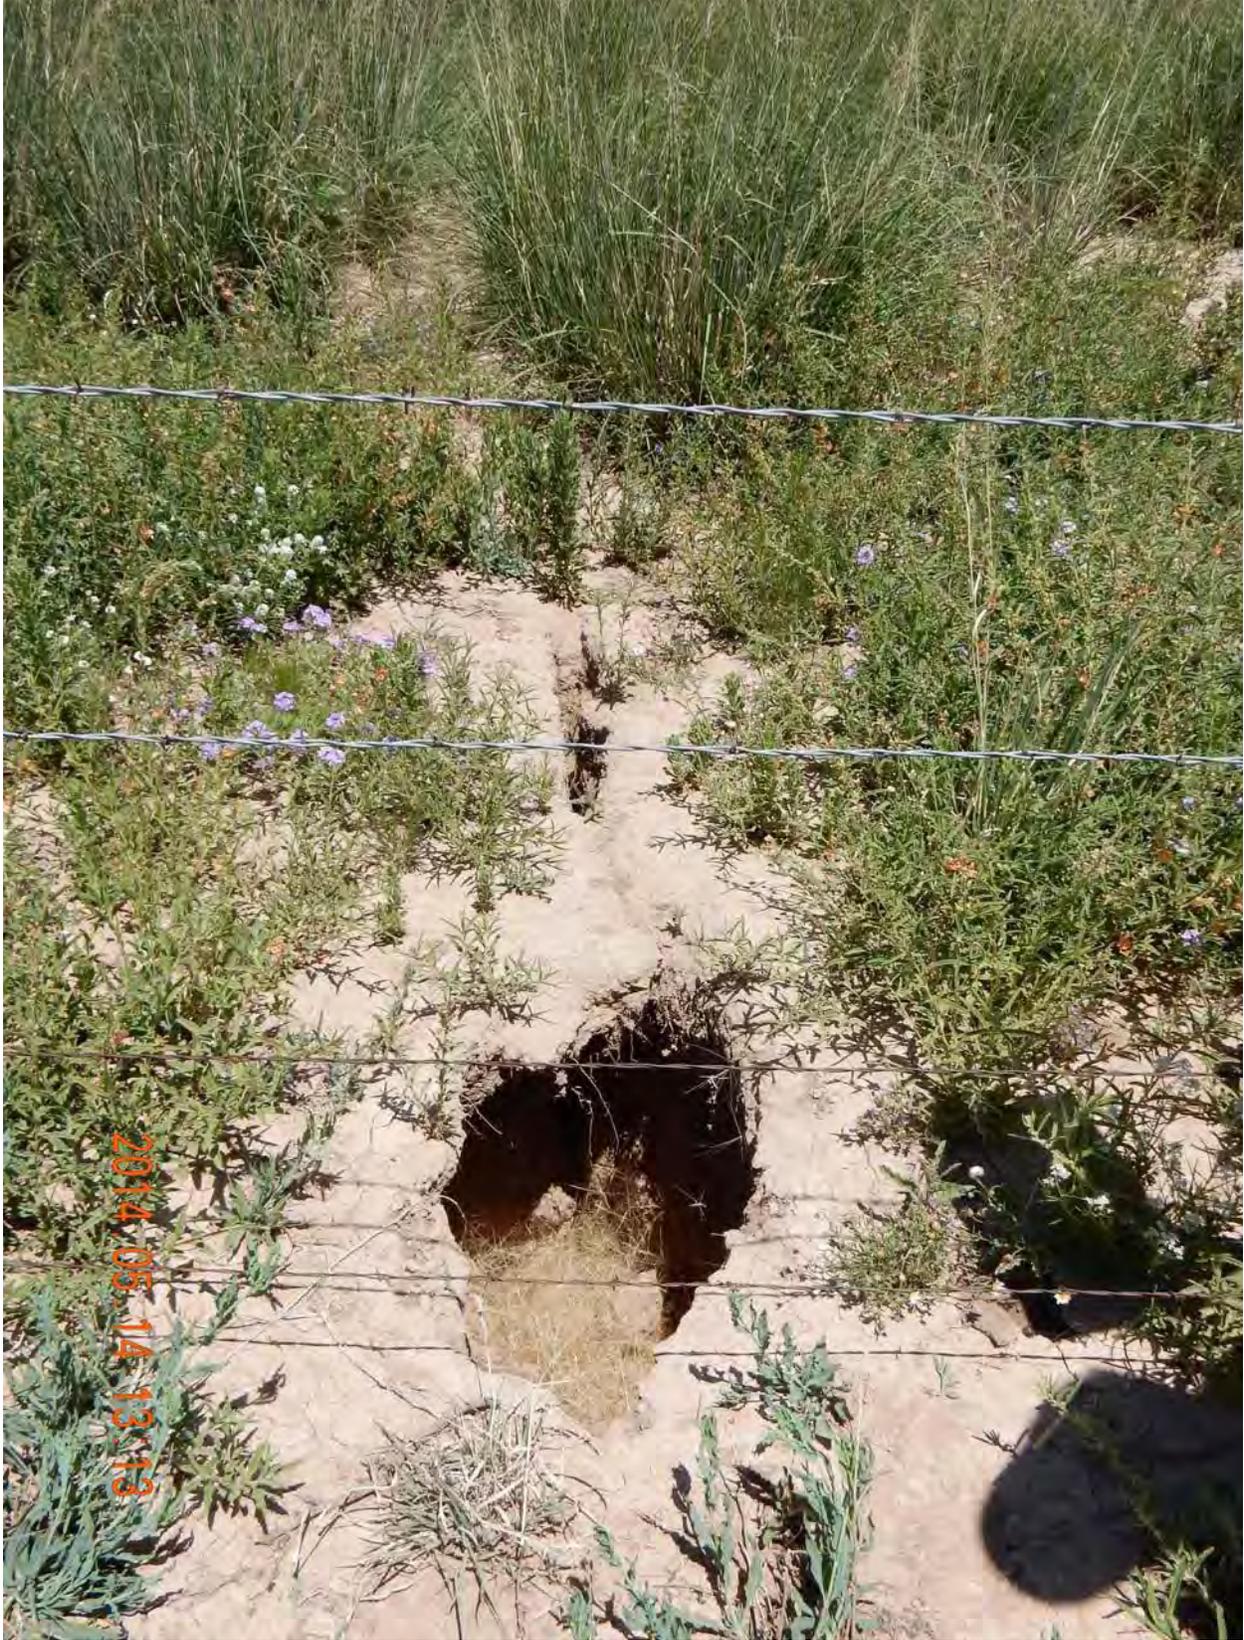
Figure A-11. Fifth sinkhole in a cluster of five, north side Lakewood Road. Length 0.84 m, width 0.38 m, depth 0.84 m. Sinkhole follows fracture with azimuth of 177°. 558427, 3610725, 3 m.

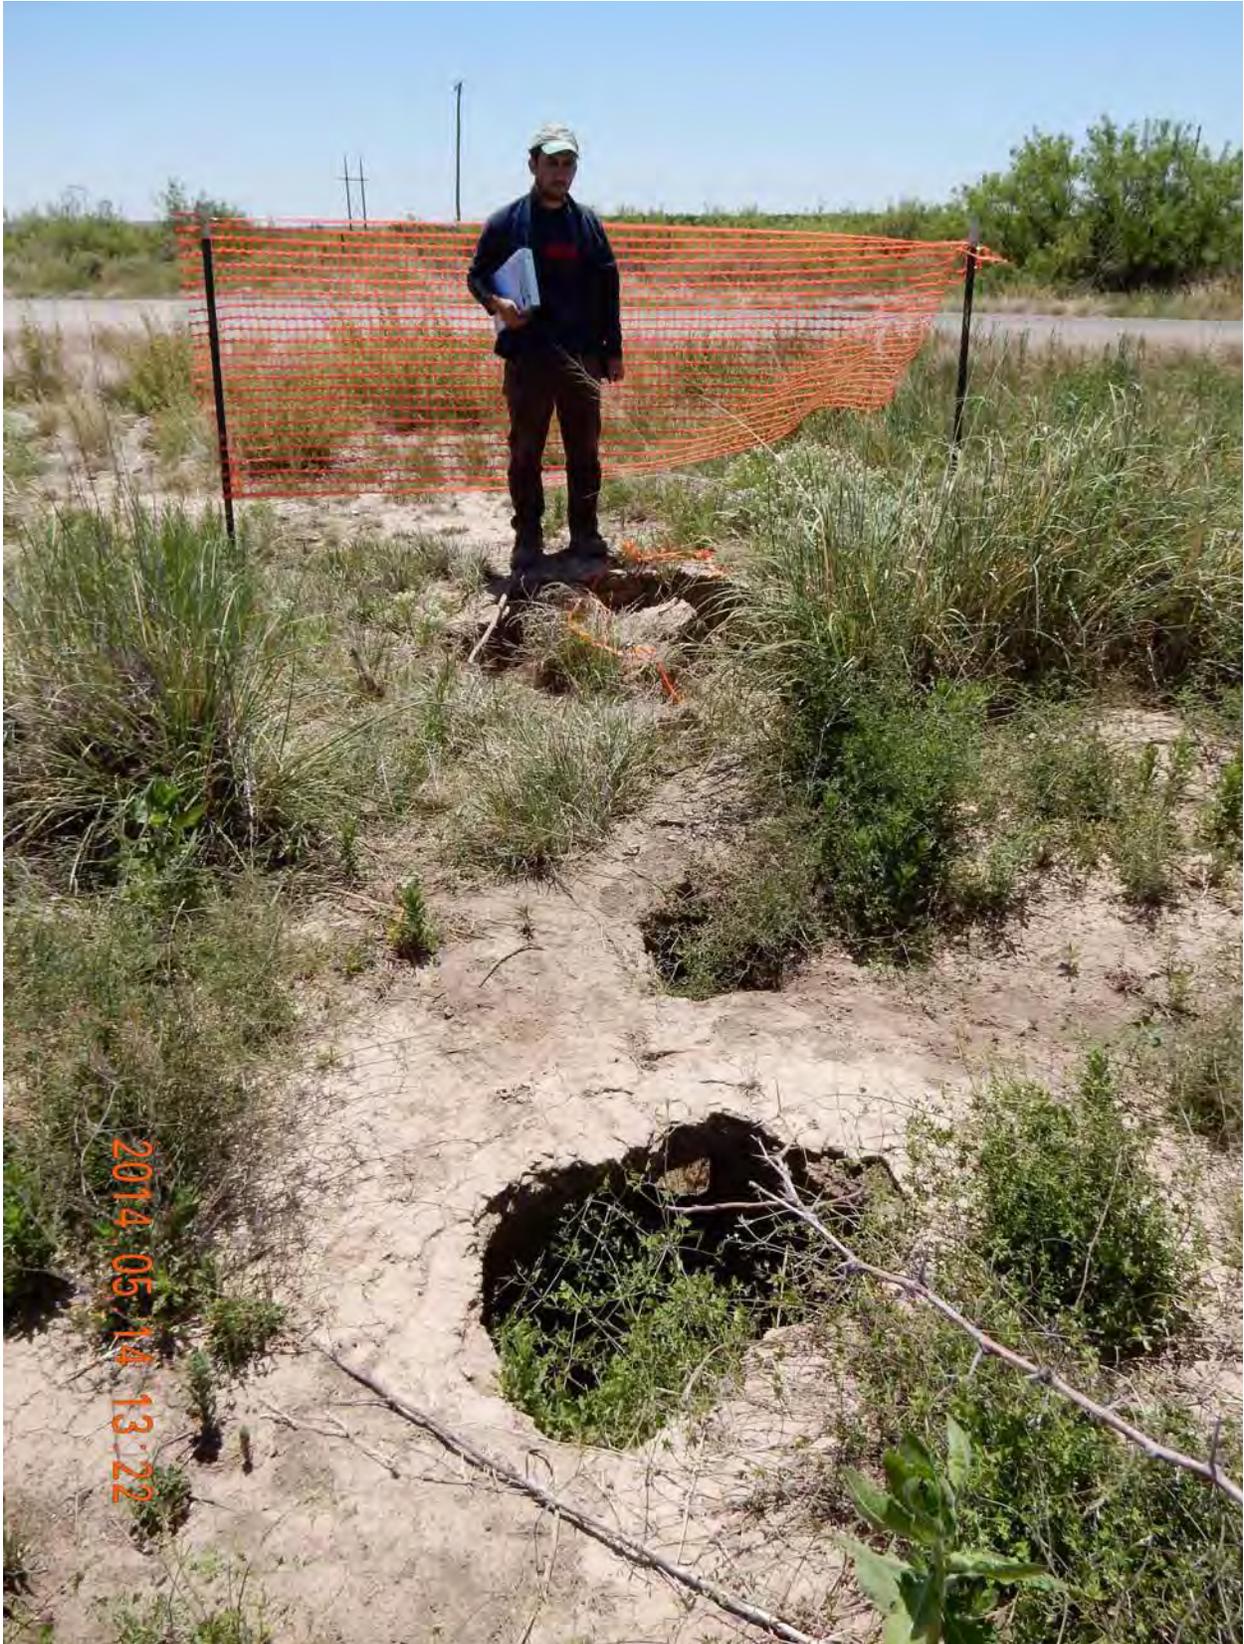
Figure A-12a. Line of three sinkholes, north side Lakewood Road. Line of sinkholes is oriented azimuth 146° . 558392, 3610717, 3 m.

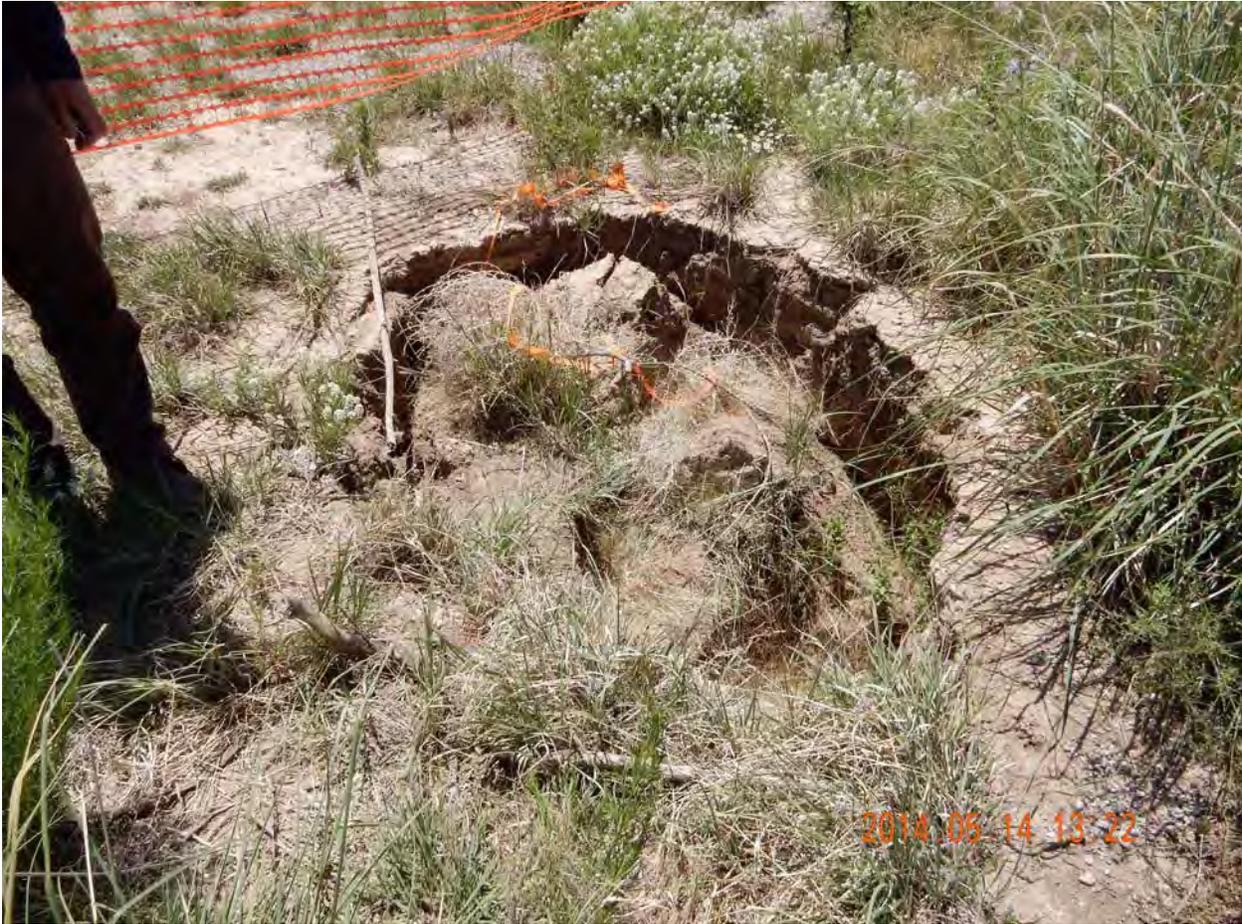
Figure A-12b. First of three sinkholes in line, north side of Lakewood Road. Length 1.78 m, width 1.45 m, depth 0.87 m. 558392, 3610717, 3 m.

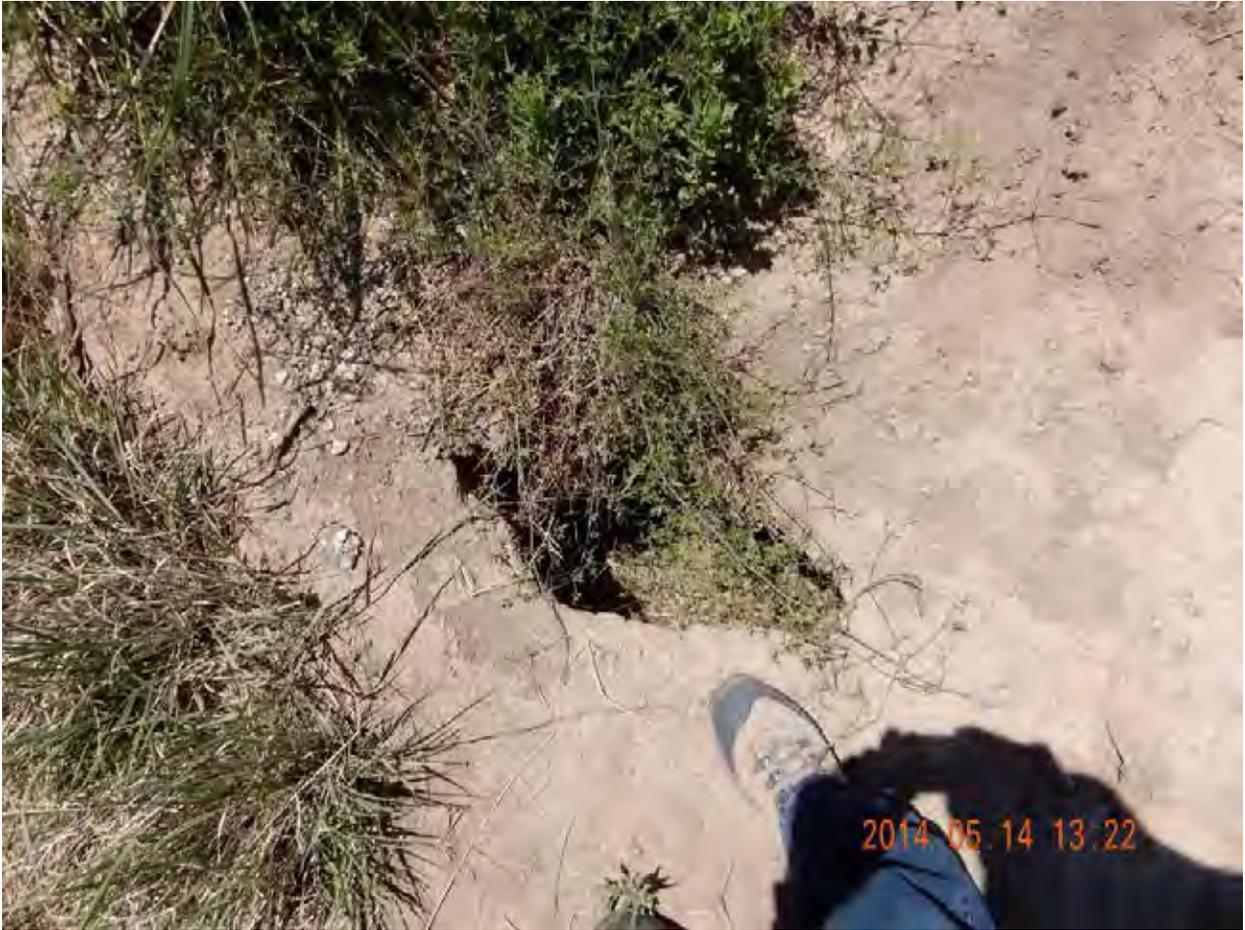
Figure A-12c. Second of three sinkholes in line, north side of Lakewood Road. Length 0.56 m, width 0.35 m, depth 0.69 m. 558392, 3610717, 3 m.

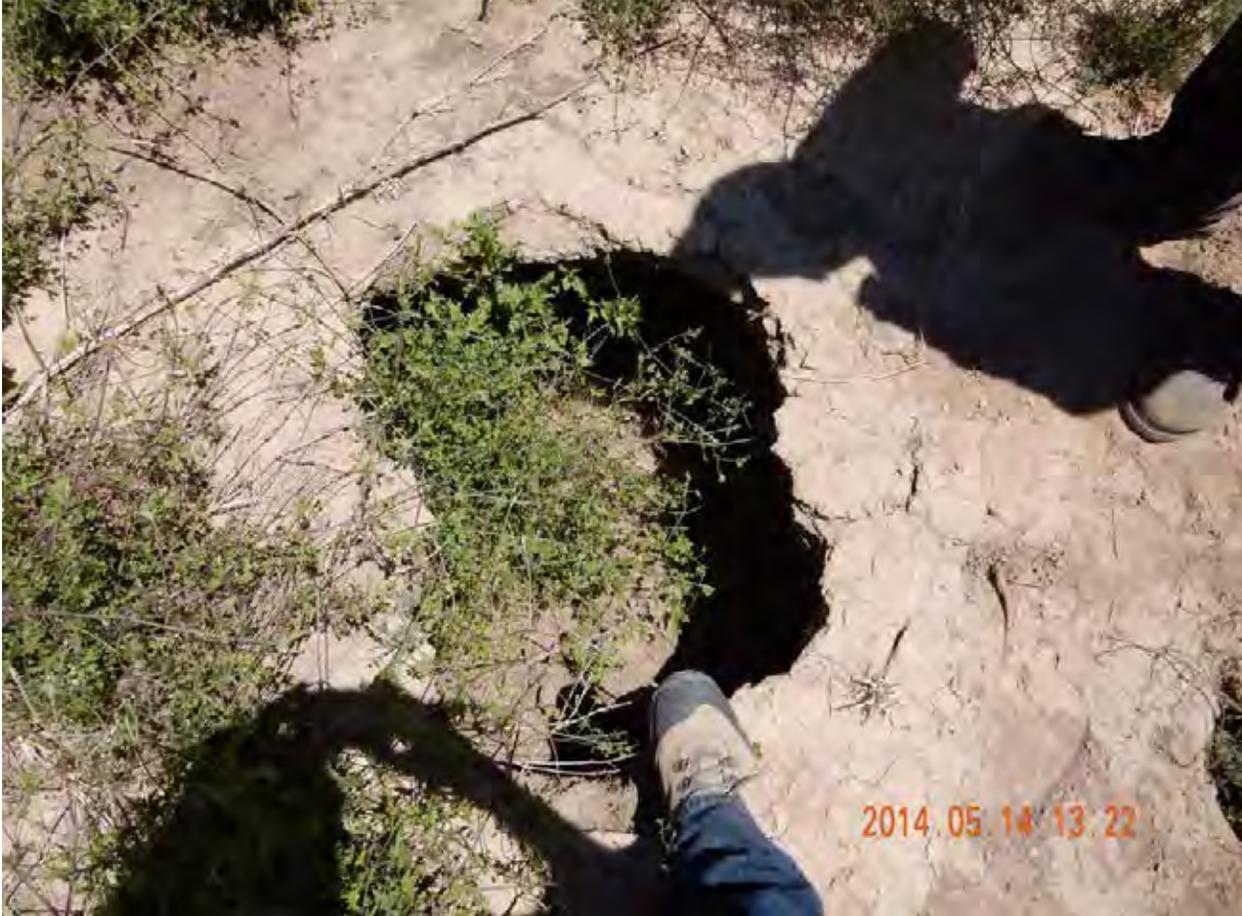
Figure A-12d. Third of three sinkholes in line, north side of Lakewood Road. Length 0.73 m, width 0.46 m, depth 0.57 m. 558392, 3610717, 3 m.

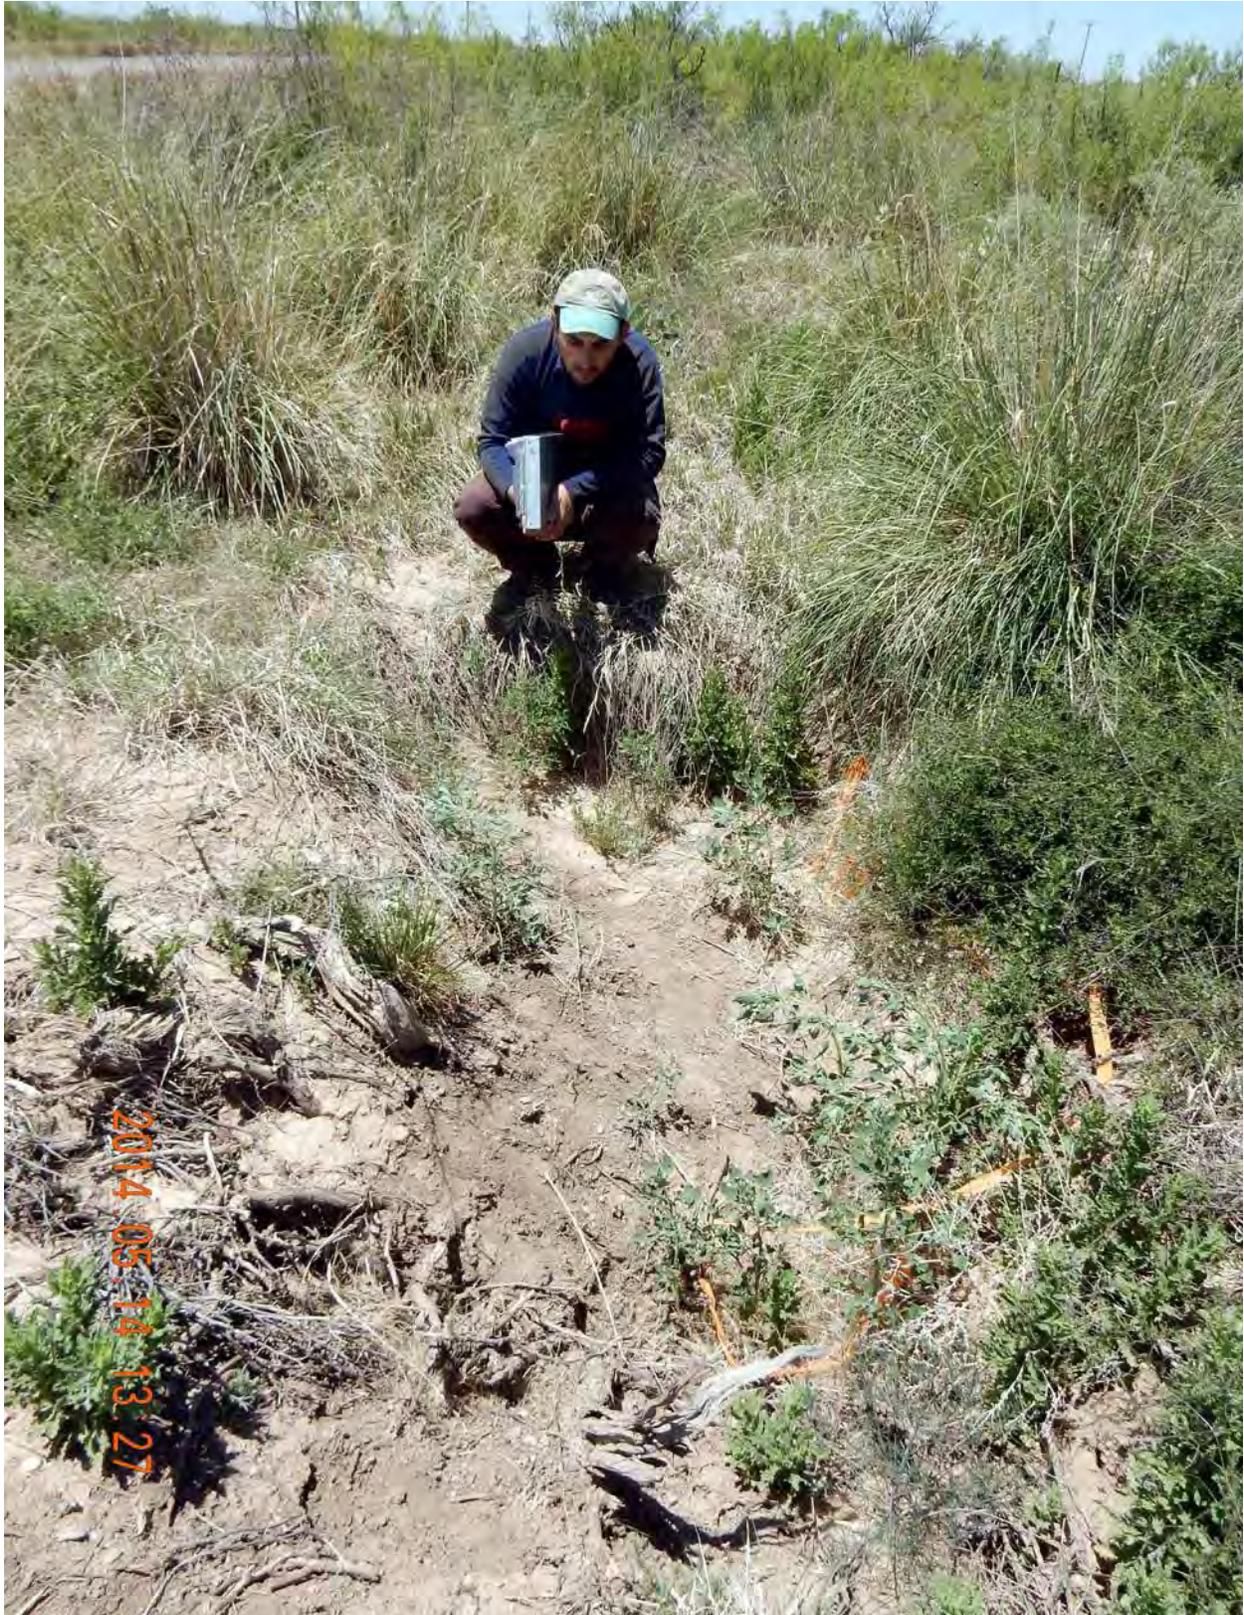
Figure A-13. Sinkhole, north side Lakewood Road. Length 2.67 m, width 1.7 m, depth 0.64 m. 558385, 3610719, 3 m.

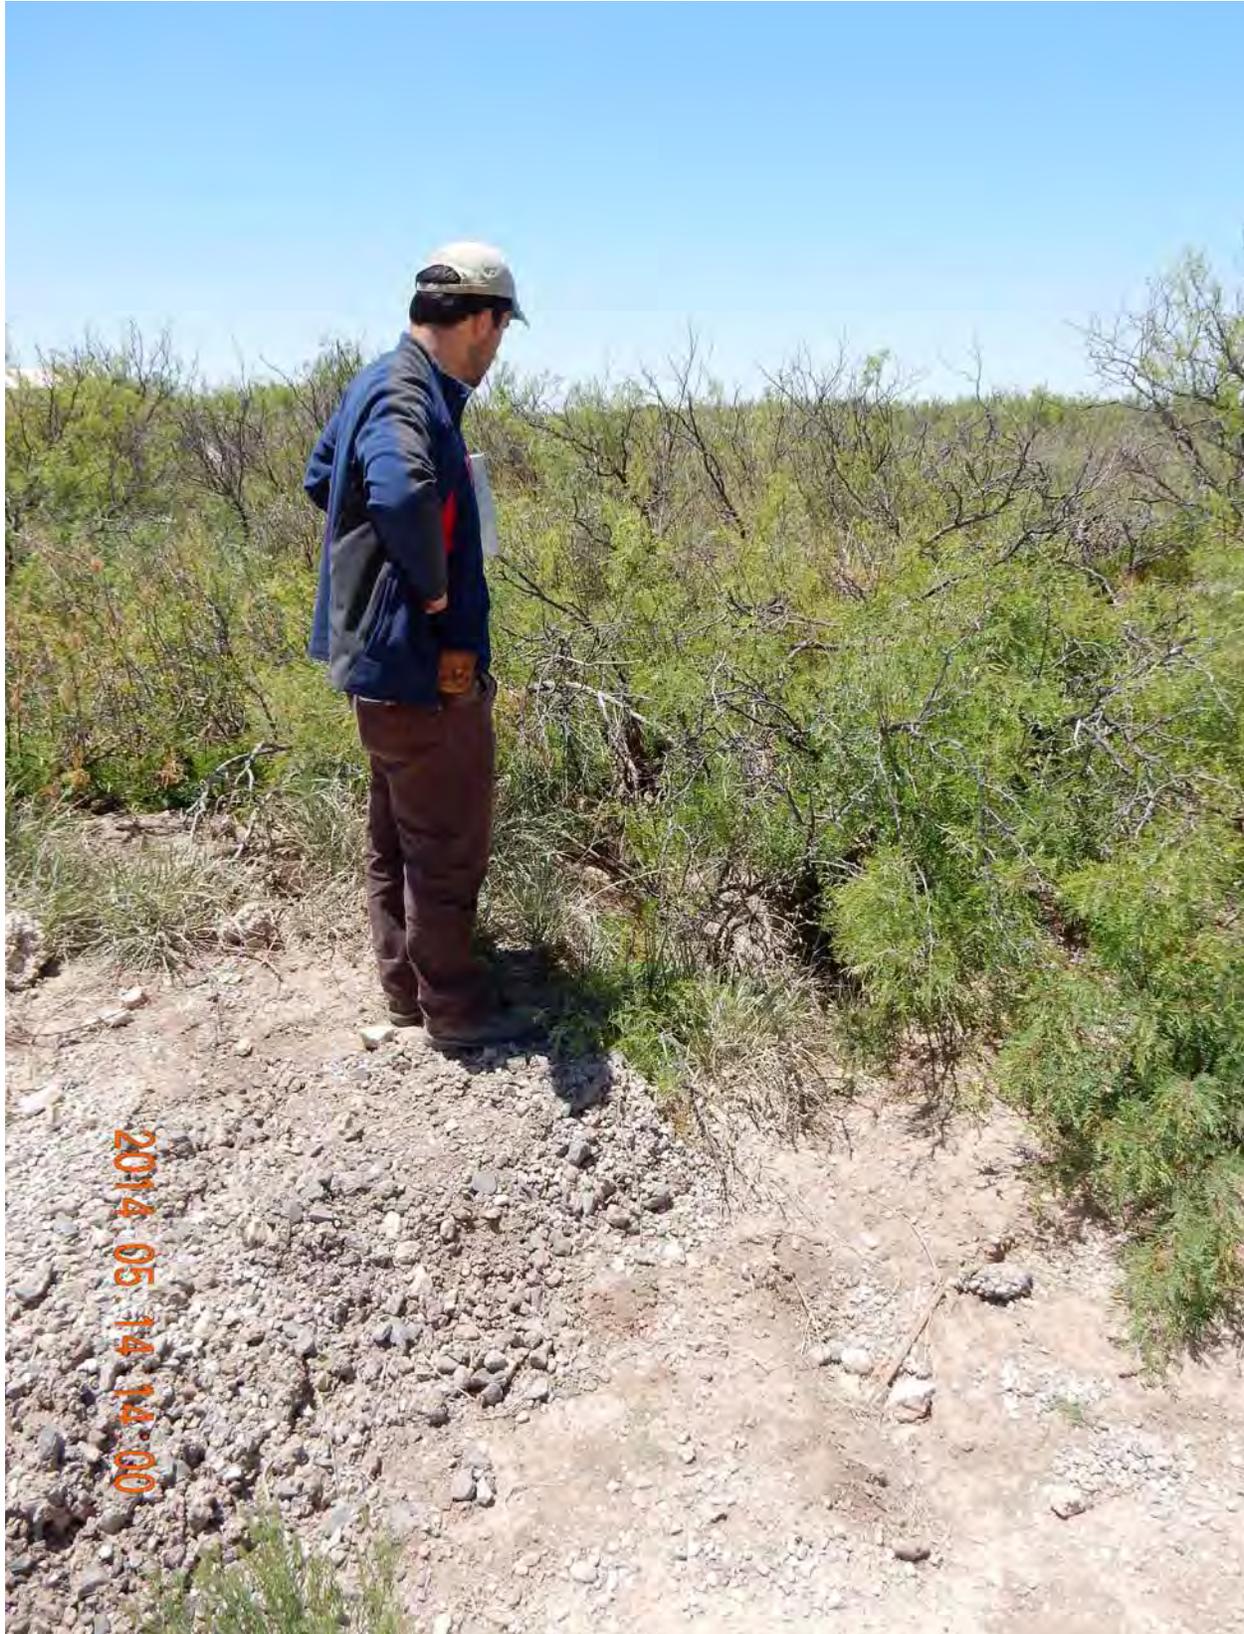
Figure A-14. Discontinuous soil fracture, mostly concealed by dense mesquite, west side of Lake Road. Length ~20 m, maximum width 1.55 m, maximum depth 1.37 m, azimuth 97°. 559128, 3610938, 4 m.

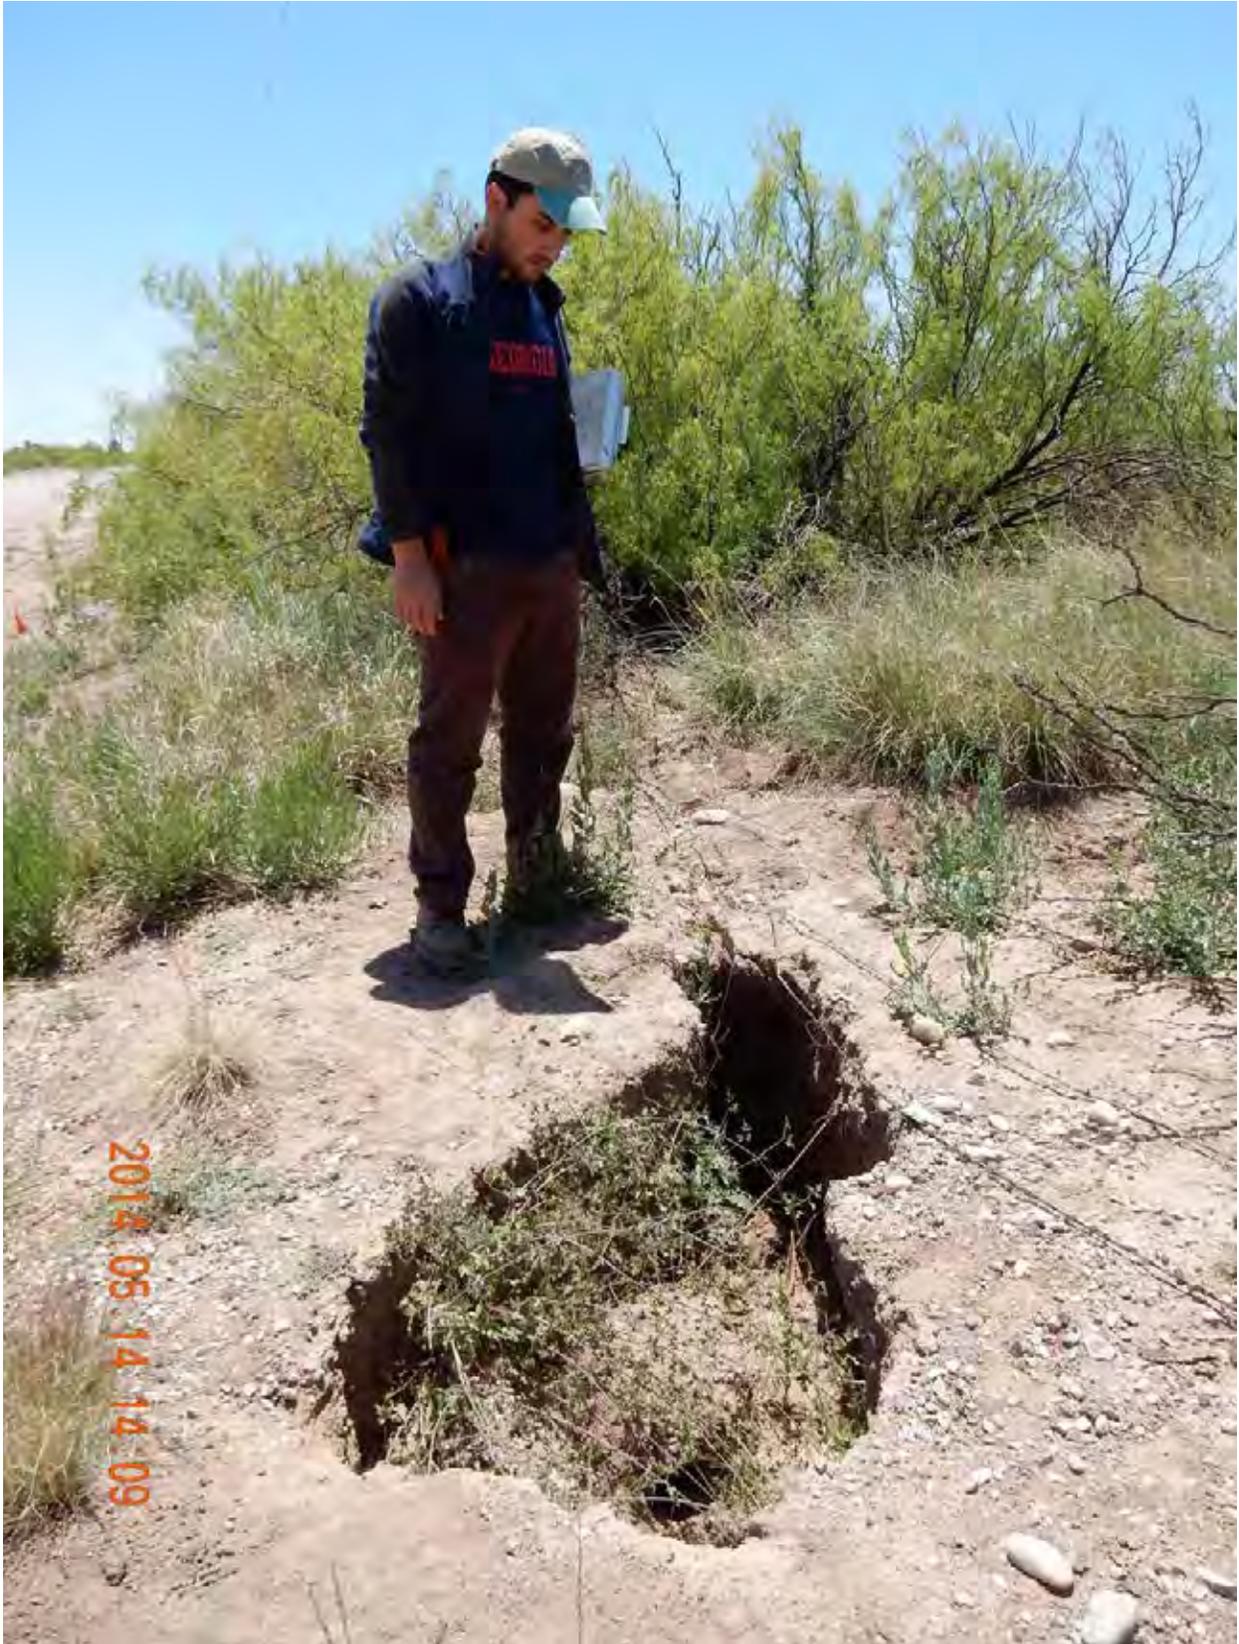
Figure A-15a. First of two sinkholes following fracture, west side of Lake Road. Length 1.65 m, width 1.1 m, depth 0.7 – 1.6 m. Fracture azimuth 2°. 559133, 3610963, 3 m.

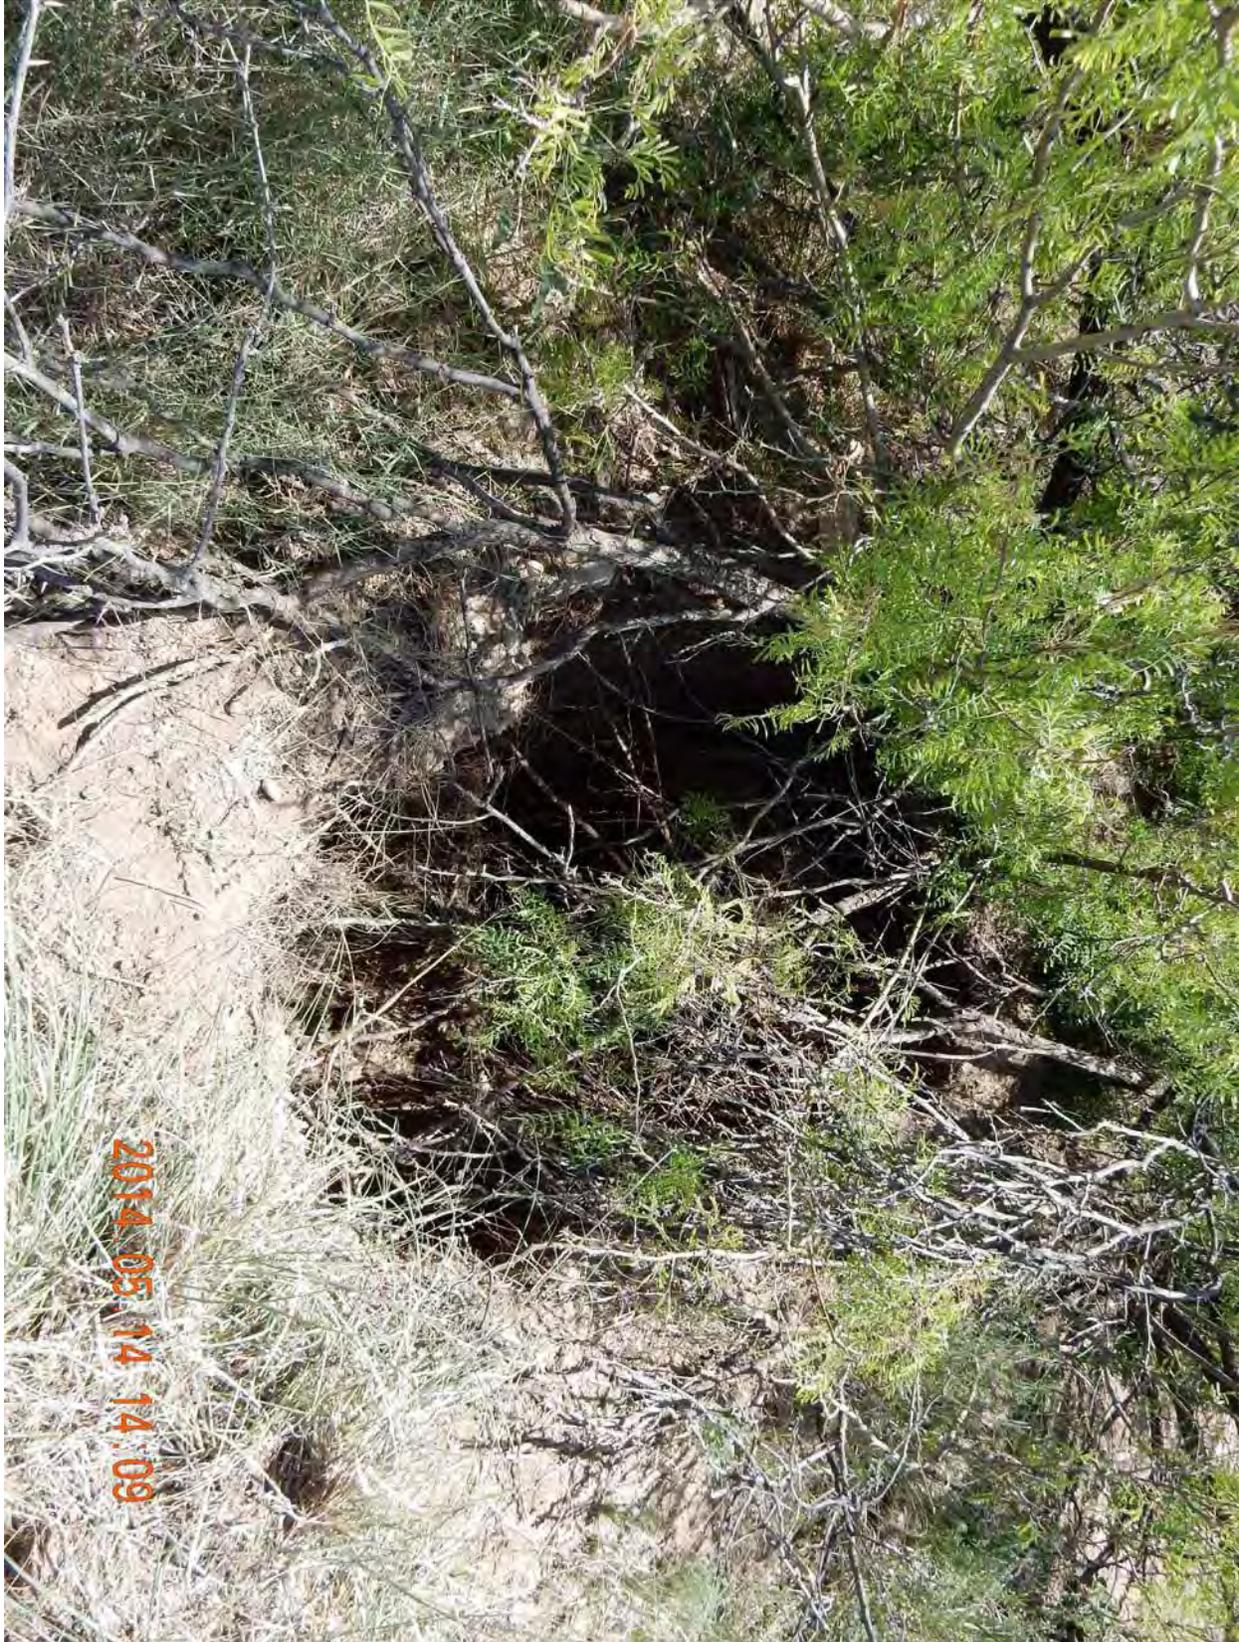
Figure A-15b. Second of two sinkholes following fracture, west side of Lake Road. Length 1.62 m, width 0.54 m, depth 0.7 m. Fracture azimuth 2°. 559133, 3610963, 3 m.

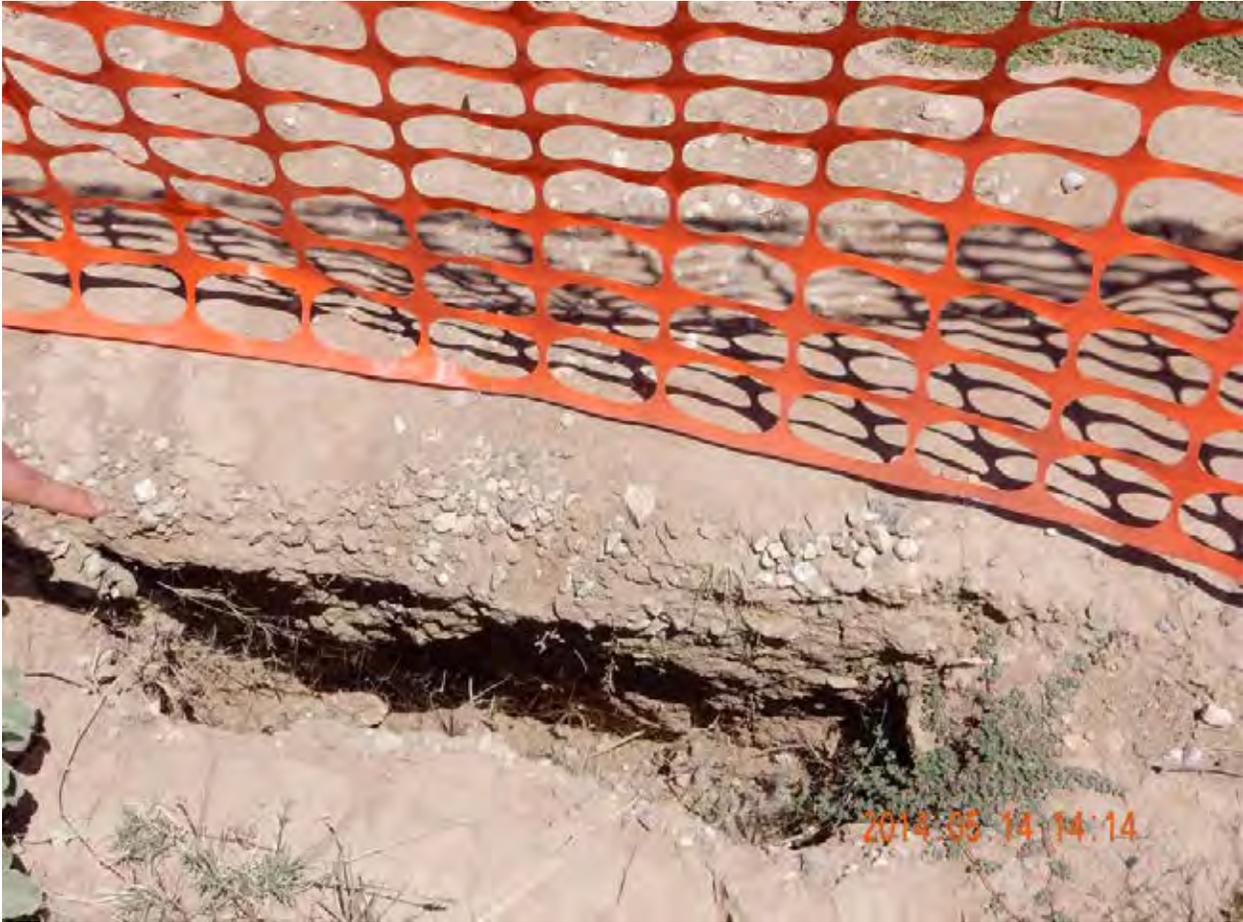
Figure A-16. Soil fracture, west side of Lake Road. Length 0.66 m, width 0.1 m, depth 0.4 m, azimuth 172°. 559138, 3610973, 4 m.

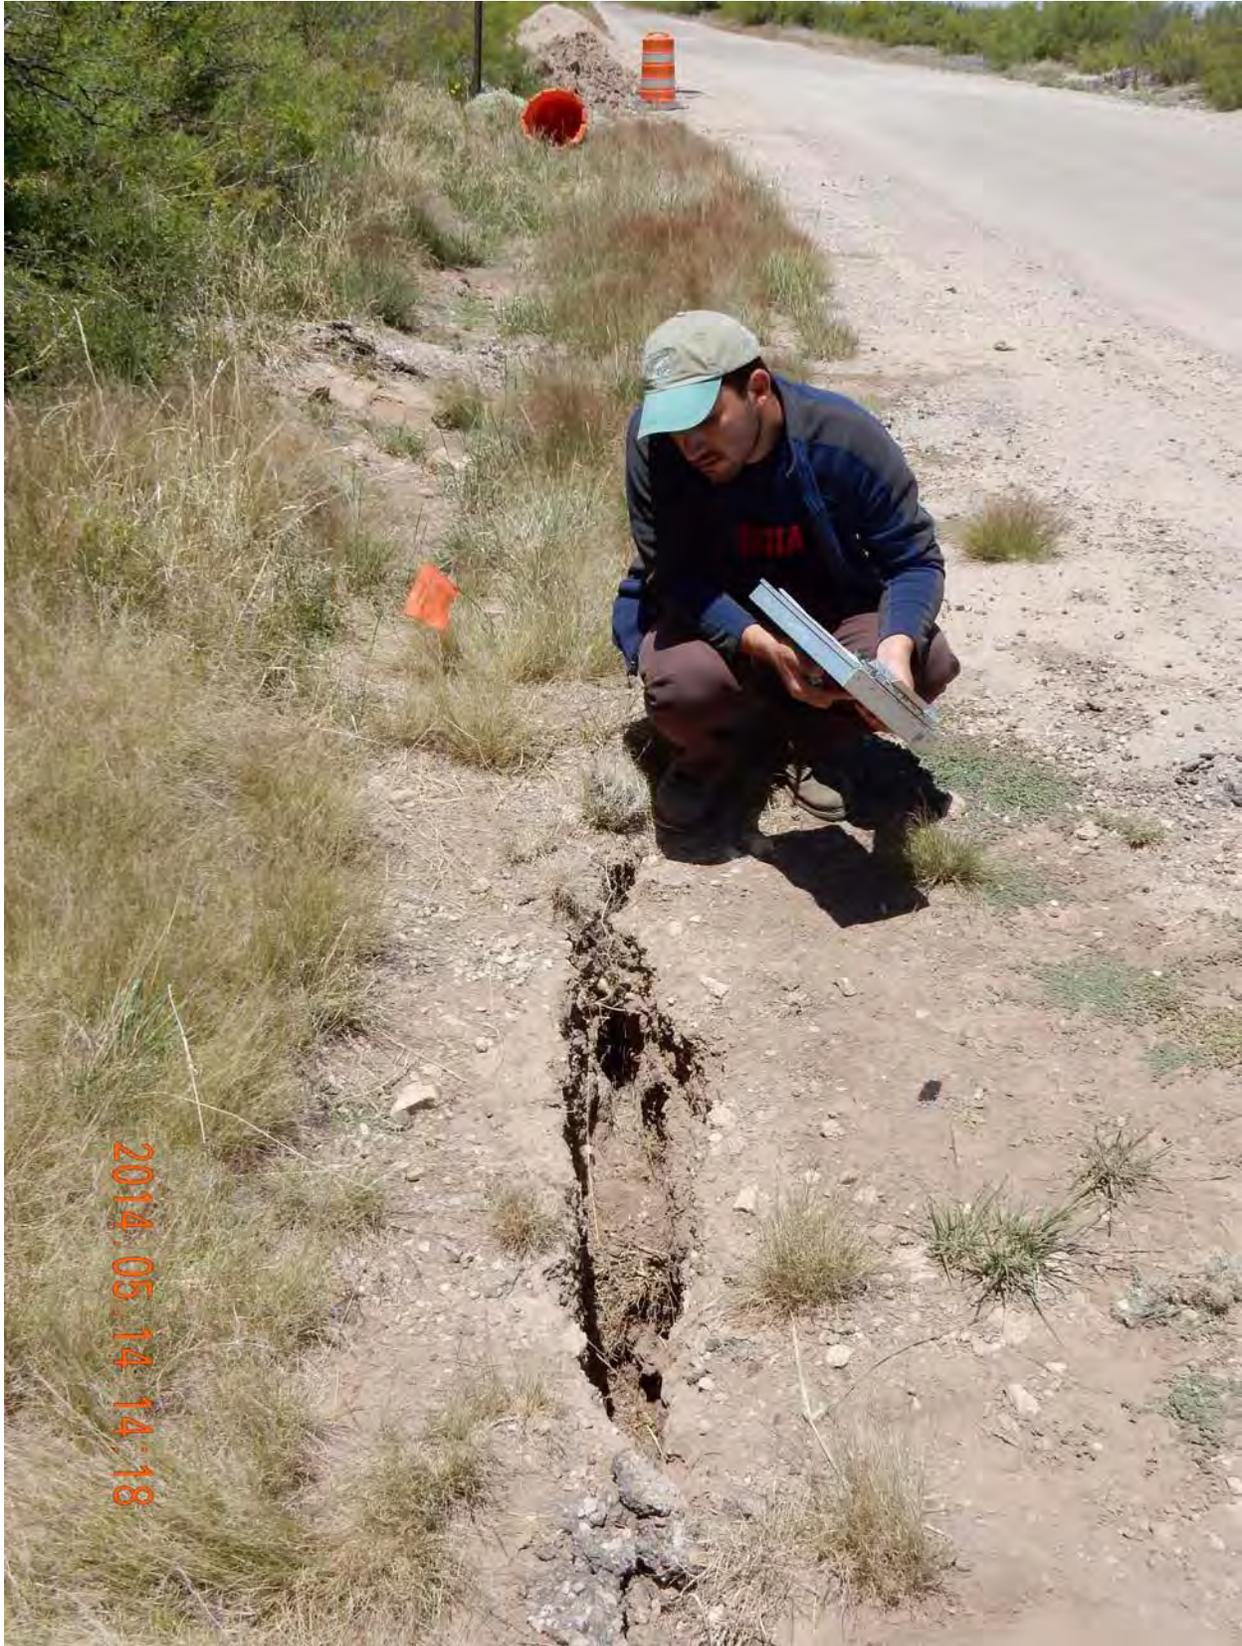
Figure A-17. Soil fracture, west side of Lake Road. Length 2.0 m, width 0.19 m, depth 1.8 m, azimuth 172°. 559137, 3610990, 4 m.

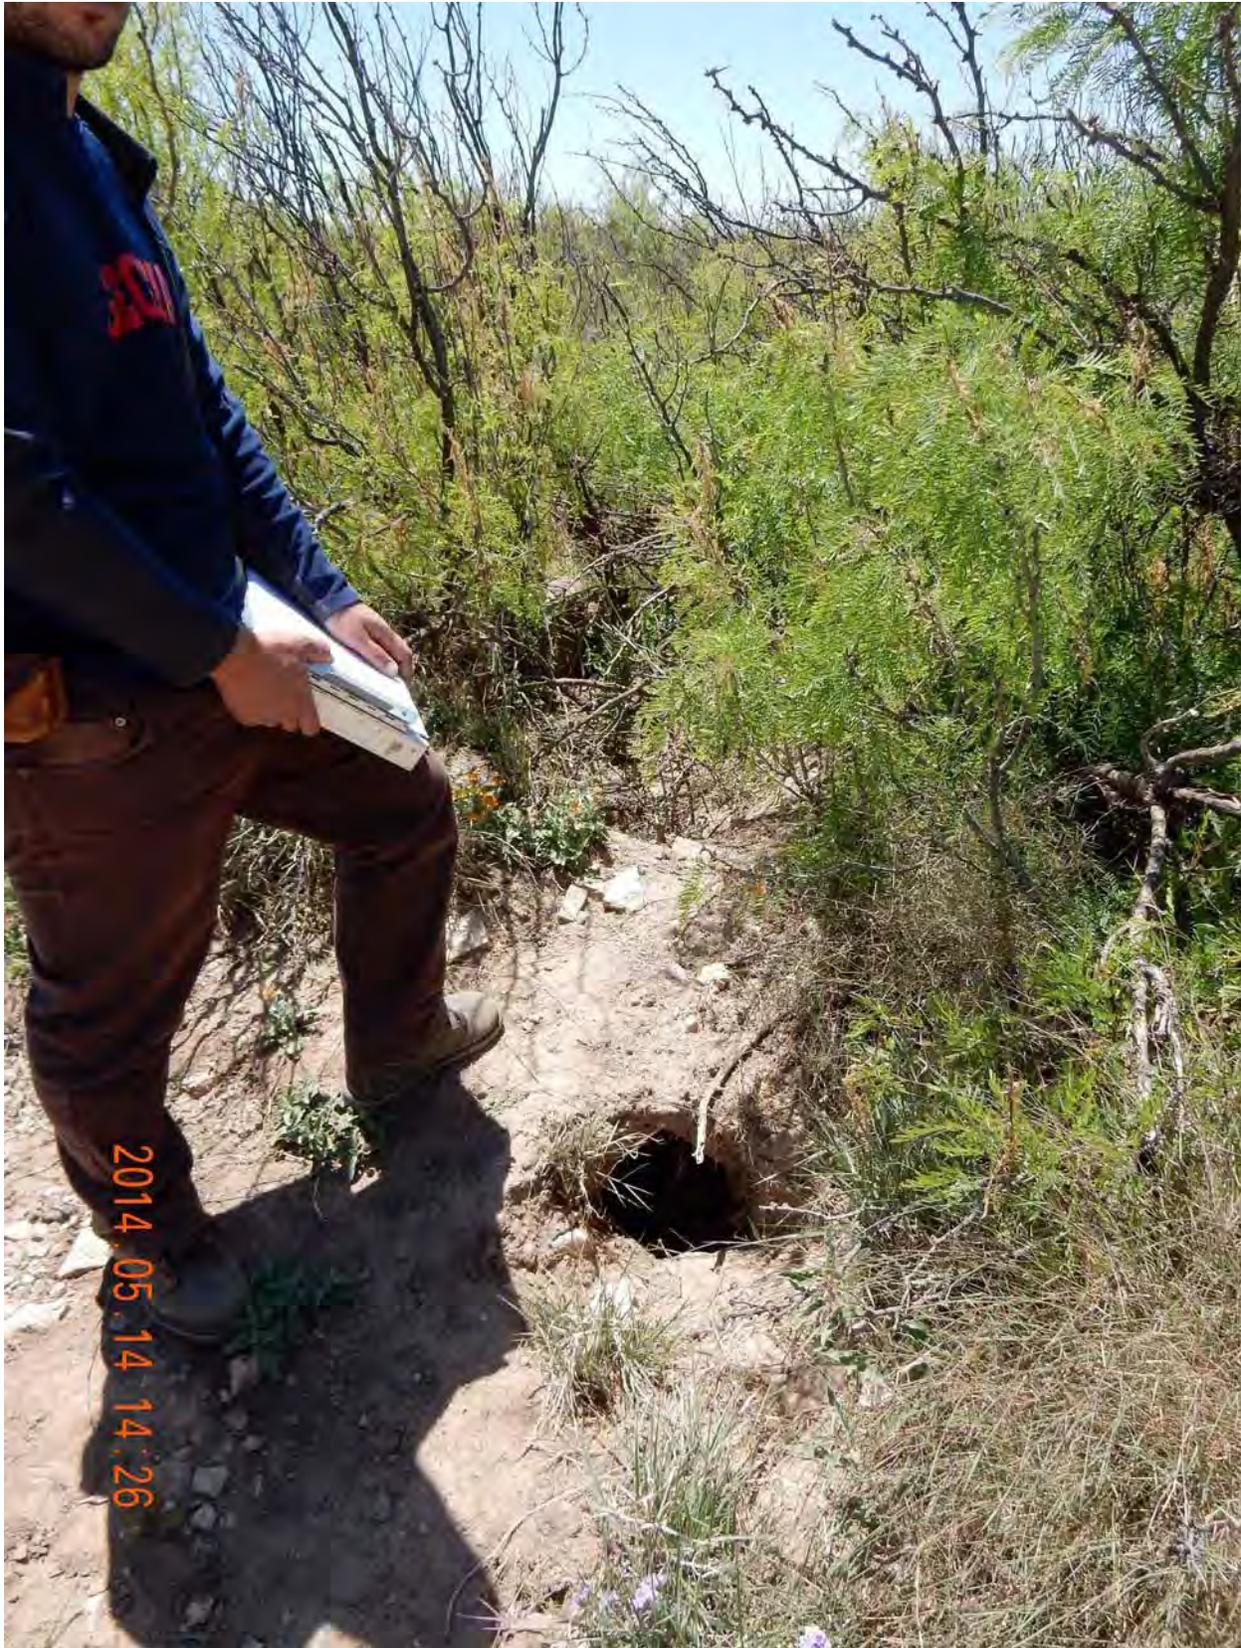
Figure A-18. Poorly exposed, irregular and discontinuous soil fracture extending into mesquite. Length >20 m, width ~0.5 m, depth ~0.5 m. 559133, 3611008, 4 m.

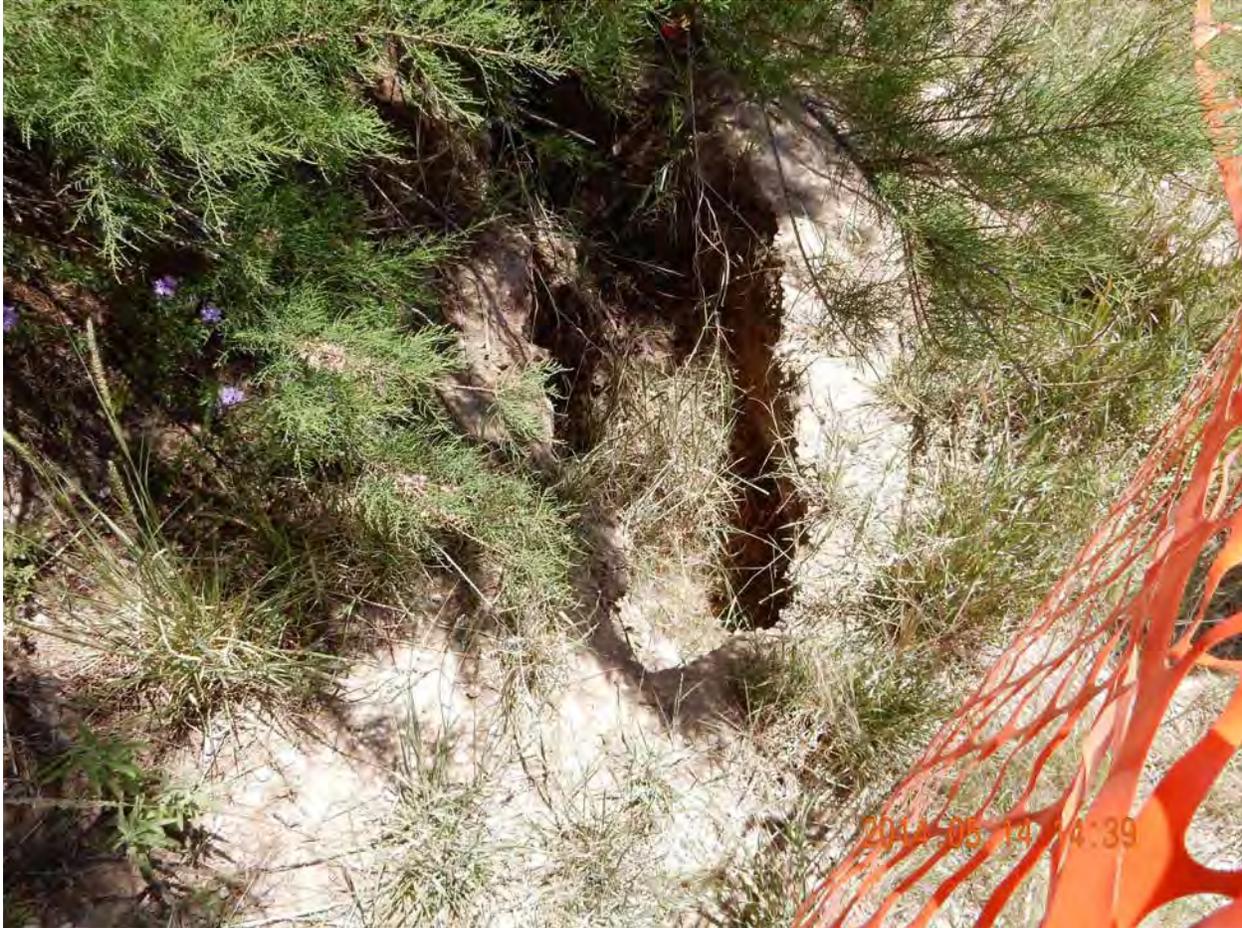
Figure A-19. Soil fracture, west side of Lake Road. Pavement damage indicates that fracture extends beneath road to opposite shoulder, where a poorly exposed fracture with the same orientation extends into mesquite. Length ~15 m (assuming fracture extends beneath road), width ~0.5 m, maximum depth 1 m, azimuth 112°. 559135, 3611177, 3 m.
