NCKRI REPORT OF INVESTIGATION 6

**GEOPHYSICAL INVESTIGATION OF FLOOD-INDUCED
SINKHOLE COLLAPSES, LAKEWOOD REGION,
EDDY COUNTY, NEW MEXICO**

Lewis Land
Lasha Asanidze

June 2014

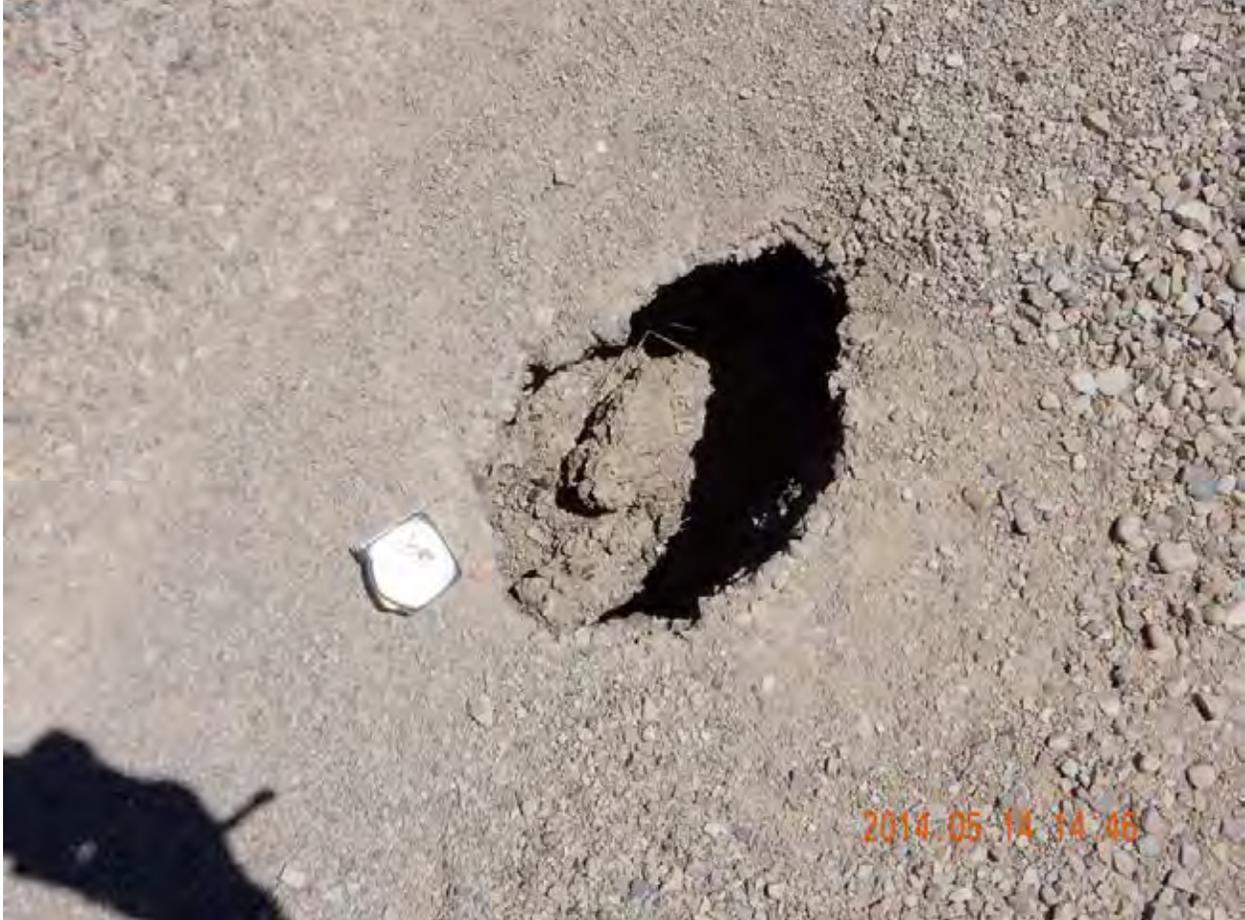
Figure A-20. Sinkhole in asphalt, west shoulder of Lake Road. Length 0.33 m, width 0.2 m, depth 0.3 m. This sinkhole aligns with asphalt patches in road that are probably filled sinkholes, and another sinkhole on the opposite shoulder. Orientation of these features is azimuth 27°. 559134, 3611322, 3 m.

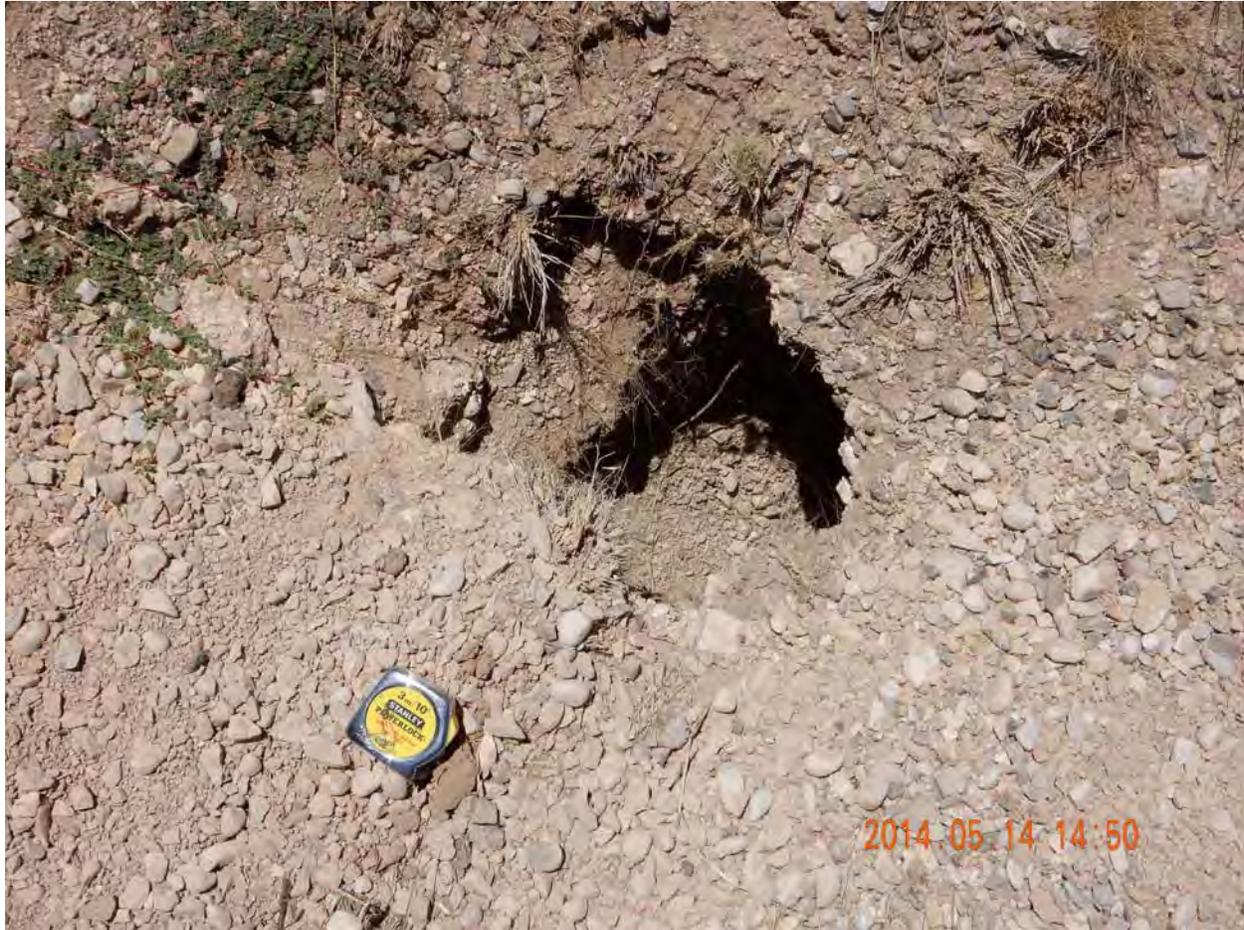
Figure A-21. Sinkhole, east side of Lake Road. Length 0.3 m, width 0.23 m, depth 0.43 m. This sinkhole aligns with asphalt patches in road that are most likely filled sinkholes, and another sinkhole on the opposite shoulder. Orientation of these features is azimuth 27°. 559144, 3611341, 3 m.

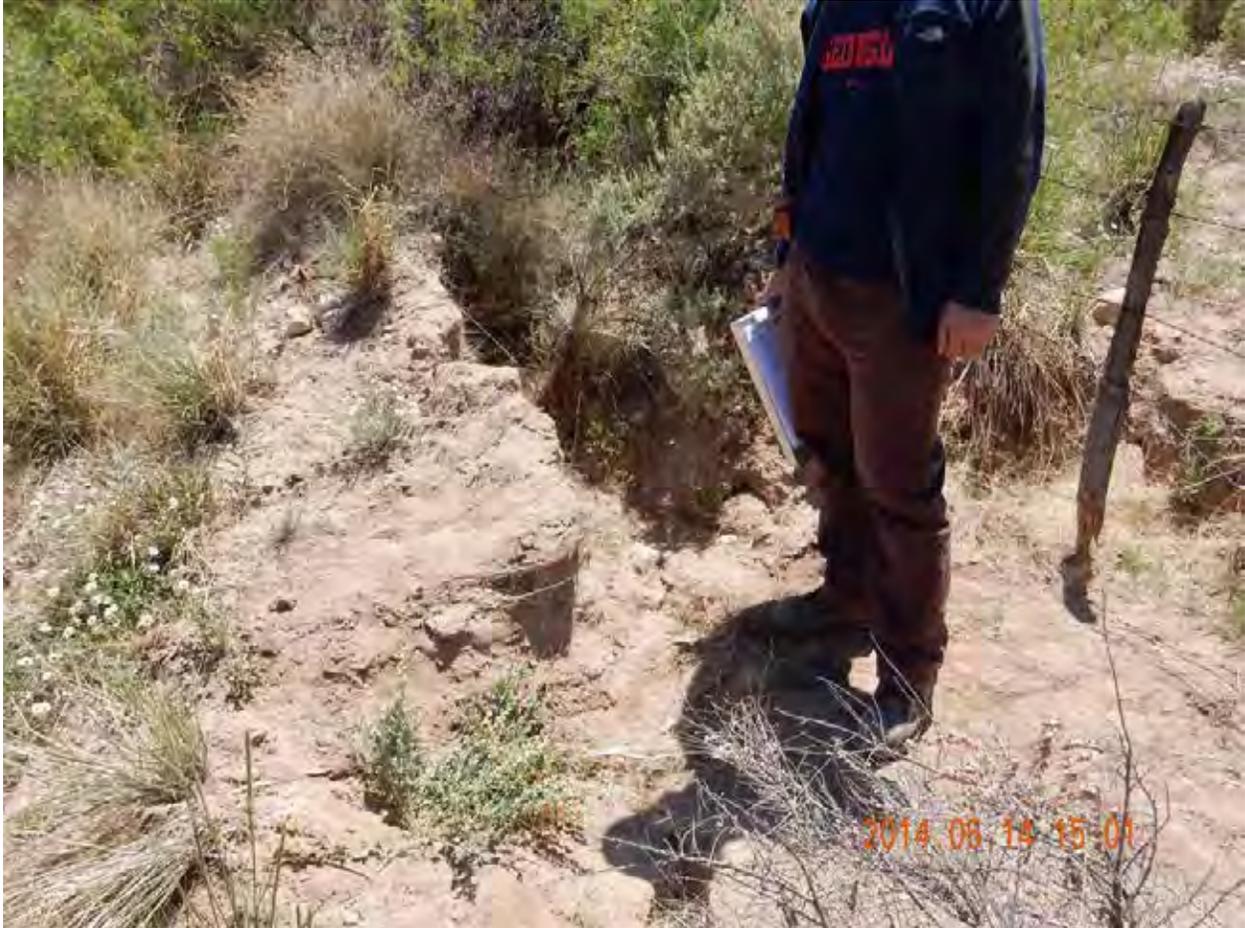
Figure A-22. Soil fracture extending into dense stand of mesquite, west side of Lake Road. Length ~3 – 4 m, width 0.66 m, depth 0.4 m, azimuth 22°. 559132, 3611532, 3 m.
