NCKRI REPORT OF INVESTIGATION 3

ELECTRICAL RESISTIVITY SURVEY OF INTREPID POTASH
INJECTION WELL SITE: EDDY COUNTY, NEW MEXICO

October 2012

LEWIS LAND AND GEORGE VENI
NATIONAL CAVE AND KARST RESEARCH INSTITUTE

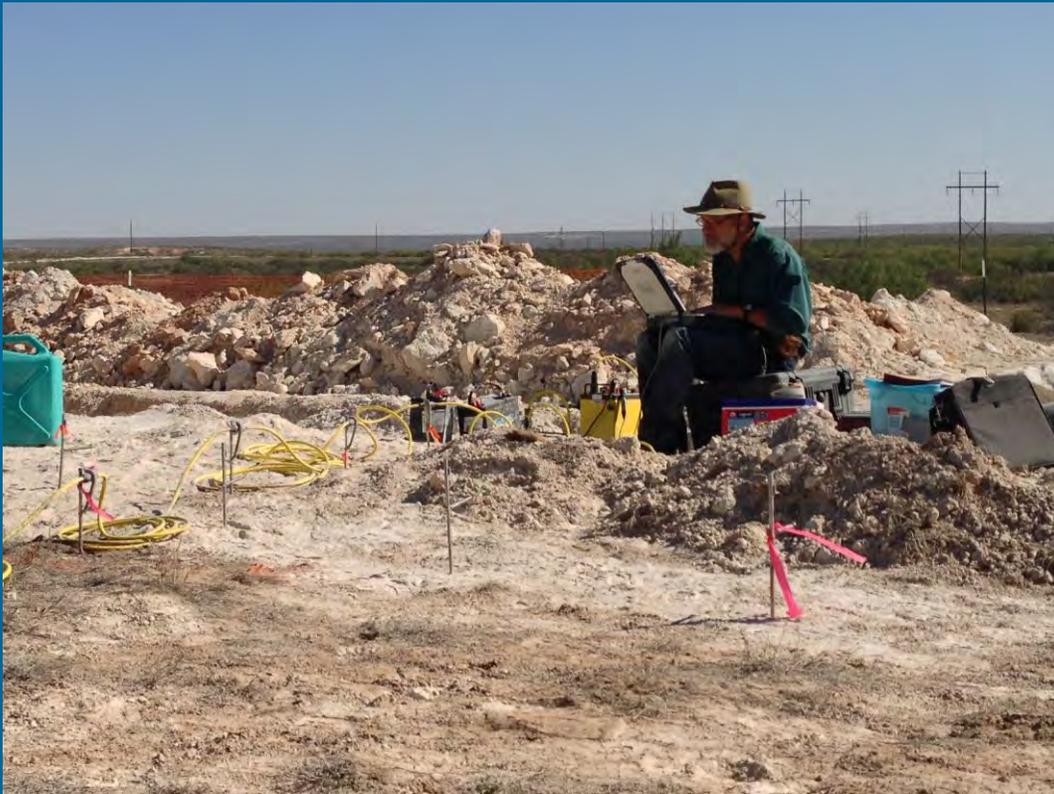
Front cover photo: Dr. Lewis Land analyzing data collected from an electrical resistivity survey of the Intrepid injection well site. Disturbed soil in the background is the product of the pipeline excavation that accidentally broke into a shallow cave formed in gypsiferous soil at the site. The AGI SuperSting resistivity meter is the yellow box on the ground next to Dr. Land.

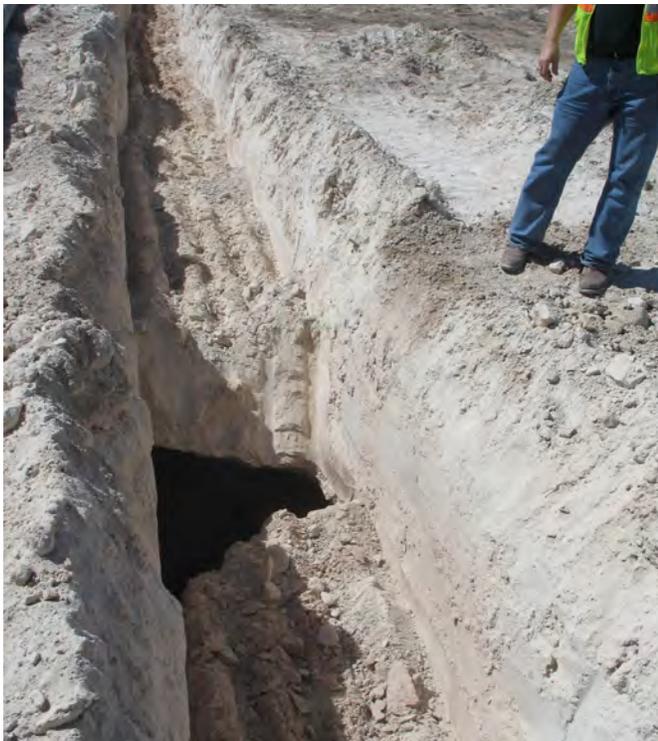
Figure 1: Cave entrance excavated during construction of pipeline ditch.

In October 2012, Intrepid Potash Company was in the process of constructing a well pad, access road, and pipeline for an injection well as part of a larger potash solution mining project in eastern Eddy County, New Mexico. During excavation of the pipeline trench, Intrepid employees discovered a small cavity (Figure 1) that extended approximately 1 m below ground level and opened into a cave approximately 8 m long by 5 m wide and extending to a maximum depth of about 10 m. Observations of the cave interior (Figure 2) by Bureau of Land Management (BLM) personnel indicate that the cave is formed entirely in compacted gypsiferous soil, not bedrock, and that the cave might be deeper and more extensive than their preliminary examination indicated.

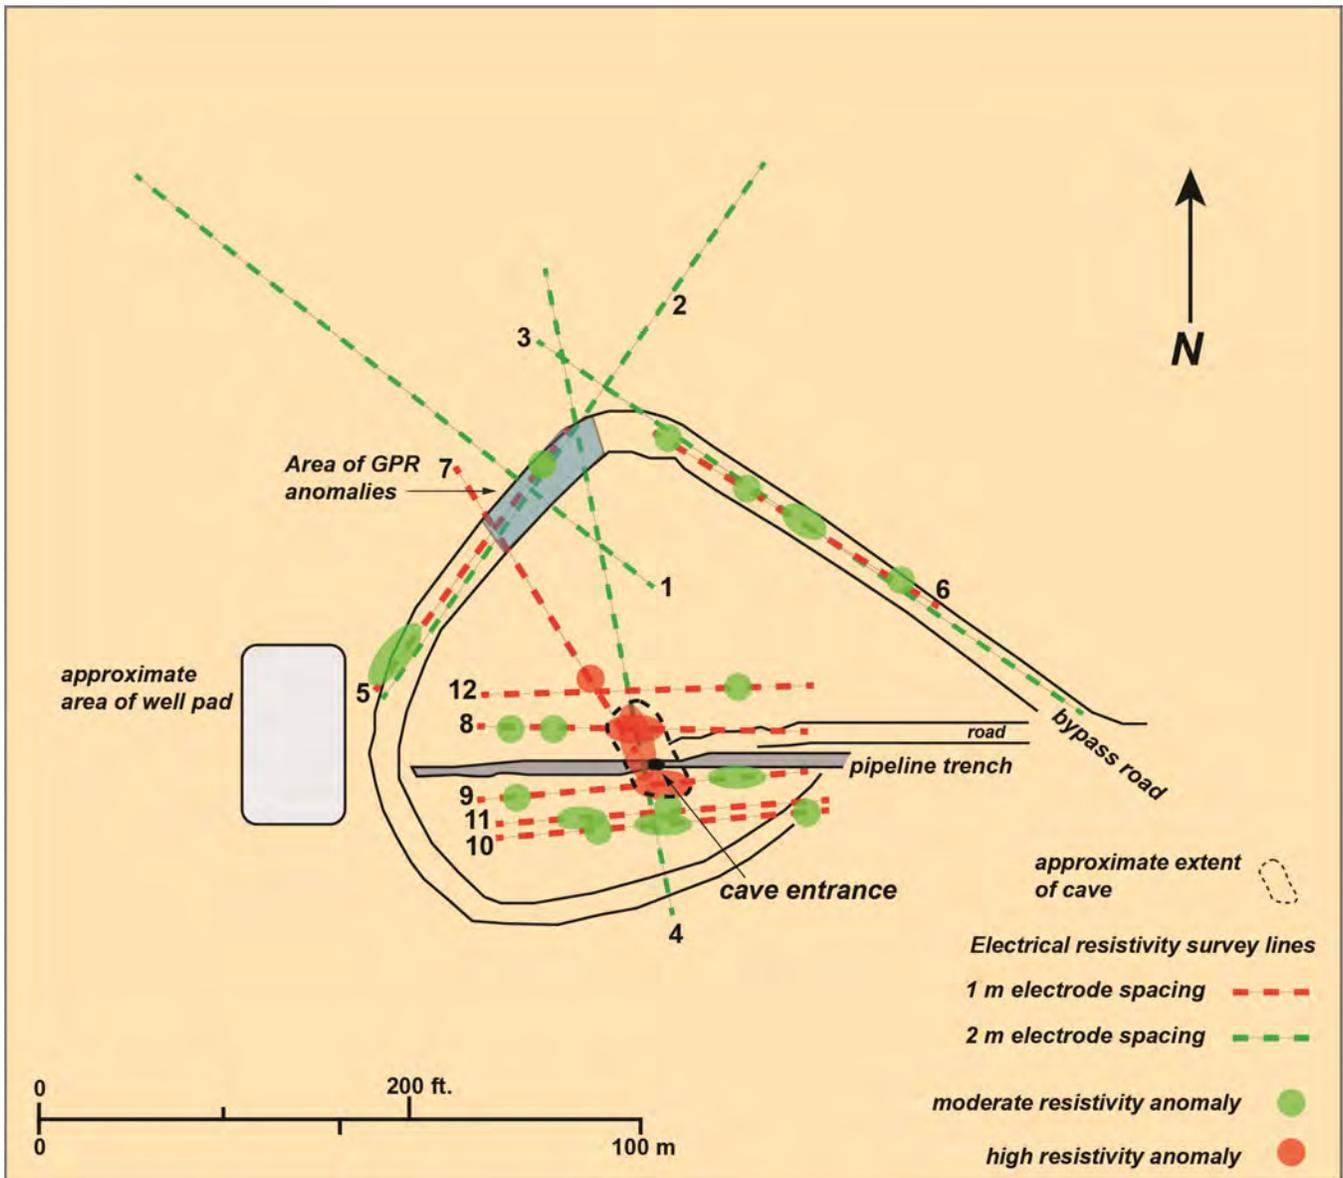
NCKRI conducted four ER surveys on 24 October 2012 using 56 electrode arrays at 2 m spacing. On 25-26 October 2012, eight additional surveys were conducted using 56 electrode arrays at 1 m intervals to achieve better resolution of near surface voids. The positions of the survey lines relative to the cave, each other, and other features in the immediate area are shown in Figure 3. The ER surveys were conducted with an Advanced Geosciences Inc. Su-

Figure 3: Map showing Intrepid Potash injection well site and electrical resistivity survey lines. Dashed line shows approximate extent of

proposed revised pipeline route along the bypass road, shown in Figure 3, that may be caused by additional undiscovered deeper voids. BLM staff expressed concern about the risk of subsidence or catastrophic collapse during or after construction activities, and proposed that Intrepid conduct additional geophysical surveys to determine the extent of the cave that was discovered during excavation, and the depth and extent of the anomalies identified on the GPR profiles in the area.

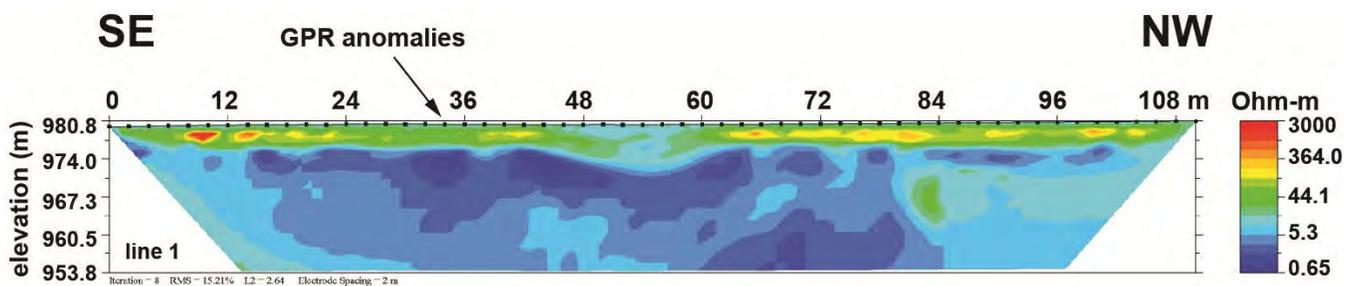
Figure 4: Electrical Resistivity Survey Line 1

ER Survey Line 1 extends SE-NW across the area where GPR anomalies were identified beneath the bypass road (Figure 3). There is no evidence on this line of any features that would likely cause significant collapse or subsidence (Figure 4).

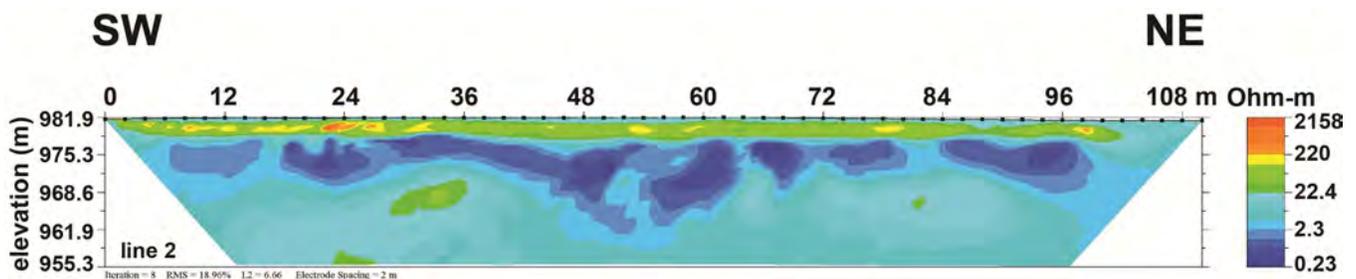
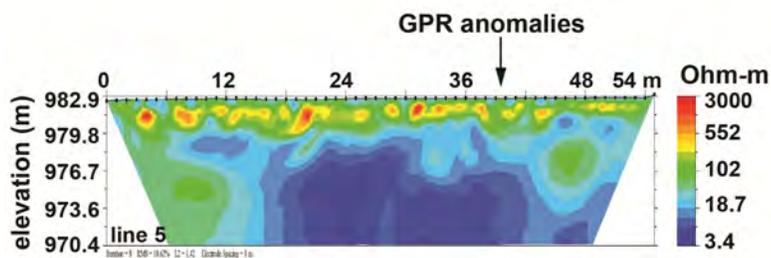
Figure 5: Electrical Resistivity Survey Lines 2 and 5

Lines 2 and 5 extend parallel to the west leg of the bypass road and across the GPR anomalies (Figure 3) discovered by Pettigrew and Associates (2012b). Line 2 is the longer line and Line 5 overlaps the southwest half of its length with higher resolution imaging but at shallower depths (Figure 5). Lines 2 and 5 show moderate resistivity anomalies at 36 m, indicated by green to yellow shading. Line 5 also shows such an anomaly at 45 m and Line 2 at 62 m. These anomalies may warrant monitoring and possibly further investigation but do not seem likely sites of significant collapse or subsidence at this time.

Electrical resistivity survey lines 2, 3, 5 and 6 (Figure 3) do not indicate any significant evidence of large caves beneath the bypass road. Smaller, shallow resistivity anomalies may be the result of air pockets in gypsiferous soil, and as such may present a minor traffic hazard because of subsidence. Such features could also account for the GPR anomalies observed in previous surveys.

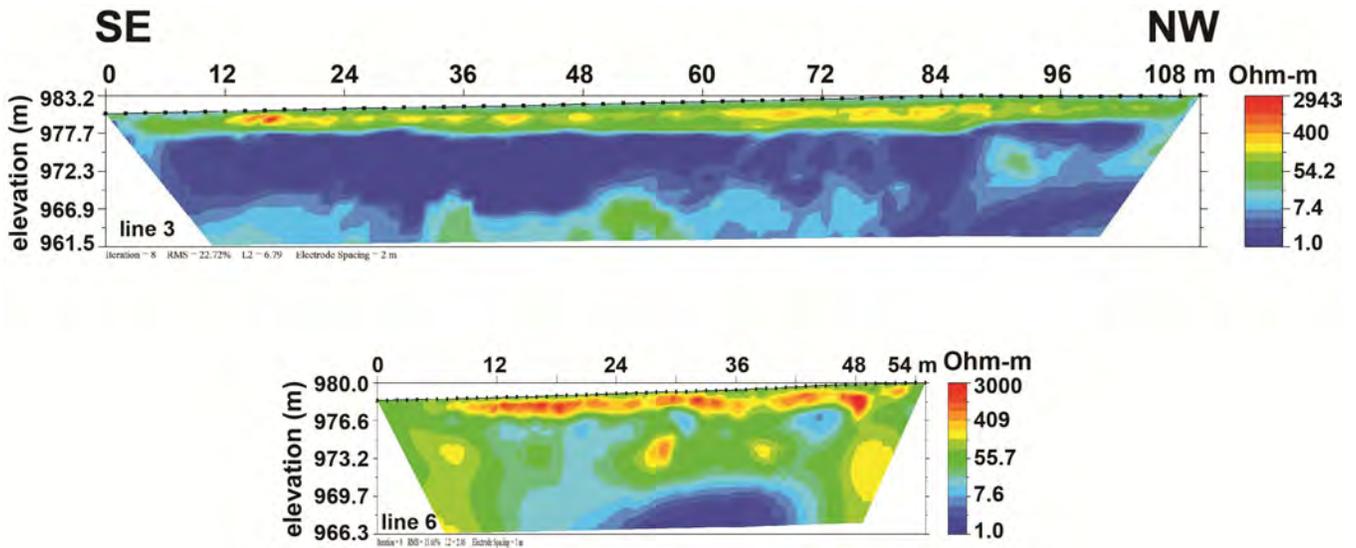
Figure 6: Electrical Resistivity Survey Lines 3 and 6

Lines 3 and 6 extend parallel to the east leg of the bypass road (Figure 3). Line 3 is the longer line and Line 6 overlaps half its length along the middle of Line 3 with higher resolution but shallower imaging (Figure 6). Line 3 shows a moderate resistivity anomaly between 88 and 94 m, about 8 to 10 m below ground level. Line 6 indicates several moderate resistivity anomalies at 7, 28, 38, and 50 m. These moderate resistivity features warrant monitoring and possibly further analysis but do not seem likely sites of significant collapse or subsidence at this time.

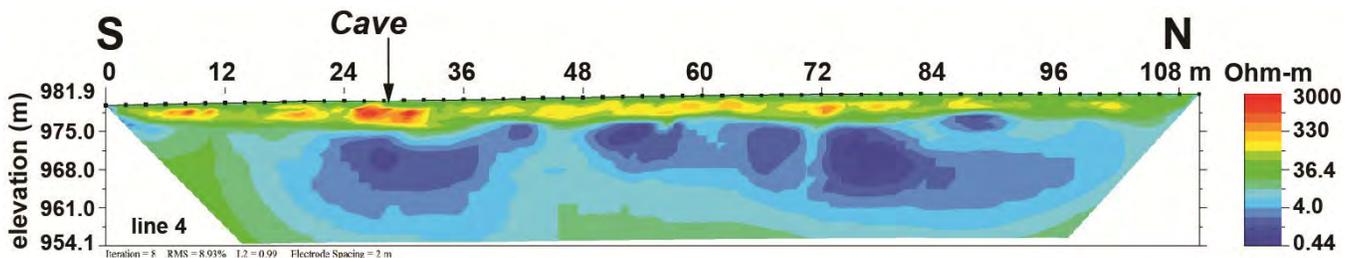
Figure 7: Electrical Resistivity Survey Line 4

Line 4 crosses the pipeline ditch 30 m from the line's south end (Figure 3). It shows a part of the known cave between 26 and 34 m, indicated by higher resistivity values 2-6 m below ground level (Figure 7). Line 2 intersects this transect at 81 m.

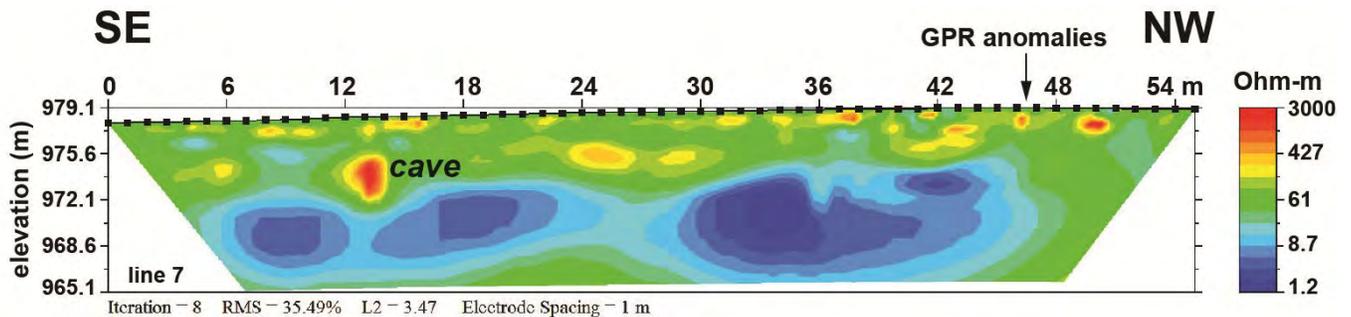
Figure 8: Electrical Resistivity Survey Line 7

Line 7 (Figure 8) extends SE-NW across the uncompacted area between the bypass road and trench, and crosses the area where GPR anomalies were identified at around 45 m along the line (Figure 3). No ER anomalies were identified in that area that might indicate a danger of significant collapse or subsidence. However, a small cave is indicated at 13 m, about 5 m below ground level. This cave presents

a moderate risk of collapse, and placement of infrastructure over it should be avoided.

The known cave was successfully imaged on electrical resistivity lines 8 and 9, demonstrating the effectiveness of the ER method in identifying air-filled voids in compacted gypsiferous soil. A second small cave has also been identified on line 7. Placement of infrastructure or roads in that area should be avoided.

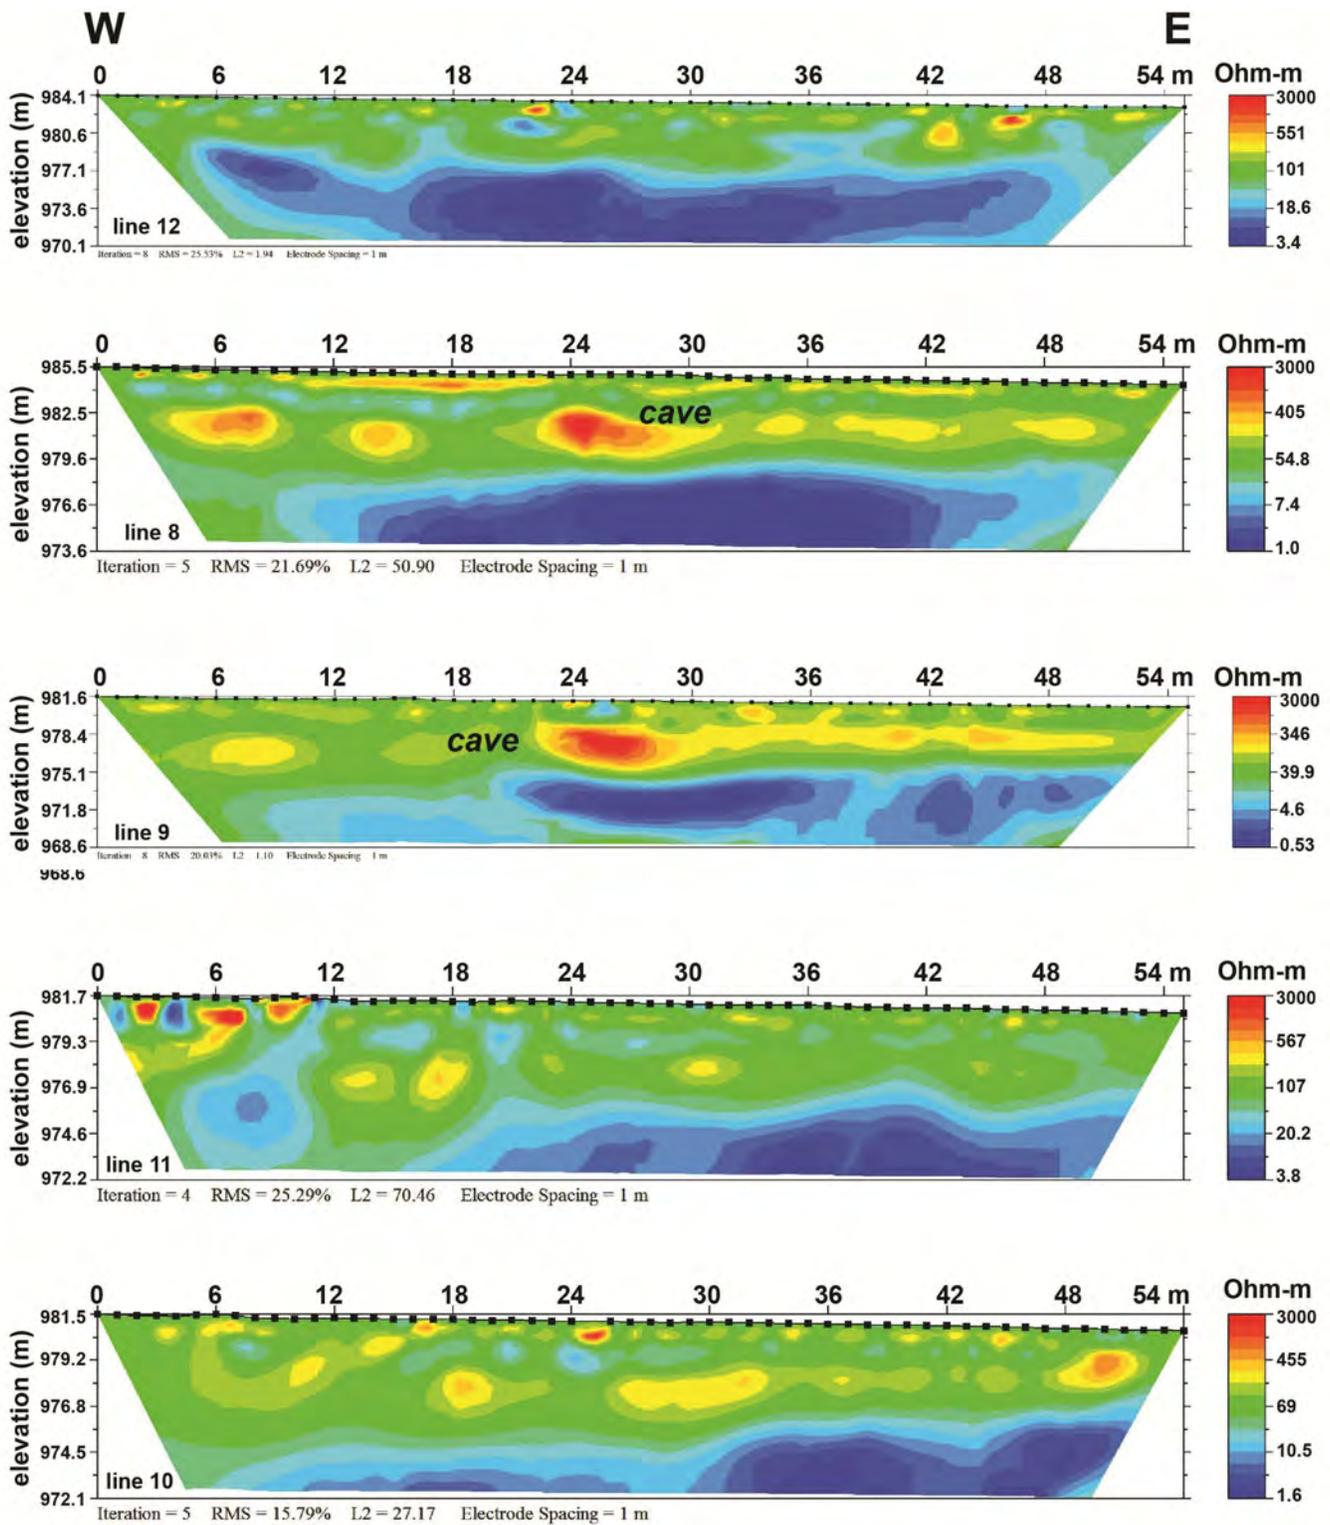
Figure 9: Electrical Resistivity Survey lines 8-12

Figure 9 shows the profiles of lines 8-12. Lines 8 and 9 cross the known cave between about 22 and 30 m. The cave is indicated by a high resistivity zone 3 to 6 m below ground level in lines 8 and 9, but is not present on lines 10, 11, and 12. Moderate resistivity anomalies are also present

on line 8 at 8 and 16 m and between 40 and 46 m; on line 10 at 18, 32 and 50 m; on line 11 between 12 and 18 m; and on line 12 between 42 to 47 m (Figures 3 and 9). Line 10 also shows a very shallow high resistivity anomaly at 26 m, immediately adjacent to a pothole where a truck driver

for Intrepid reported evidence of subsidence. This feature may be caused by a shallow air pocket in gypsiferous soil. Further investigations with a hand auger could confirm this hypothesis.
