NCKRI REPORT OF INVESTIGATION 1

GEOLOGIC AND HYDROLOGIC RECONNAISSANCE OF LAS CRUCES, PETÉN DEPARTMENT, GUATEMALA

Lewis Land
George Veni

January 2011

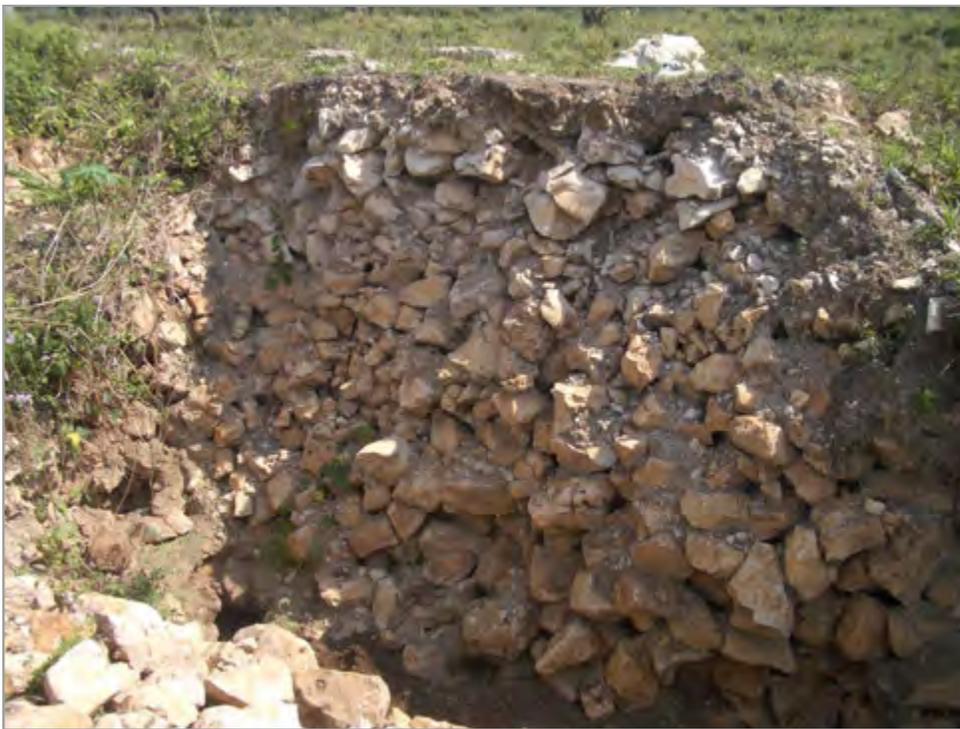
Figure A11. Rock-lined pit near Test Pit 40 of presumed Maya origin.

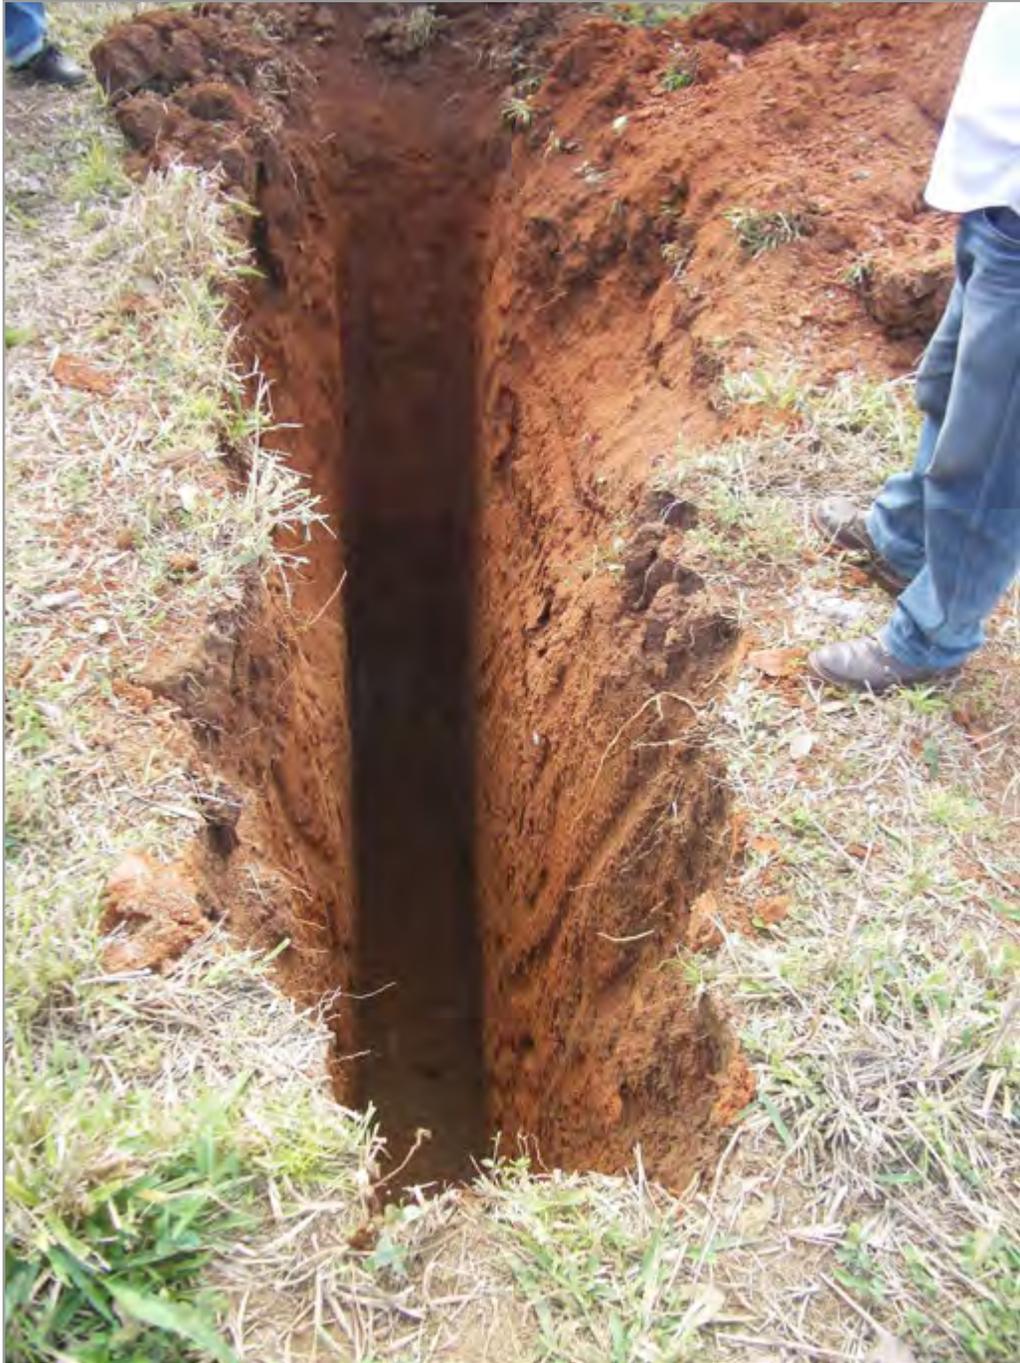
Figure A12. Test Pit 50.

Description: Maximum depth 3.9 m. Deep red clay-rich soil from the surface extends to the bottom. From this pit, the transect turns due south into open fields, following a property line.

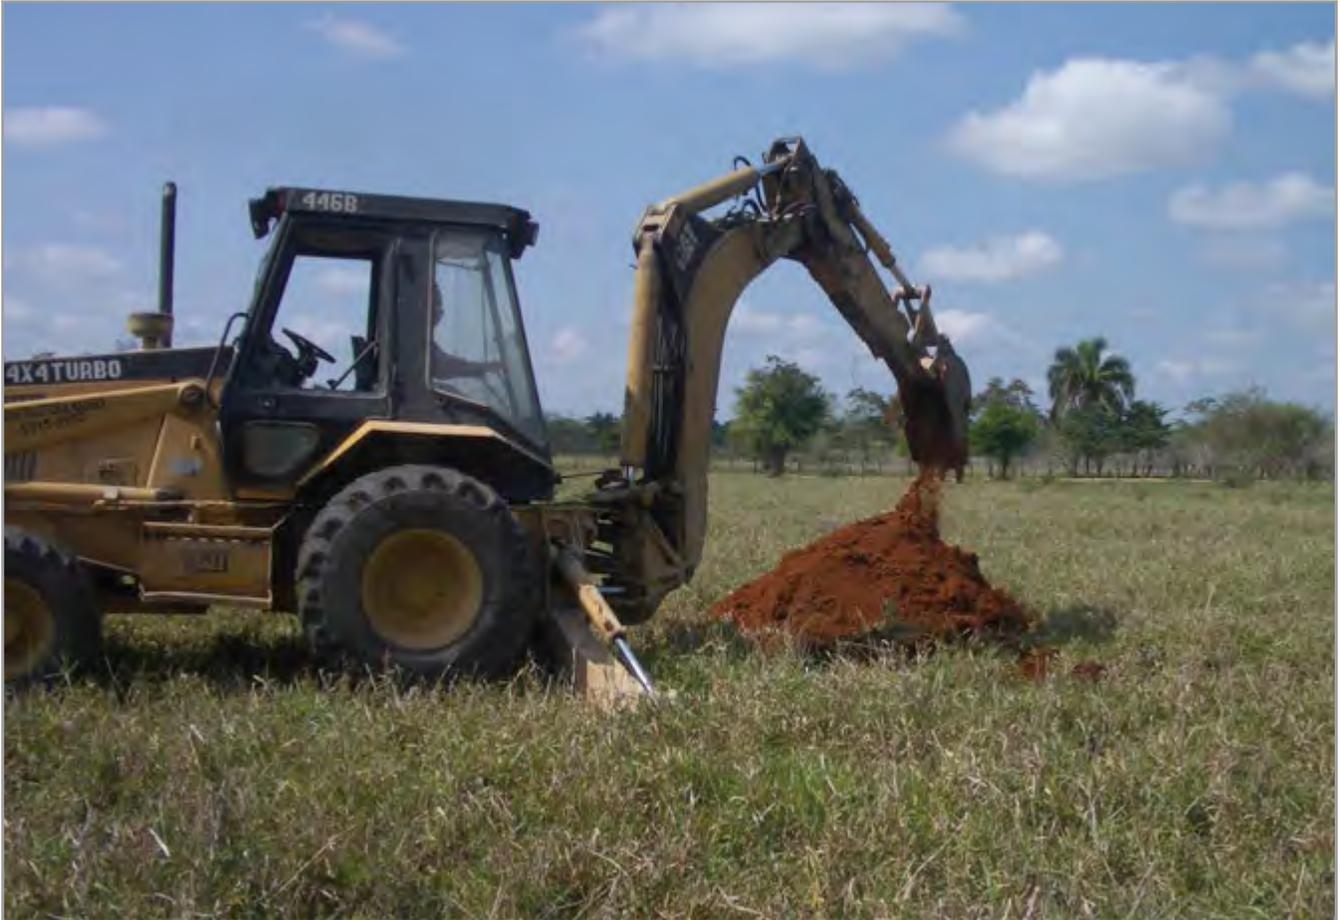
Figure A13. Backhoe excavation of Test Pit 60.

Description: Maximum depth 3.7 m. Clay-rich red soil, becoming more compacted with depth, with dense, orange clay at the bottom.

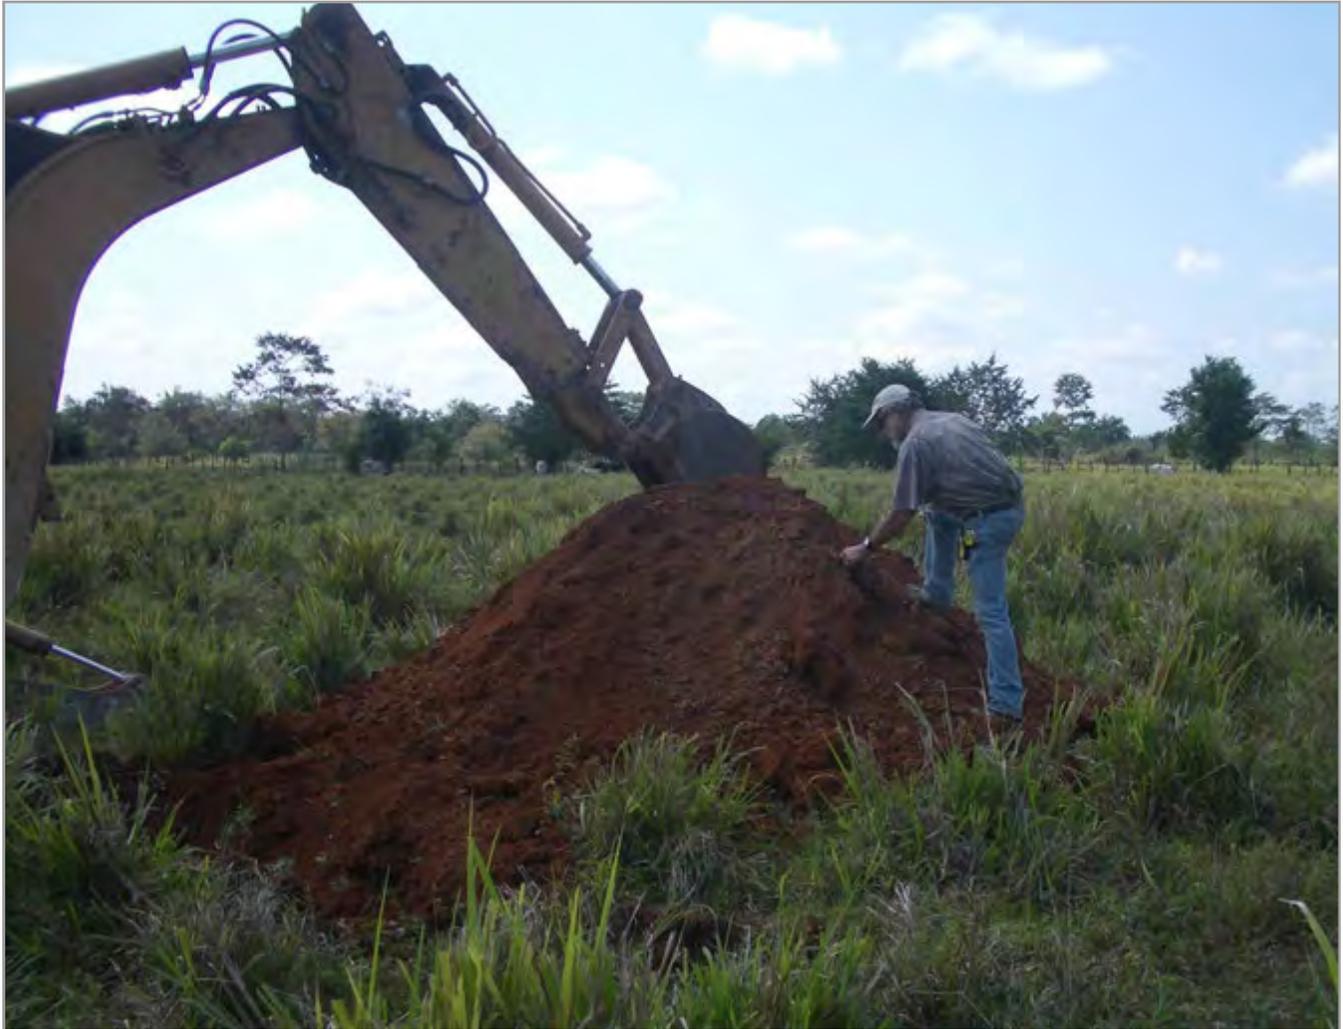
Figure A14. Dr. Land inspecting soil content from Test Pit 70 excavation.

Description: Maximum depth 3.8 m. Red-brown clay-rich soil with dense red clay at the bottom.

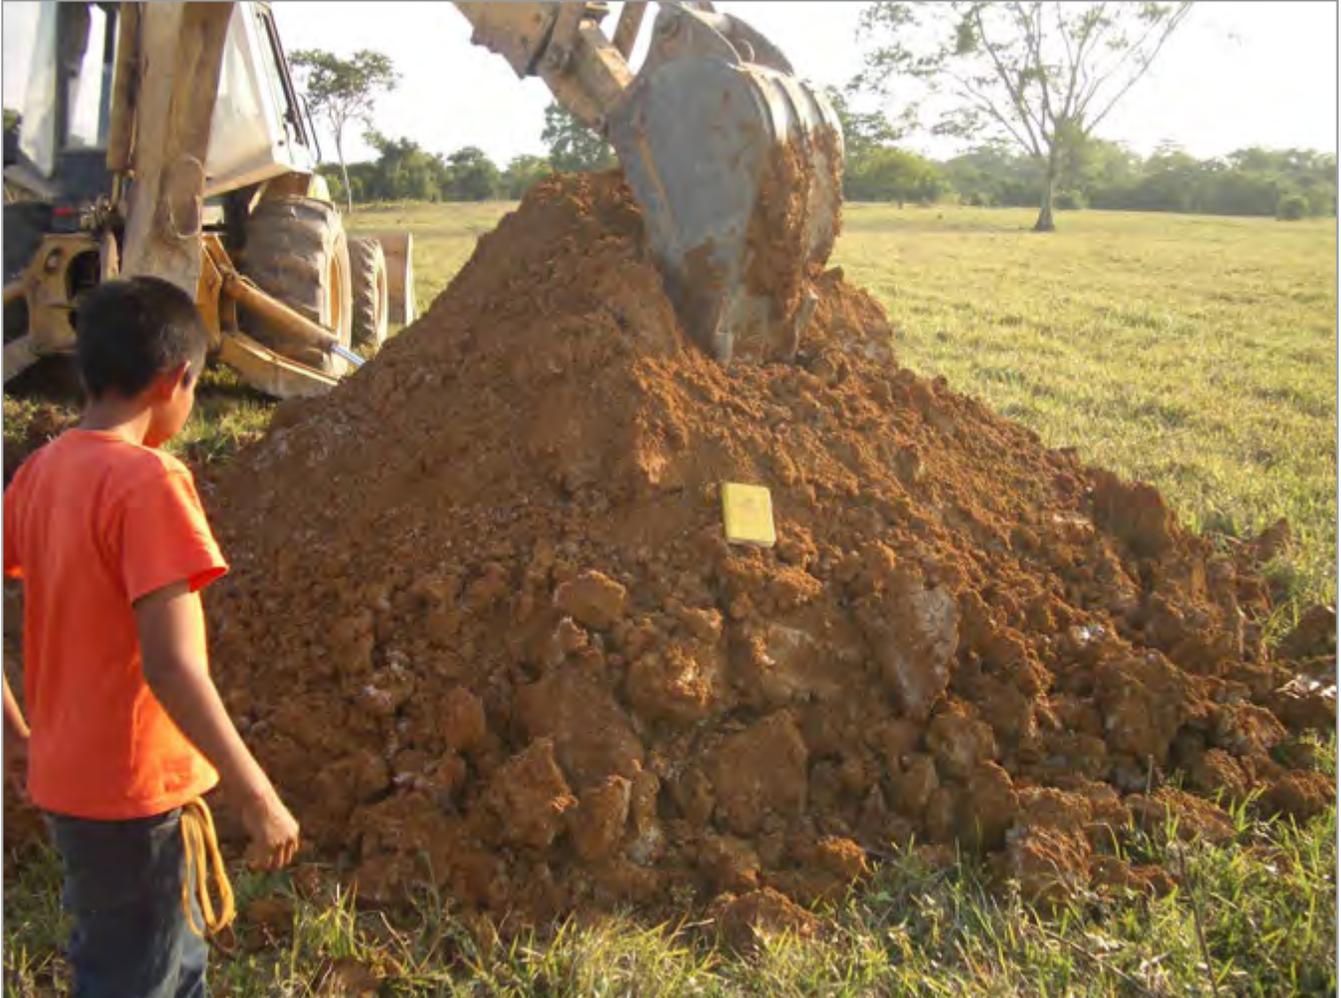
Figure A19. Sediment excavated from Test Pit 230.

Description: Maximum depth 3.7 m. Reddish-brown soil down to approximately 3 m followed by stiff orange-gray clay to the bottom.

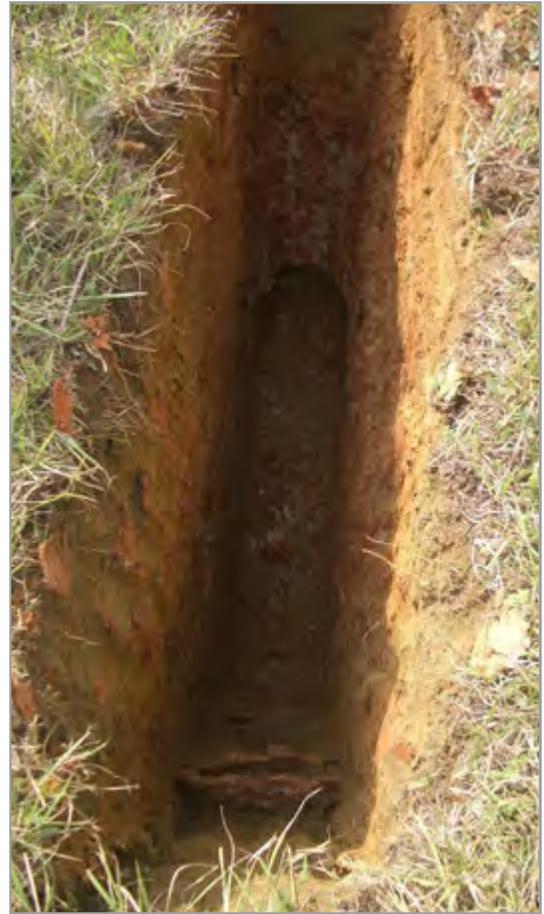
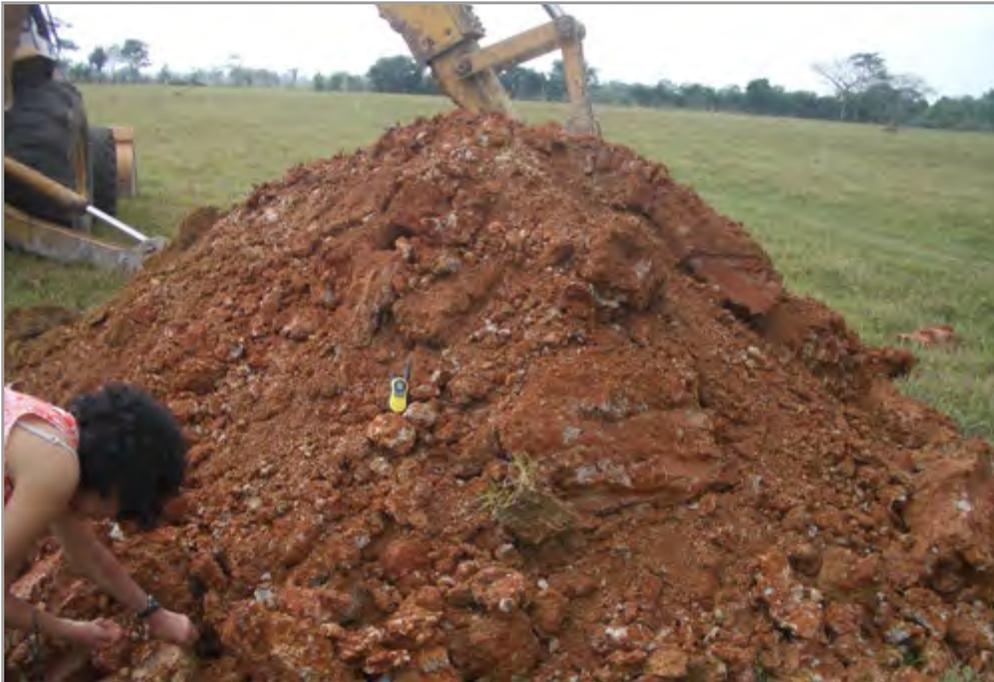
Figure A28. Test Pit 120.

Description: Maximum depth 3.7 m. Red-brown soil, more friable than previous two test pits, followed by dense orange clay from 2 m to the bottom.

Figure A29. Sediment excavated from Test Pit 120.

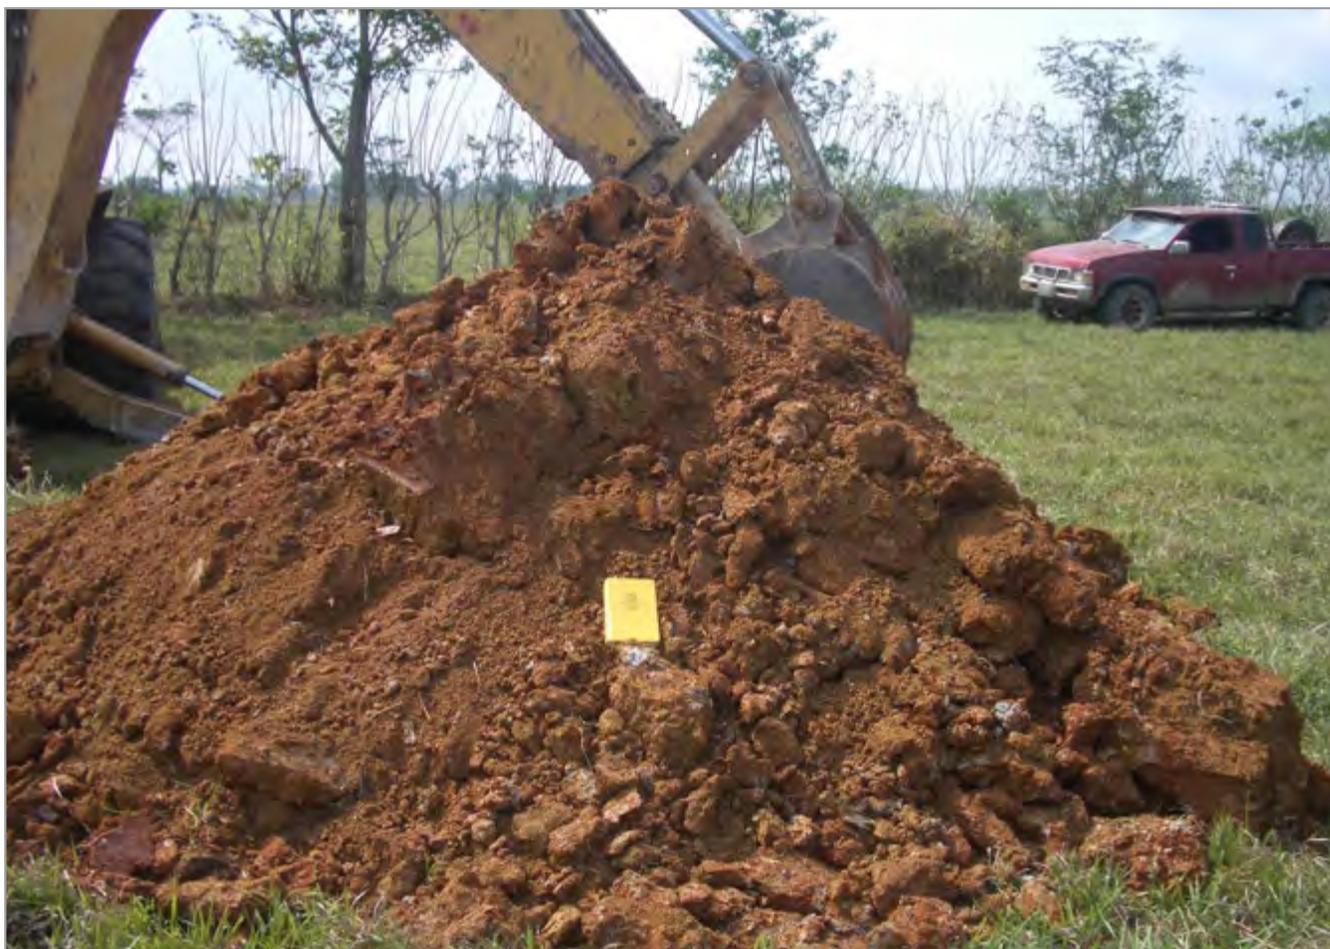
Figure A30. Sediment excavated from Test Pit 130.

Description: Maximum depth 3.5 m. Friable orange soil down to approximately 2 m followed by dense orange clay to the bottom.

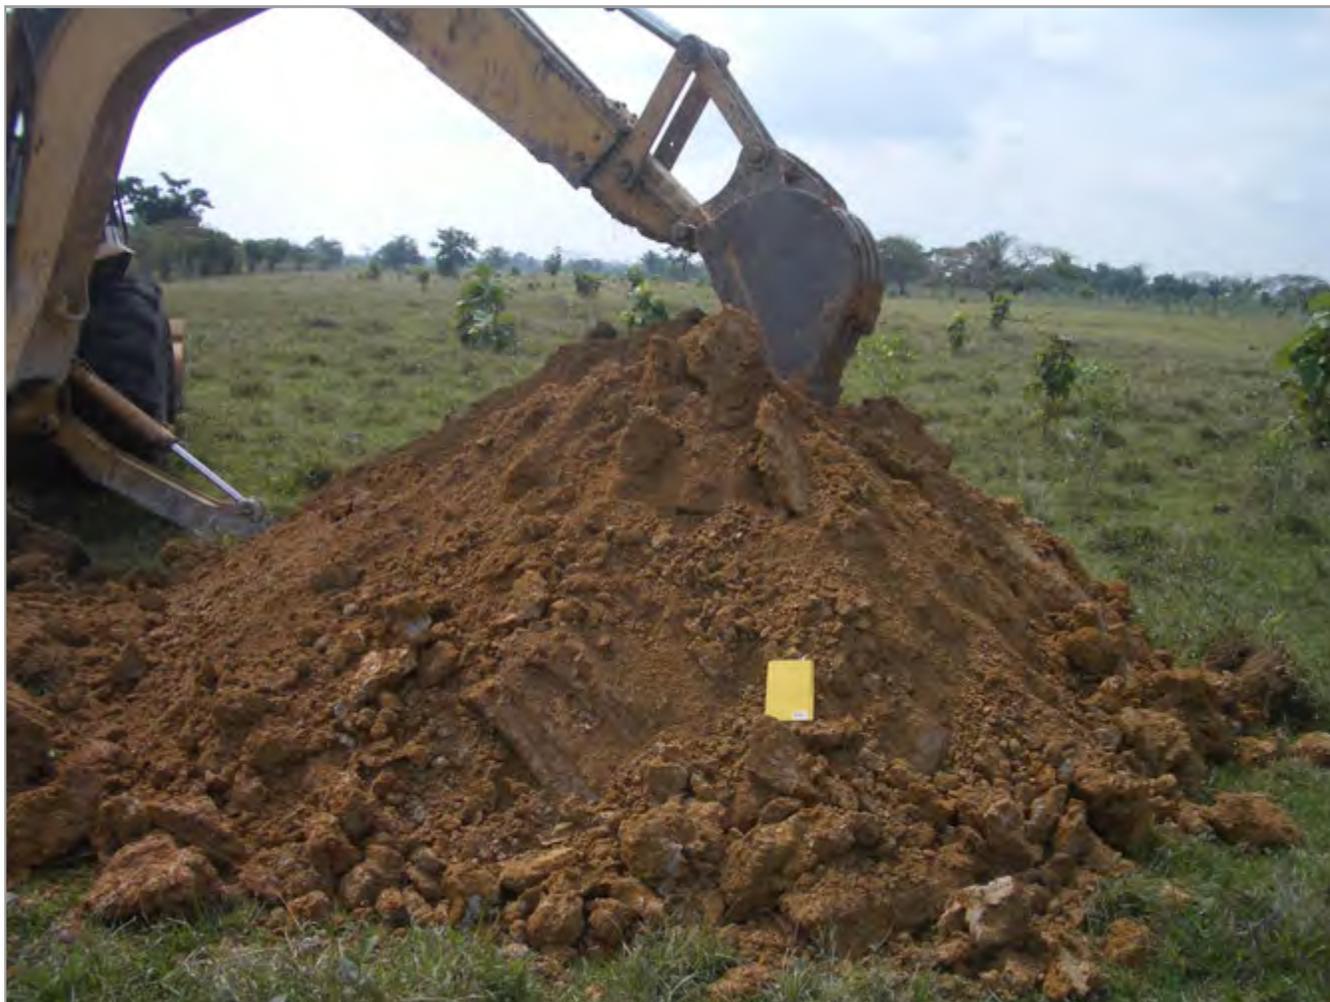
Figure A31. Sediment excavated from Test Pit 140.

Description: Maximum depth 3.6 m. Light reddish-brown, friable soil near the surface followed by dense orange clay to the bottom.

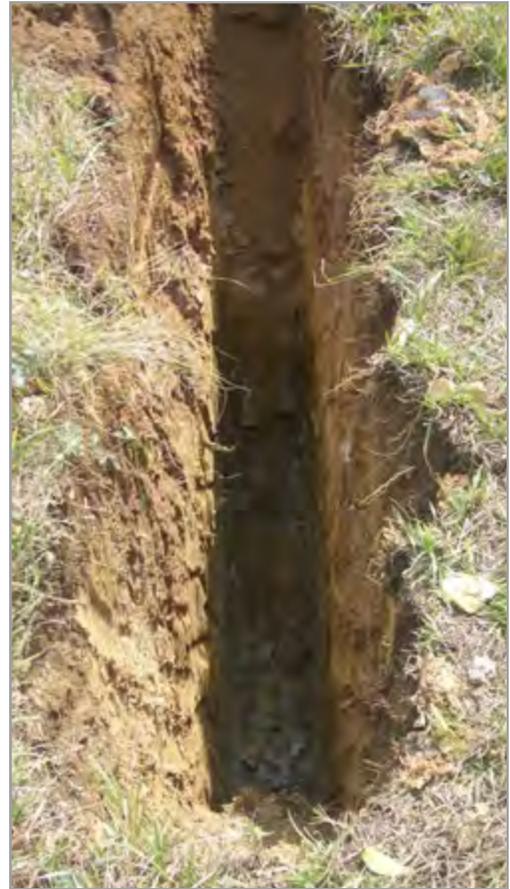
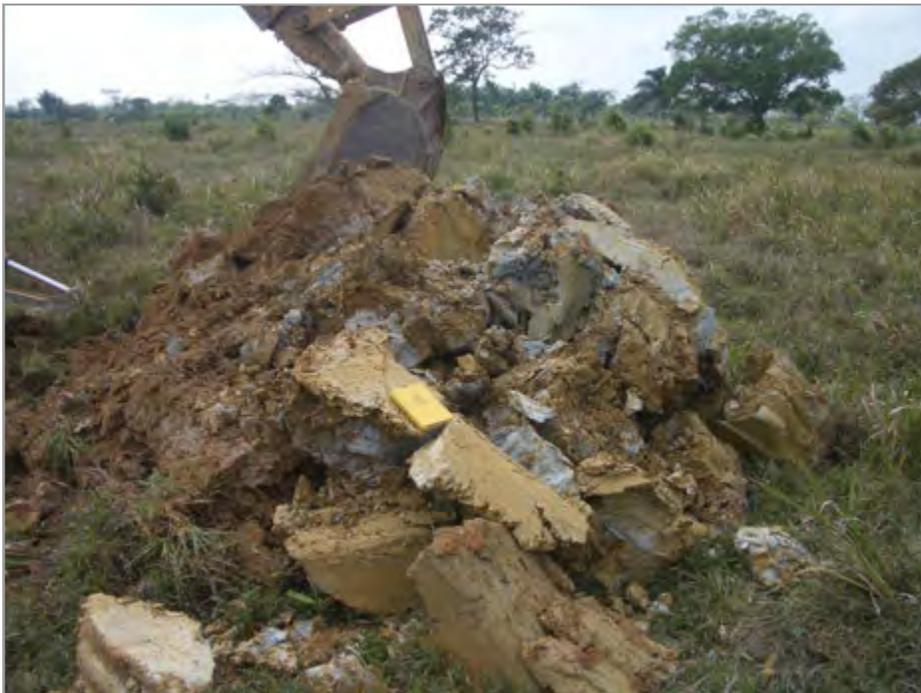
Figure A32. Test Pit 150.

Description: Maximum depth 3.8 m. Brown soil near the surface underlain by dense orange and gray clay to the bottom.

Figure A33. Dense clay excavated from Test Pit 150.

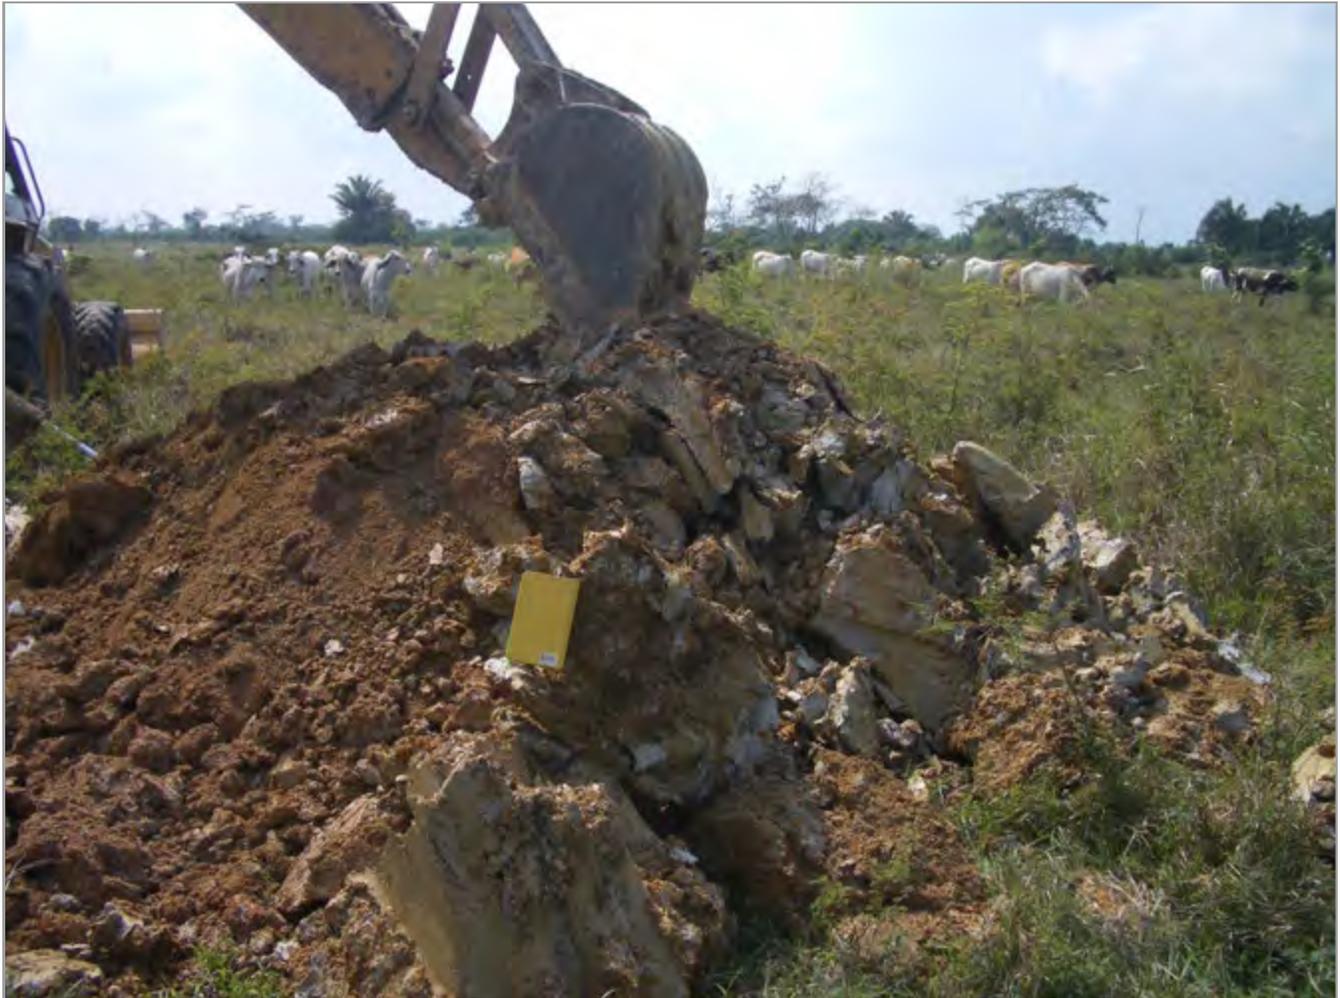
Description: Maximum depth 3.6 m. Very dense, high plasticity orange and gray clay.

Figure A34. Sediment and dense clay excavated from Test Pit 160.

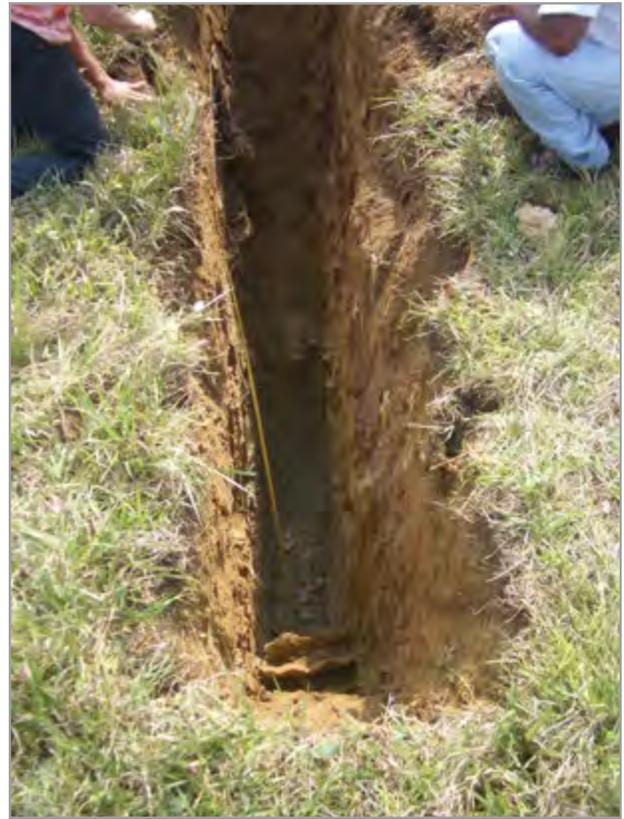
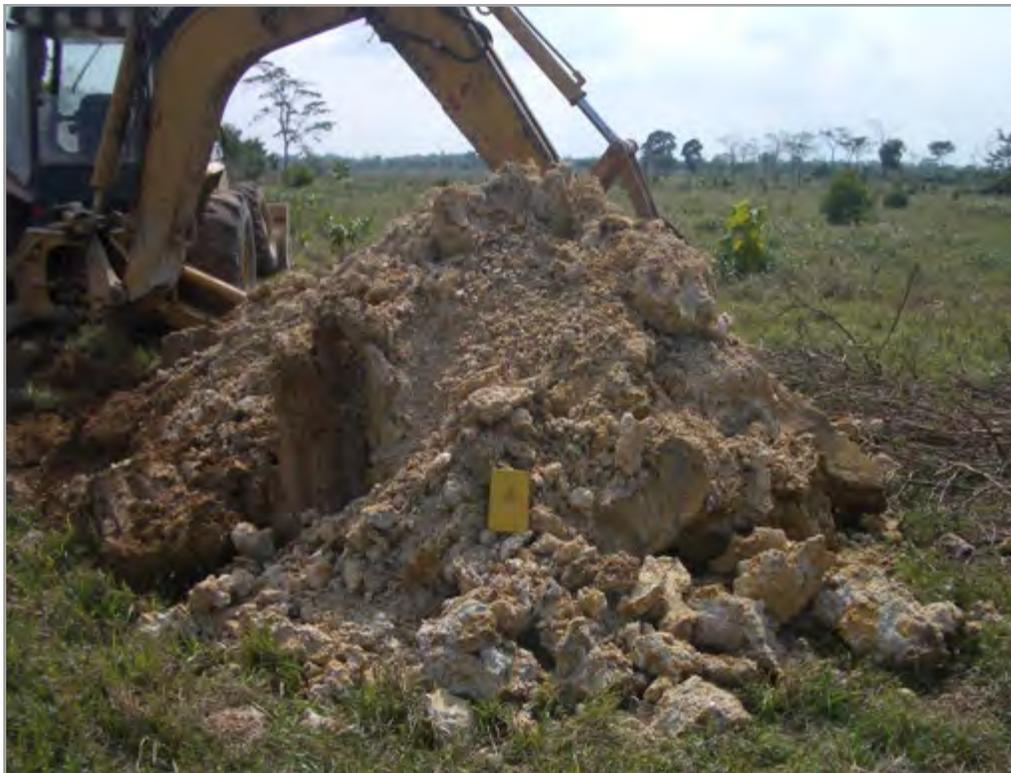
Figure A36. Test Pit 180.

Figure A37. Sediment excavated from Test Pit 180.

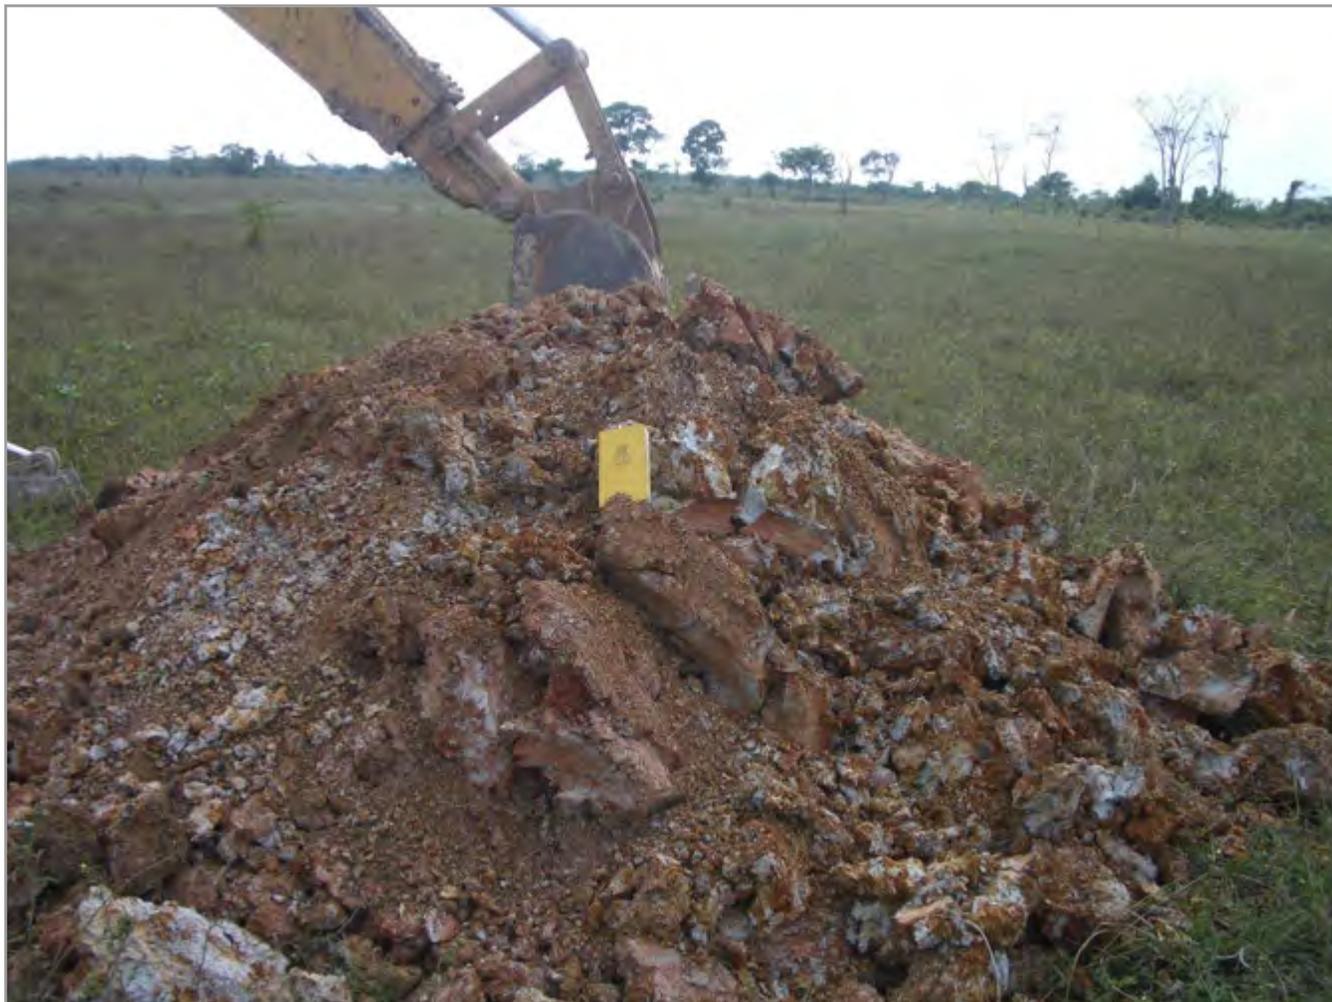
Figure A38. Sediment excavated from Test Pit 190.

Description: Maximum depth 3.8 m. Light-brown soil down to 1.5 m, underlain by dense orange and gray clay.

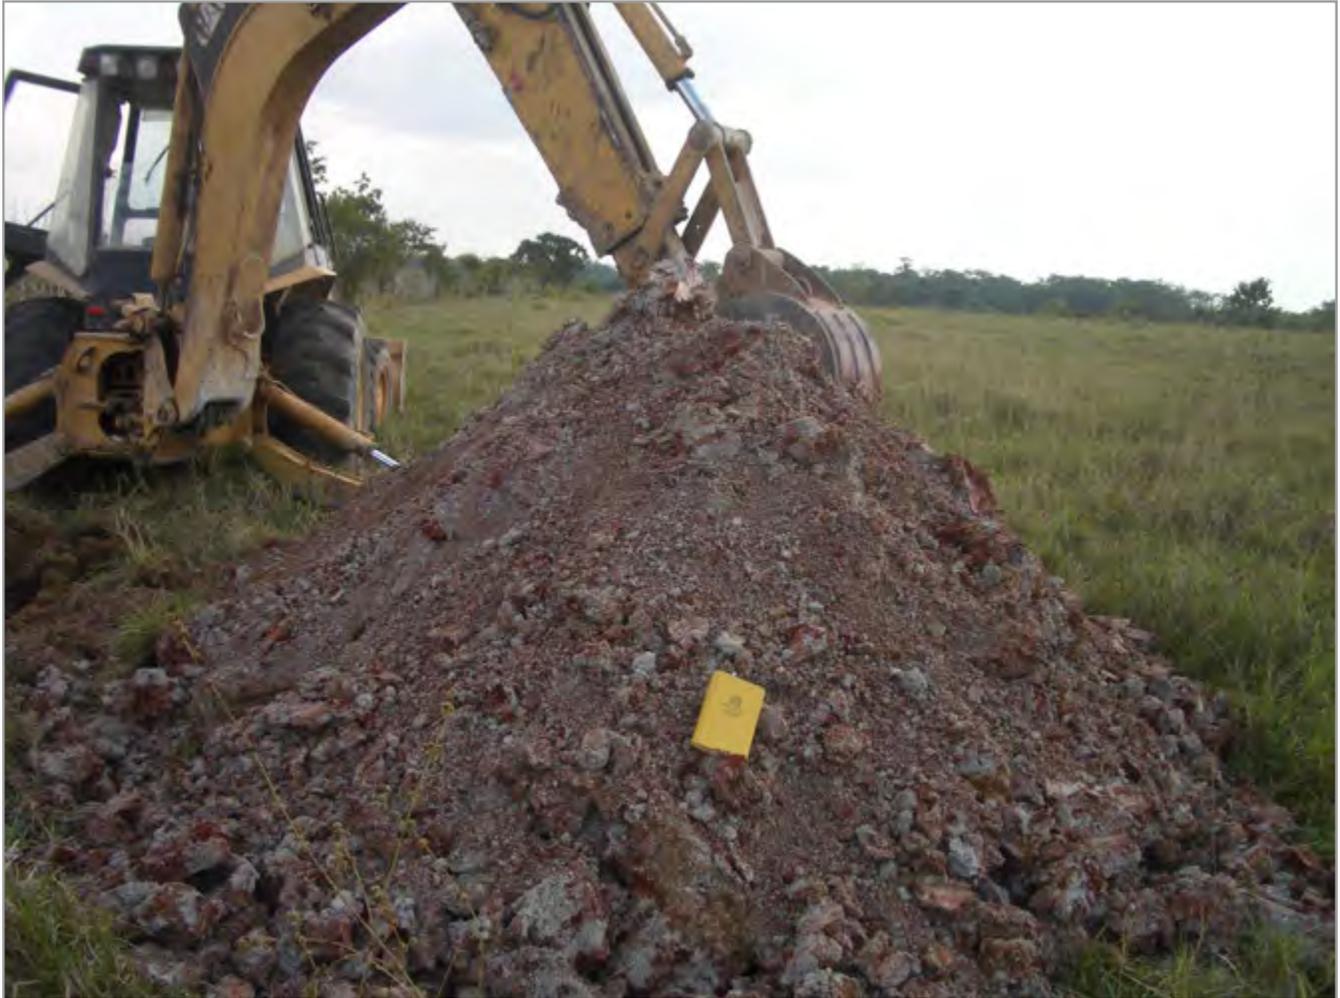
Figure A41. Sediment excavated from Test Pit 210.

Description: Maximum depth 3.7 m. Reddish-brown soil, becoming more clay-rich with depth. The bottom of the pit was in orange clay.
