NCKRI REPORT OF INVESTIGATION 6

**GEOPHYSICAL INVESTIGATION OF FLOOD-INDUCED
SINKHOLE COLLAPSES, LAKEWOOD REGION,
EDDY COUNTY, NEW MEXICO**

Lewis Land
Lasha Asanidze

June 2014

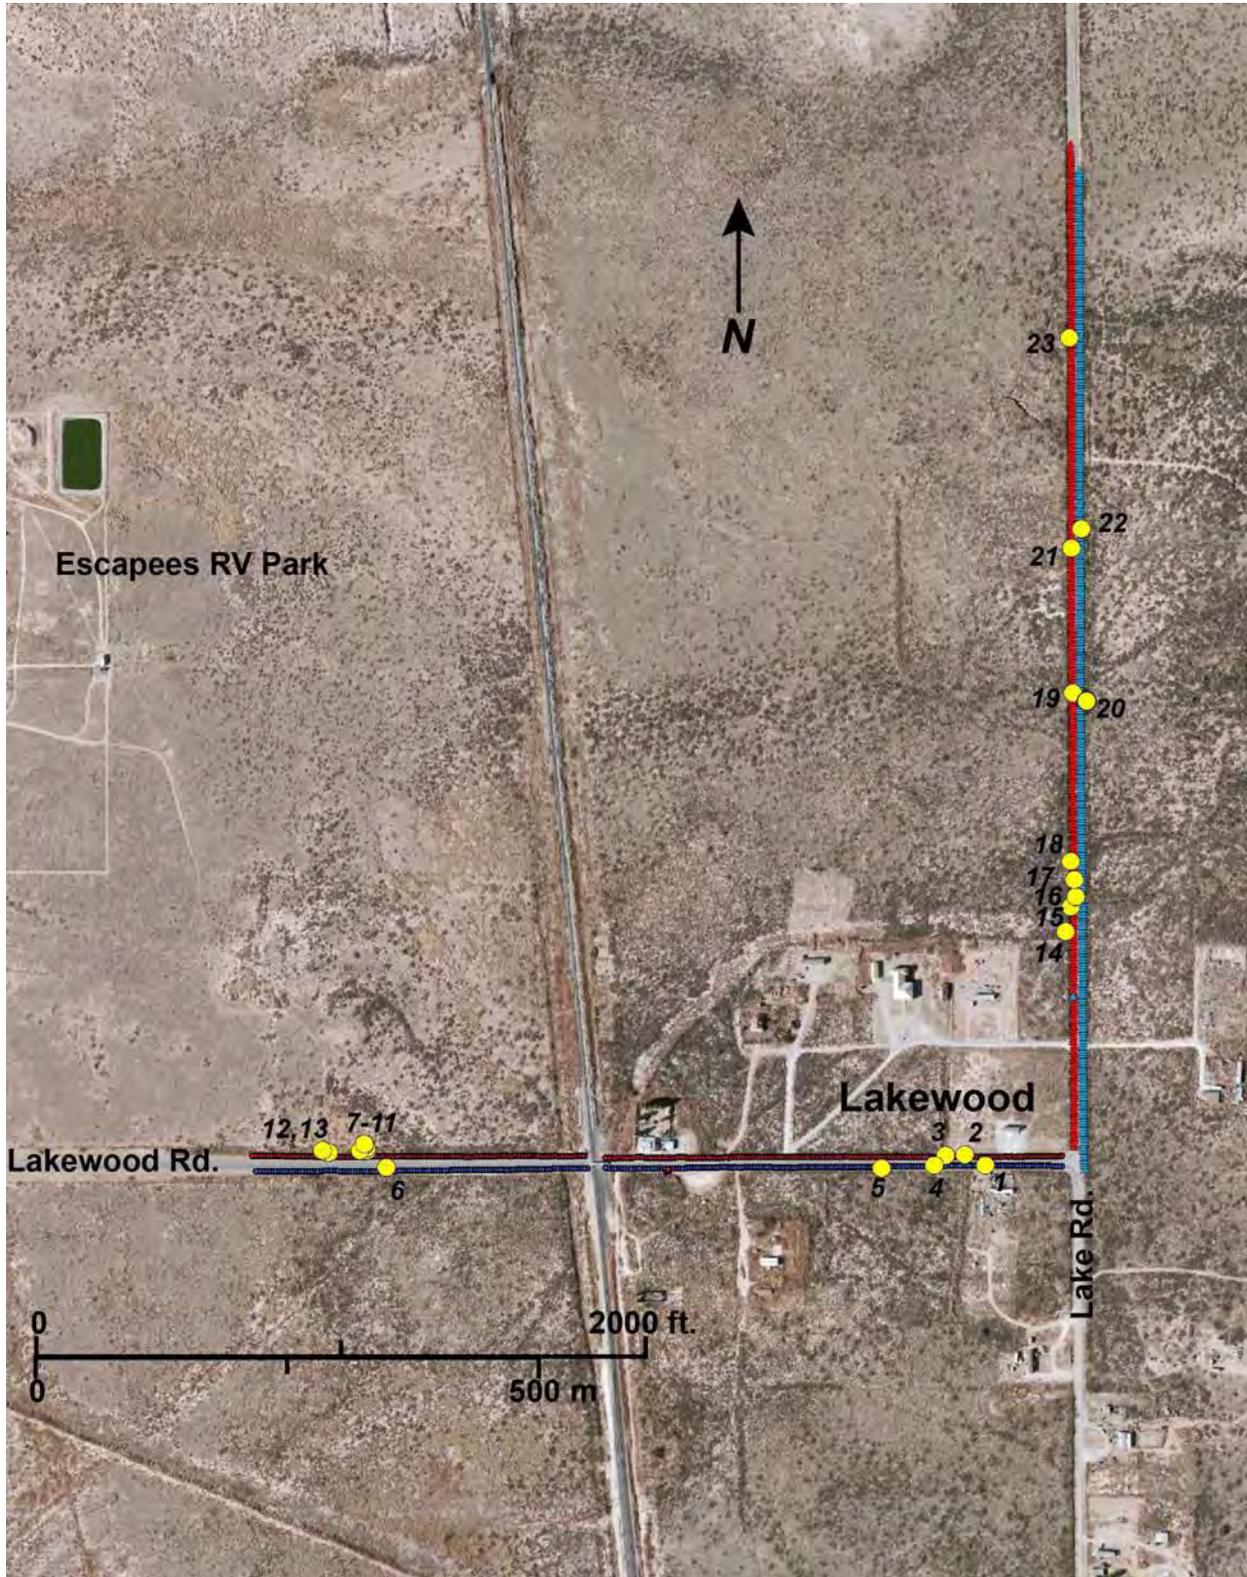
Figure 2. Lakewood, NM, study area. ER survey lines parallel to Lake and Lakewood roads are indicated by red and blue dots; each dot represents one electrode in the array. Yellow filled circles show locations of sinkholes and other karst features photographed during resistivity surveys ([Appendix](#)).
